Landmark Trees

FURTHER INVESTIGATION REPORT:

14 Greenaway Gardens
London
NW3 7DH

Date: 8th December 2022

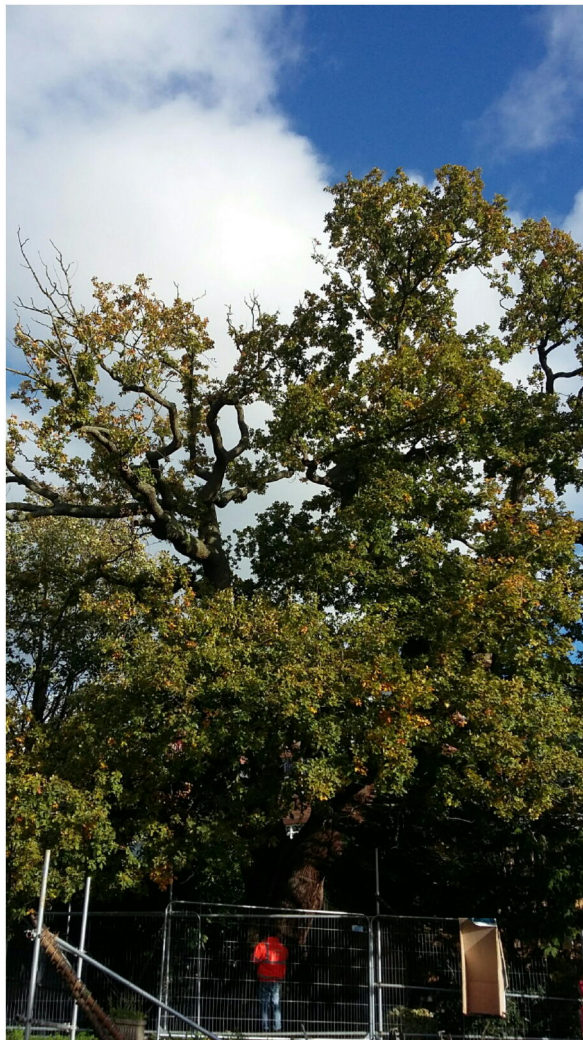
Photograph 1: T29

This mature tree is situated 6m from the north eastern boundary of the property. The crown to the west is sparse with significant deadwood and dieback. There are pruning wounds throughout from deadwood clearance performed last year. There is an open cavity 15cm diameter at ground level to the south west. Although not currently visible, Honey Fungus (*Armillaria mellea*) has been reported around the south west of the stem. Further fungal remnants are visible (Photo 2), most likely of *Pseudoinonotus dryadeus*. At 7m to the east further fungal remains are visible erupting from a pruning wound, most likely *Laetiporus sulphureus*.

Remove upper / outer deadwood and reduce live crown by approximately 3-4m. Please note that this recommendation is made upon the assumption of a client preference to retain the tree. Continue to monitor ongoing health of tree with annual inspections.

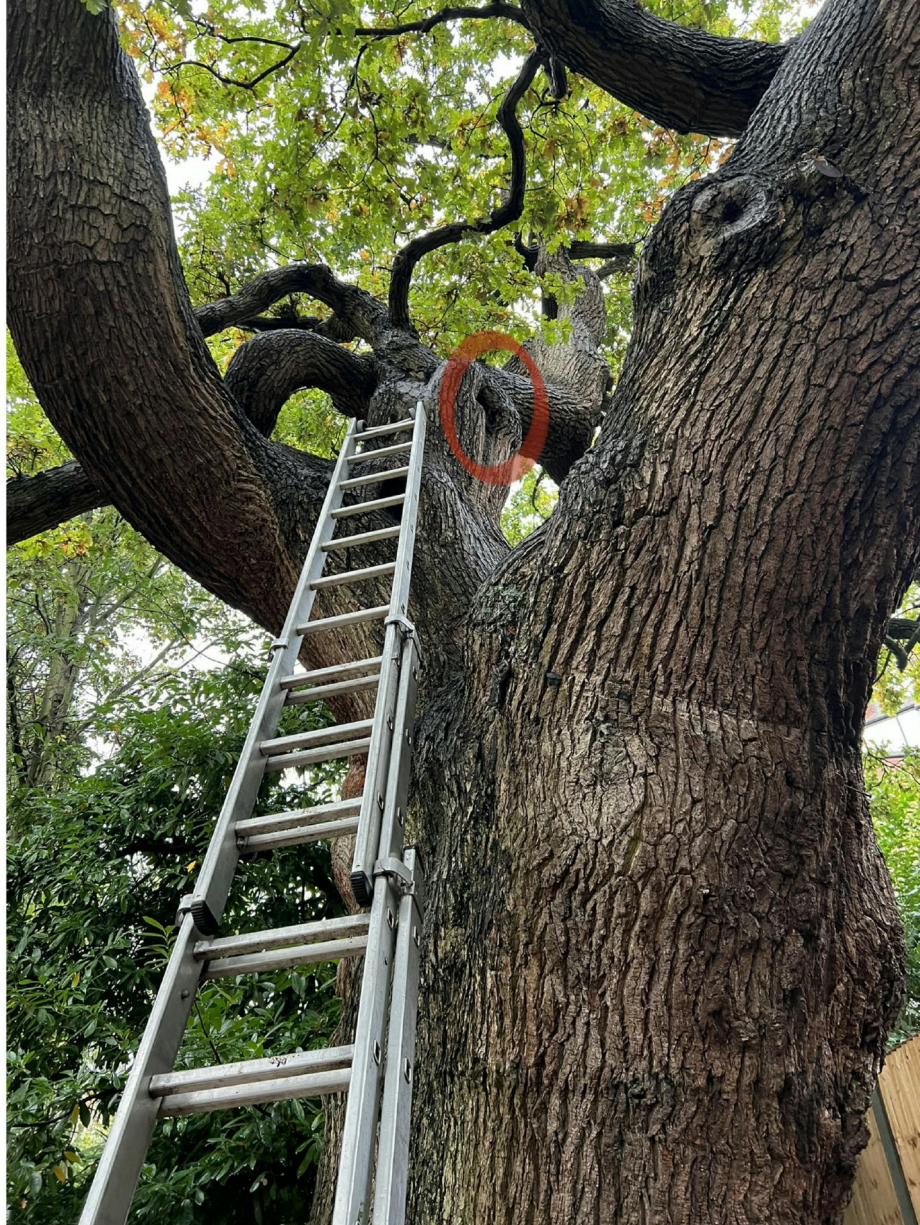
Photograph 2: T29 lower crown with cavities front on / from SW

On the ascending co-dominant stem to the west is an open cavity 2m in length that resembles a hammock, with little residual sound wood.

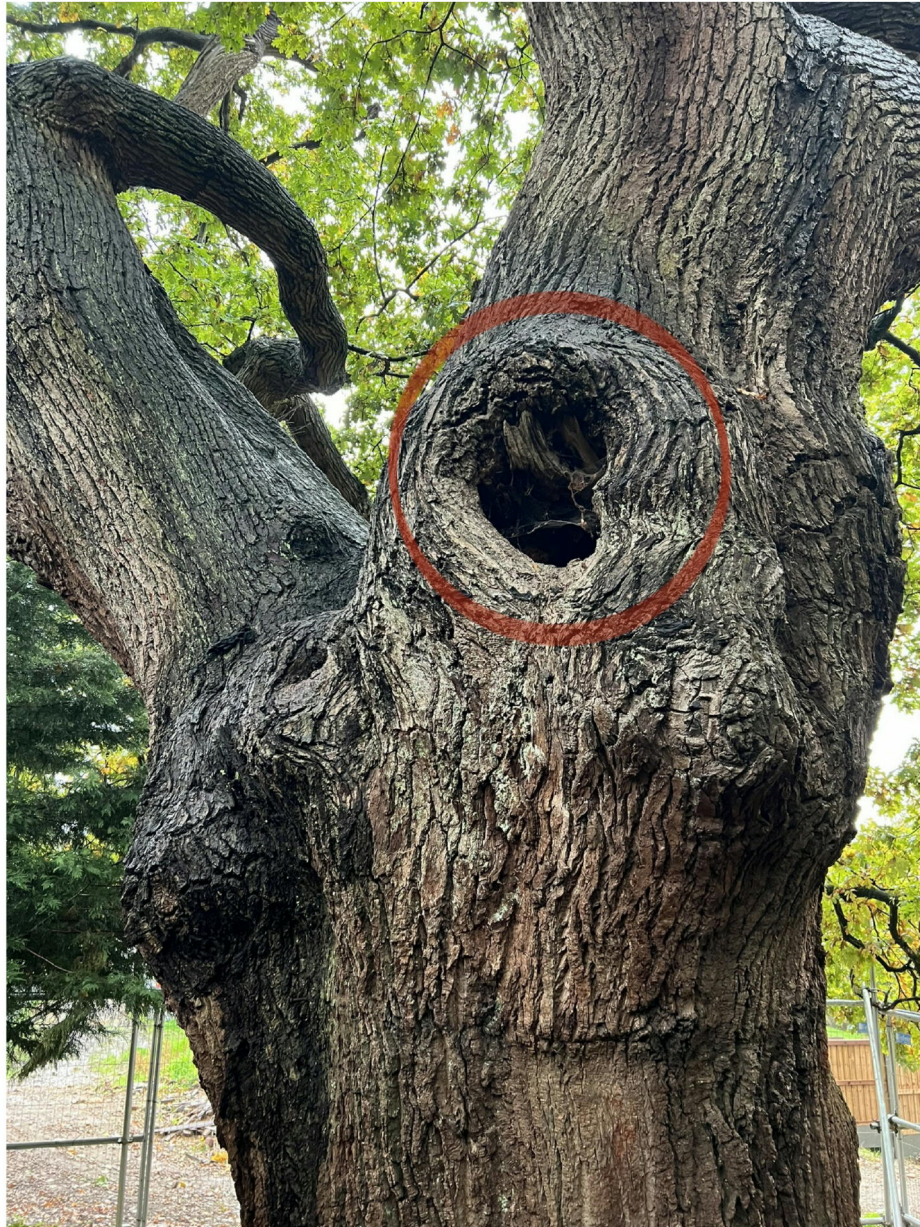
Photograph 3: T29 lower crown with cavities from rear NE

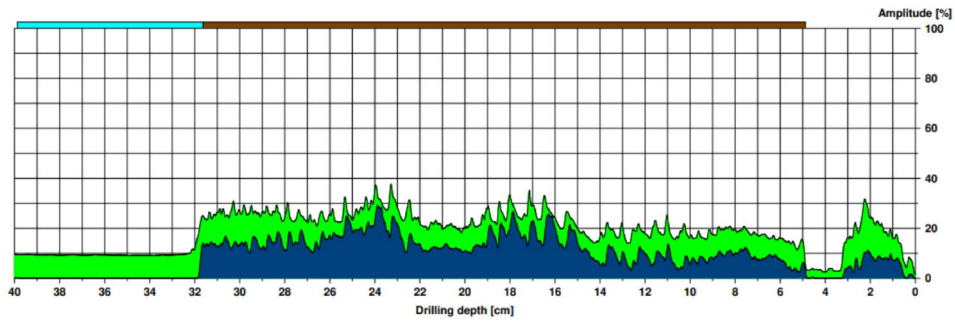
14 GREENWAY OAK 30 cm NM001

From	4.88 cm	to	31.63 cm	:	Good Wood
From	31.63 cm	to	39.87 cm	:	Cavity

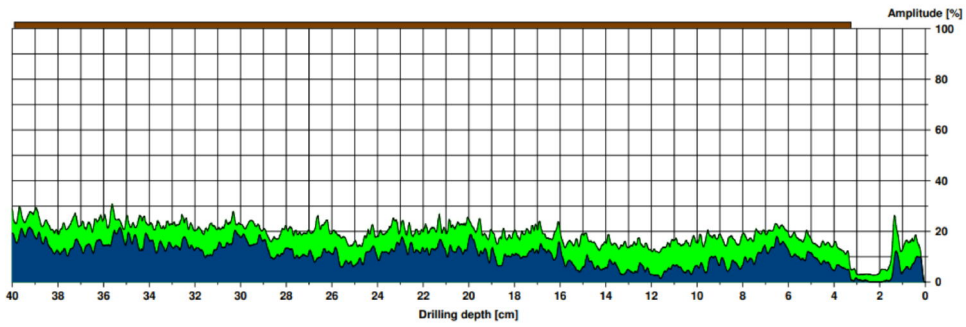
14 GREENAWAY OAK 30 cm NEM006

From 3,26 cm to 39,90 cm : Good Wood

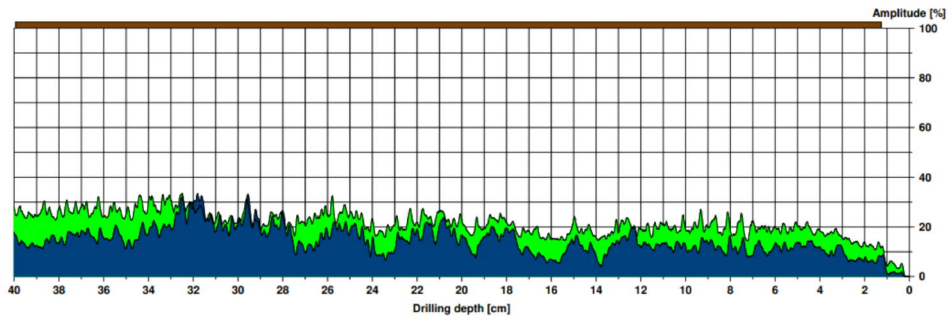
14 GREENAWAY OAK 30 cm EM005

From 1,26 cm to 39,94 cm : Good Wood

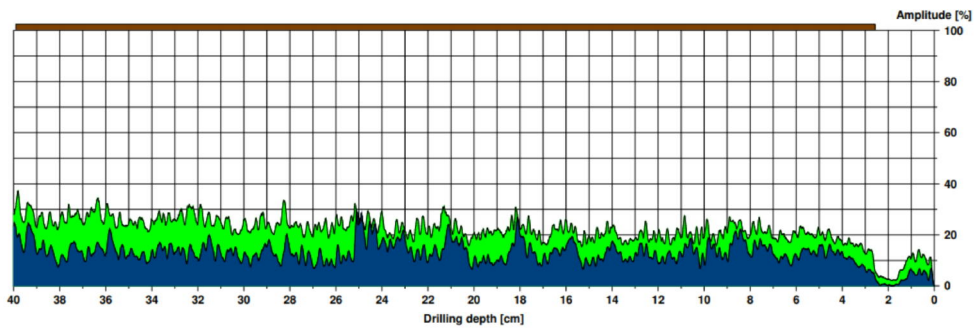
14 GREENAWAY OAK 3.5M SSEM009

From 2.58 cm to 39.90 cm : Good Wood

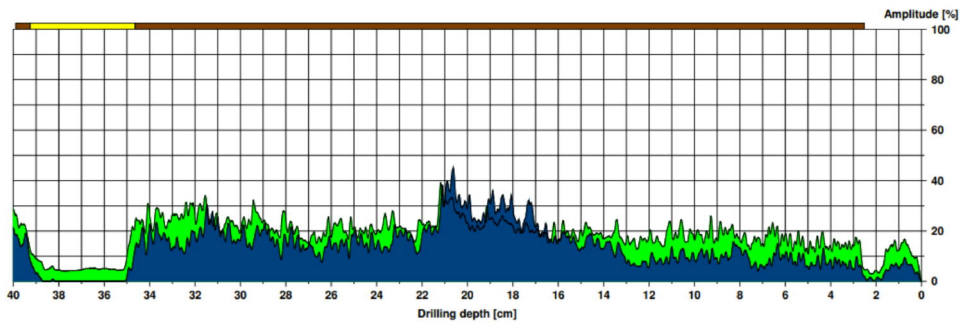
14 GREENAWAY OAK 3.5M SM008

From	2,52 cm	to	34,64 cm	:	Good Wood
From	34,64 cm	to	39,26 cm	:	Crack
From	39,26 cm	to	39,90 cm	:	Good Wood

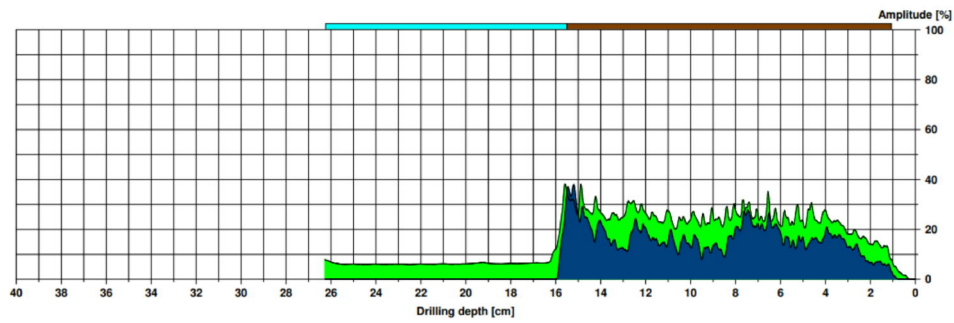
14 GREENAWAY OAK 30 cm WM003

From	1,07 cm to	15,51 cm	: Good Wood
From	15,51 cm to	26,24 cm	: Cavity

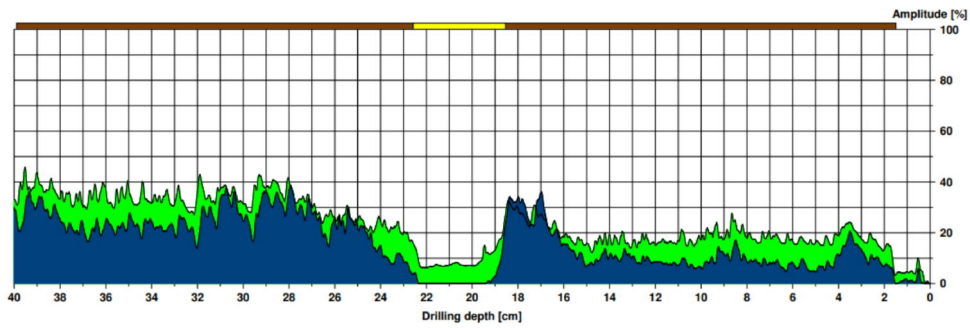
14 GREENAWAY OAK 30 cm NWM002

From	1,49 cm to 18,55 cm	: Good Wood
From	18,55 cm to 22,58 cm	: Crack
From	22,58 cm to 39,90 cm	: Good Wood
