ARBORICULTURAL ASSESSMENT REPORT

43 Gondar Gardens, London, NW6 1EP

Survey Date: 14/10/2022

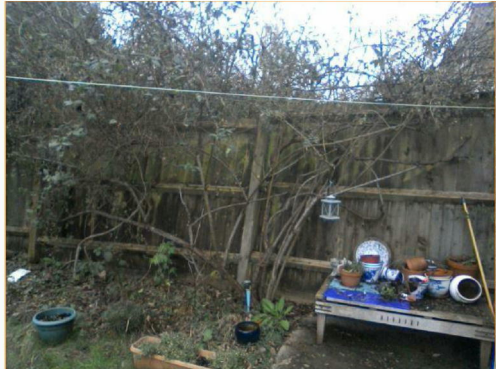
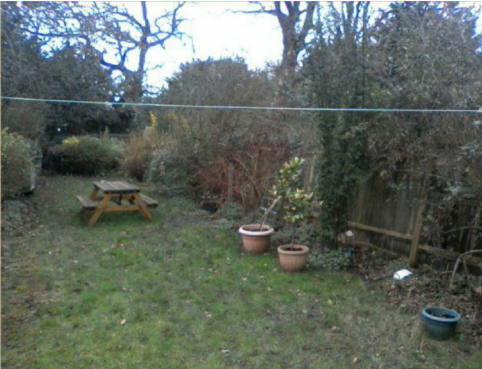
HG1 - Rose, Pyracantha (February 2021)

Tree No	Common Name	Age Class	Condition	Height (m)	Crown Spread (m)	Stem diam. (mm)	Dist to bldg. (m)	Roots Implicated	Pruning history	Recommendation	Tree work constraints	Notes	Owner address	Owner
HG1	Rose, Pyracantha	Semi-Mature	Fair	2	2	30	8	N	Hedge/rose removed giving 8 metre clearance from house	No work required		Checked and amended 14/10/22	43 Gondar Gardens London NW6 1EP	PH
ST1	Rose	N/A	DD	0	0	0	1.2	N	Felled as per previous recommendations	No work required		Checked 14/10/22	43 Gondar Gardens London NW6 1EP	PH
STG1	Bay	N/A	DD	0	0	0	1	N	Felled as per previous instruction	No work required			43 Gondar Gardens London NW6 1EP	PH
T1	Oak	Mature	Good	26	17.0	800*	22*	Y	No significant past tree works	Fell and treat stump (deciduous). Checked and agreed 14/10/22	Access through building	Work not carried out, reoccurrence of damage revisited 14/10/22	45 Gondar Gardens London NW6 1EP	P3P
T2	Oak	Mature	Good	17*	15.0	900*	32*	N	No significant past tree works	No work required		Checked and agreed, too far to implicate. 14/10/22	Hampstead Cemetery Fortune Green Road London NW6 1DR	LA

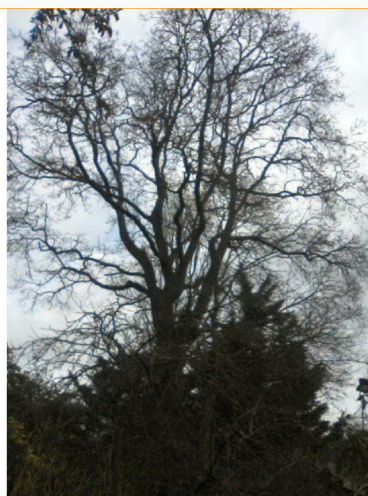
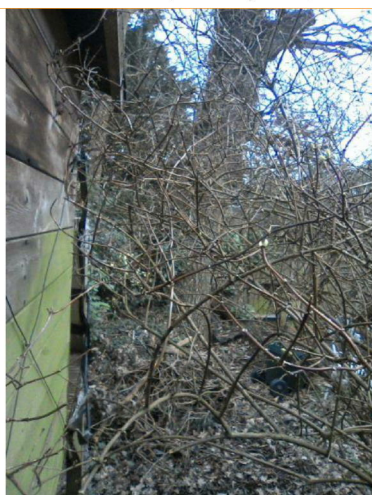
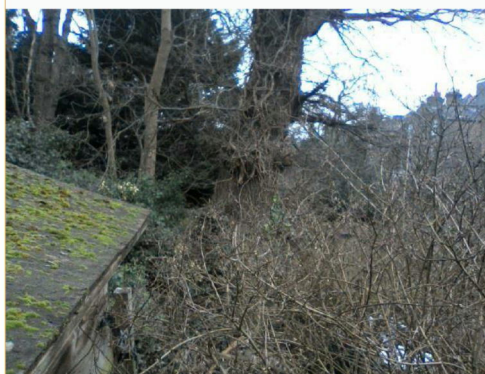
T1 - Oak (February 2021)

London Borough of Camden has confirmed that the implicated Oak vegetation is subject to a Tree Preservation Order. There are no Conservation Area controls.

Tree No:	Species	Works Required
T1	Oak	Fell and treat stump with eco plugs (deciduous).

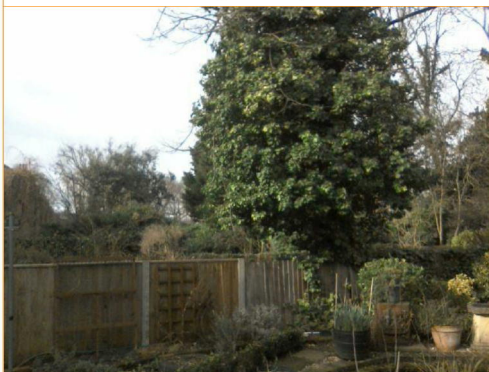
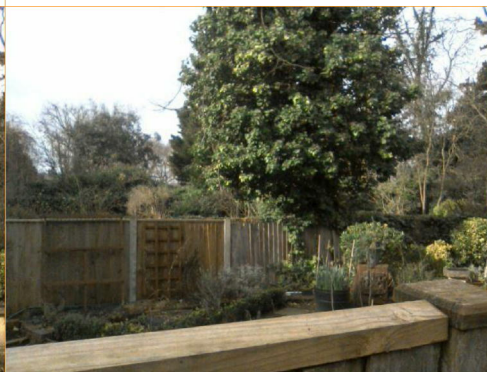
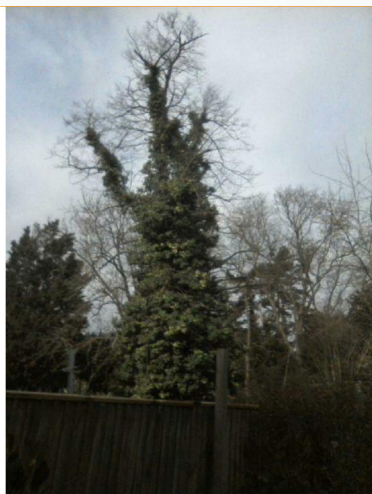
T3 – Lime (February 2021)

Tree No	Common Name	Age Class	Condition	Height (m)	Crown Spread (m)	Stem diam. (mm)	Dist to bldg. (m)	Roots implicated	Pruning history	Recommendation	Tree work constraints	Notes	Owner address	Owner
T3	Lime	Mature	Fair	19*	7.0	650*	15*	N	No significant past tree works	No work required		Checked and agreed 14/10/22	39 Gondar Gardens London NW6 1EP	P3P
