SITE INVESTIGATION FACTUAL REPORT

Report No: [REDACTED]
Client: Sedgwick International UK - Maidstone
Site: 43 Gondar Gardens
Client Ref: [REDACTED]
Date of Visit: 05/02/2020

<h1>Investigation Layout Plan</h1>	Sheet: 1 of 1	Site: 43 Gondar Gardens NW6
	Job No: [REDACTED]	
(SI)	SA (Checked)	CFT (Drawn)
Weather: DRY

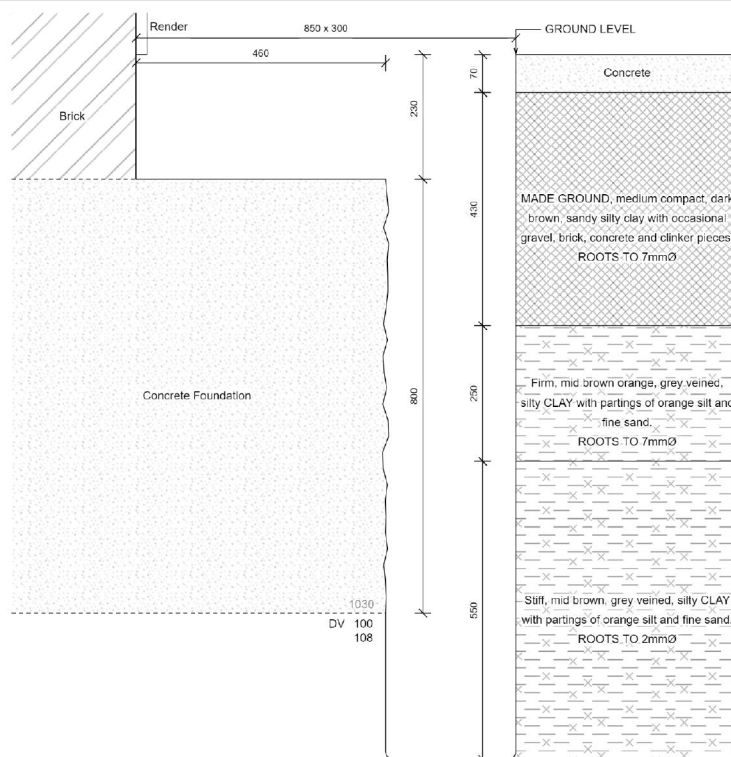
TEST REPORT: Trial Pit

For Strata below 1300mm see Bore Hole log

Water seepage at 750mm.
