Geo-Serv Limited

Issue date: 14/11/2022

Following survey No: 4 of tbc

Monitoring Plus Report

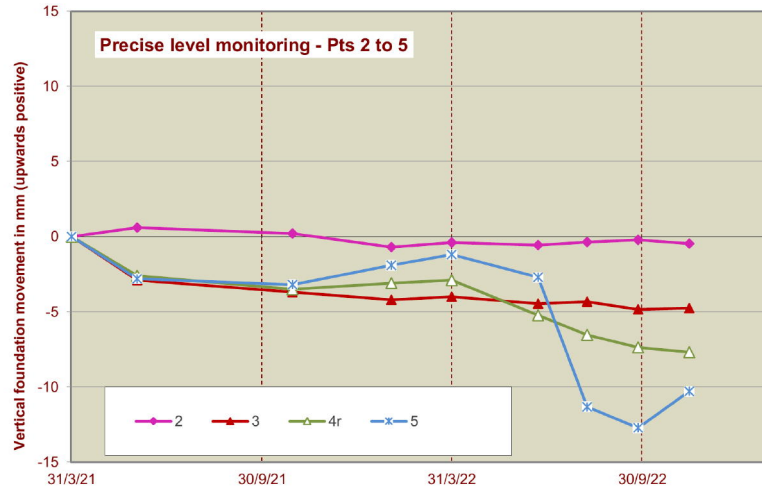
Precise level monitoring related to Point 1

Survey:	1 PB 22/06/2022		2 PB 08/08/2022		3 PB 26/09/2022		4 PB 14/11/2022		5 #N/A	
Point ID	levels mm	chngs mm	levels mm	chngs mm	levels mm	chngs mm	levels mm	chngs mm	levels mm	chngs mm
1	1000.00	0.0	1000.00	0.0	1000.00	0.0	1000.00	0.0		#N/A
2	1656.93	-0.6	1657.13	-0.4	1657.28	-0.2	1657.04	-0.5		#N/A
3	1663.23	-4.5	1663.37	-4.3	1662.85	-4.9	1662.94	-4.8		#N/A
4r	1387.97	-5.2	1386.65	-6.5	1385.82	-7.4	1385.51	-7.7		#N/A
5	883.90	-2.7	875.27	-11.3	873.87	-12.7	876.30	-10.3		#N/A

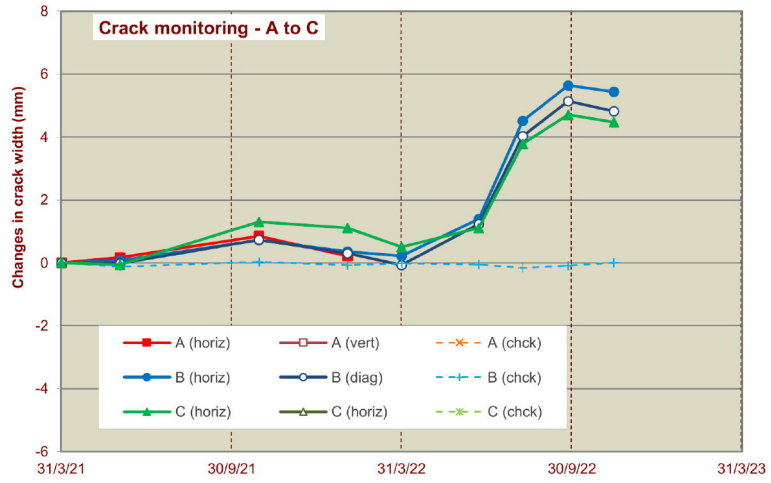
Crack monitoring

A (horiz)	internal flat D RHS wall
B (horiz)	internal hallway RHS wall high
C (horiz)	internal hallway RHS wall low

Survey: By: Date:	initial	1 PB 22/06/2022		2 PB 08/08/2022		3 PB 26/09/2022		4 PB 14/11/2022		5 #N/A	
Crack ID	width mm	sprtn mm	chngs mm	sprtn mm	chngs mm	sprtn mm	chngs mm	sprtn mm	chngs mm	levels mm	chngs mm
A (horiz)	0.0	n/a	#N/A	42.59	New	n/a	#N/A	n/a	#N/A		#N/A
B (horiz)	0.0	78.46	1.4	81.58	4.5	82.71	5.6	82.51	5.4		#N/A
B (diag)		91.20	1.2	94.00	4.0	95.11	5.1	94.79	4.8		#N/A
B (chck)		37.39	0.0	37.28	-0.2	37.35	-0.1	37.44	0.0		#N/A
C (horiz)	0.0	68.57	1.1	71.24	3.8	72.17	4.7	71.93	4.5		#N/A
