Arboricultural Impact Assessment and Method Statement

Site – 125 Albert Street, London, NW1

Date - 12-01-2023

To be read in conjunction with – Tree Constraints and Protection Plan Drawing No. MH/125AS/01

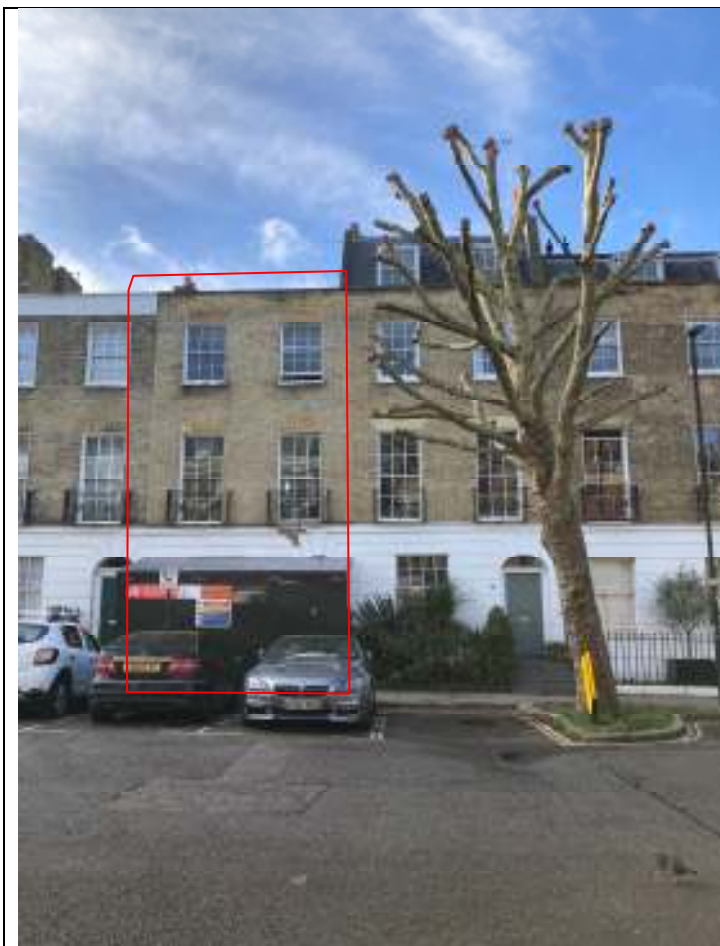
No.	Species English & Latin	Approx Height (M)	Dia. @1.5 (CM)	Spread (M)	Height Crown Clearance (m)	Age Class	Physiological condition	Structural condition	Preliminary management recommendation	Years remaining	Category grading
T1	<i>London Plane</i> <i>Platanus x hispanica</i>	10	53	N 2.0 S 3.2 E 3.0 W 2.0	4 First main limb at 4m high on the west side	Ma	Fair The secondary growth has been removed so the elongation growth is not assessable.	Fair The tree is a high pollard, which has been pruned on a cyclical basis. The most recent cycle of pruning is very recent, there is no secondary growth within the crown.	The tree is in council ownership.	40+	A123
<p>The tree has been given an 'A' rating as part of the street scene, mature pollard planes run along Albert Street and are important landscape features.</p> <p>The root area of the tree is covered in hard surfacing of the footpath, road and parking bays. There is a small open area around the base of the tree which shows signs of compaction from street users. There are some large surface roots visible on the west side of the trunk.</p> <p>Photos on next page</p>

T1 with site to the left side

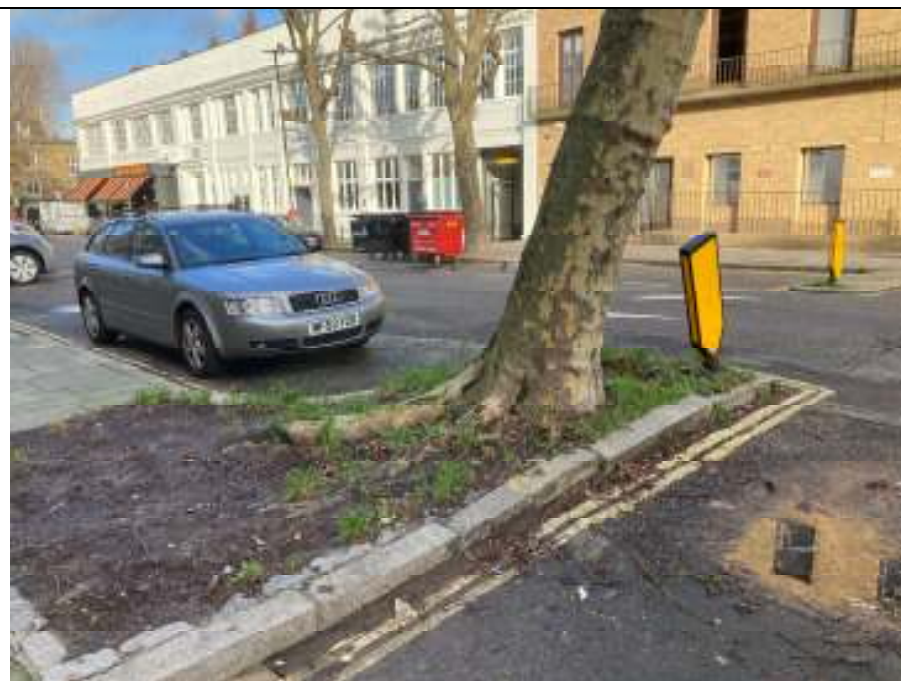
Root zone of T1

Tree no.		RPA m/sq	Radi of RPA (M)	Tree implications assessment	Mitigation
T1	London Plane	124	6.3	<p>The excavation works are outside the root protection area of the tree</p> <p>The works are also outside the crown spread of the tree.</p> <p>Access will be required over the root zone.</p>	<p>The root zone over which access is required is existing highway, parking, or footpath. These will act as ground protection over the roots for access to carry out the works.</p> <p>The site is enclosed at the front of the site by a 2m+ high wooden hoarding, which will also protect the tree.</p> <p>The crown is managed by the local authority on a pollard cycle that manages the over all size of the crown.</p>
