Arboricultural Appraisal Report

Subsidence Damage Investigation at:

11 Oakhill Avenue
London
NW3 7RD

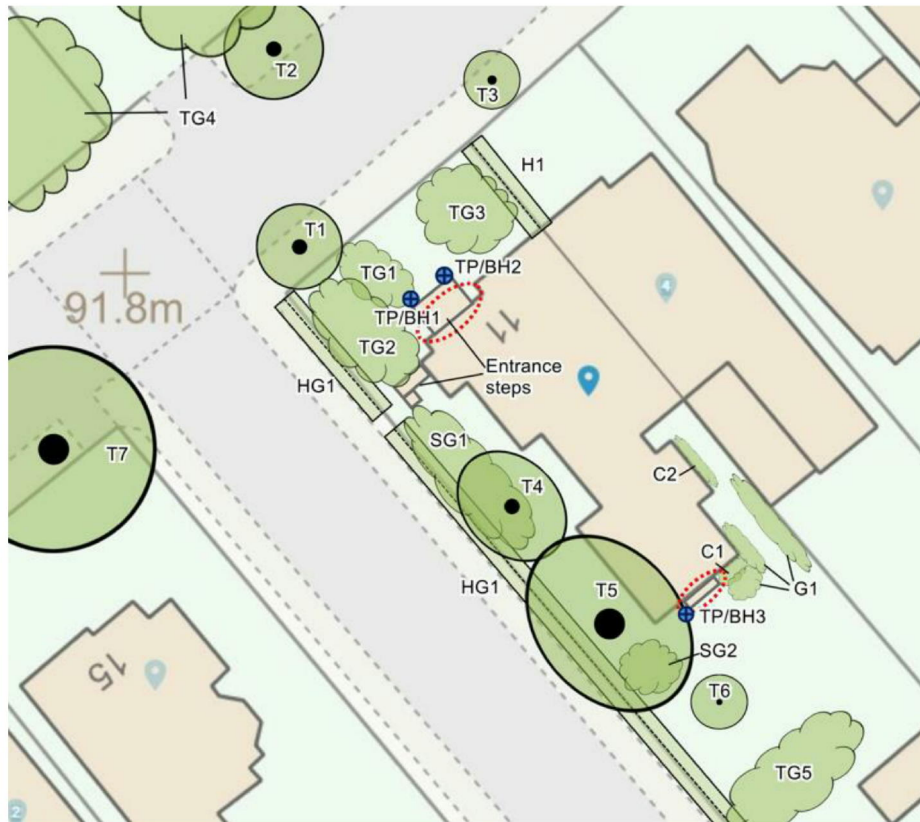
Site Plan

Approximate areas of damage
