Asbestos Survey Report 12/08/2021

Refurbishment Survey

NS9186

Specified area of 74a College Place

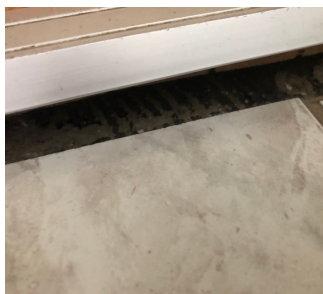
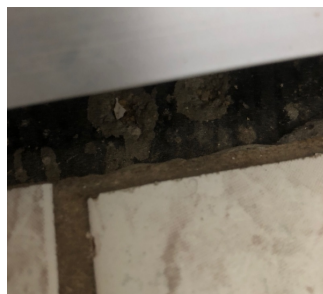
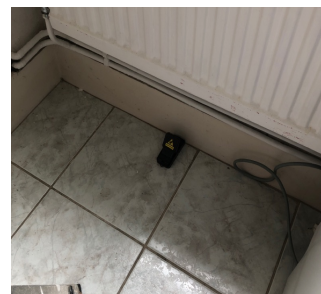
Item ID	003(OS)
Sample/link ID	NS9186-003
Property Name	Specified area of 74a College Place
Area/floor	001
Room/location	006
Specific location	Floor
Product/debris type	Flooring Adhesive
Asbestos type	Identified Chrysotile
Extent	12 m ²
Accessibility/vulnerability	Low
Additional information	N/A
Licensed/non-licensed	Non-licensed
R&D Element:	Yes
Air Test	-

Product Type (a)	1
Extent of Damage (b)	1
Surface Treatment (c)	0
Asbestos Fibre (d)	1
Total (a+b+c+d)	03
Material Risk Assessment	 Very Low

Action/recommendations	Remove ACM before Refurb. Work under FCC by FLC
------------------------	---

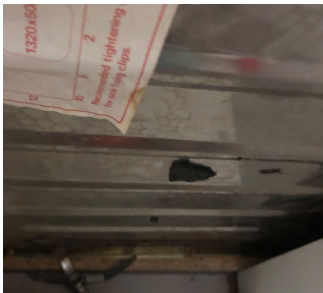
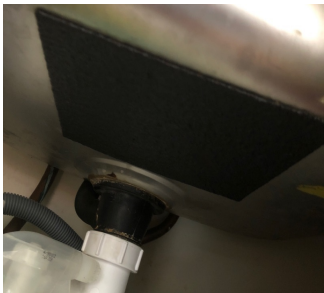
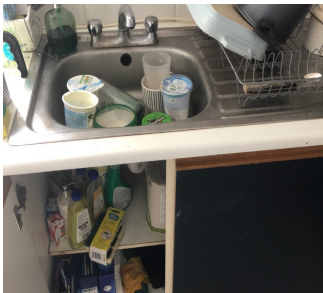
Item ID	002(OS)
Sample/link ID	NS9186-002
Property Name	Specified area of 74a College Place
Area/floor	001
Room/location	006
Specific location	Wall
Product/debris type	Bituminous Product(s) Bitumen Pad
Extent	1 m
	<div></div> No Risk

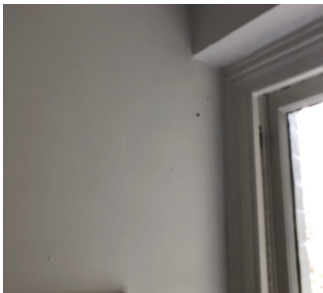
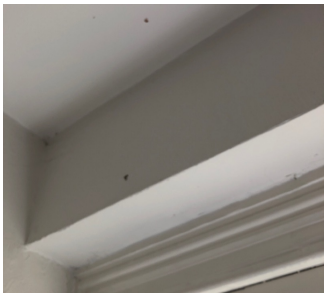
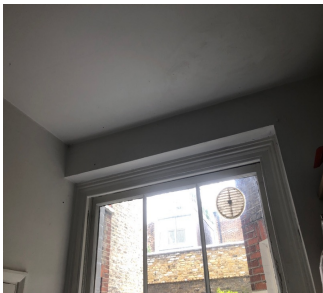
Item ID	001(OS)
Sample/link ID	NS9186-001
Property Name	Specified area of 74a College Place
Area/floor	001
Room/location	006
Specific location	Ceiling
Product/debris type	Textured Coating To Wall and Ceiling
Extent	20 m²
	<div></div> No Risk
