# Survey Details & Structural Defect Report

| Customer Contract No. <b>30361315</b> | Surveyor: <b>AGardner</b> | Survey Date: <b>2/9/22</b> |

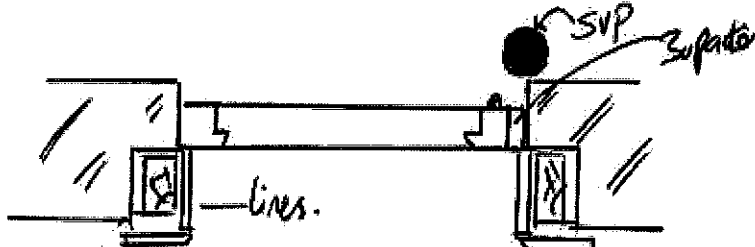
| <p><b>Remove box sash + bolster wall removal.</b></p> <p><b>Timbers 4x2 3x2.5m.</b></p> | | |
