**Refurbishment Survey
(with MA + PA)**
London Borough of Camden
5 Pancras Square
London
N1C 4AG

**Falcon Building
Old Gloucester Street
London
WC1N 3AA**

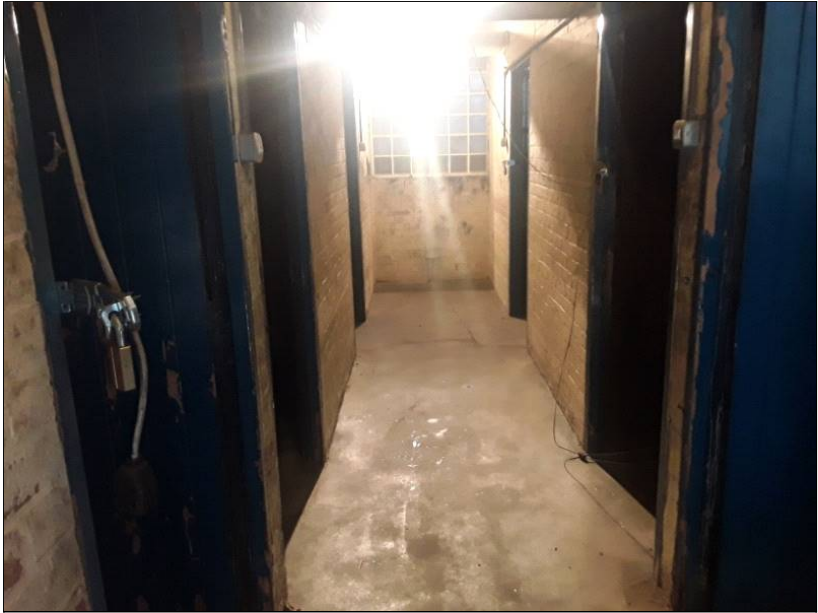
Survey Date:	Lead Surveyor	Survey Type	Floor	Analysis			
	20 Jun 2022 to 20 Jun 2022	Steve Beak	Refurbishment Survey	Z-Sub Level 1	N/A			
	Building	Room	Item		Quantity			
	Falcon Building Basement.	Sheds 1-6	No suspect materials found		N/A			
	Sample No (S,SP,P,As)	Product Type	Surface Treatment	Condition	Accessibility			
	Visual (NS)	N/A	N/A	N/A	N/A			
	Normal Occupancy	Score	Likelihood of disturbance	Score	Exposure Potential	Score	Maintenance Activity	Score
	Main type of activity	N/A	Location	N/A	Number of occupants	N/A	Type of Maintenance	N/A
	Accessibility	N/A	Frequency of use	N/A	Frequency of maintenance	N/A		
	Amount	N/A	Average Time	N/A				
Average Score	N/A	Average Score	N/A	Average Score	N/A	Average Score	N/A	
Average of Priority	N/A							
Material Assessment Score	N/A							
Recommendation	No further action required

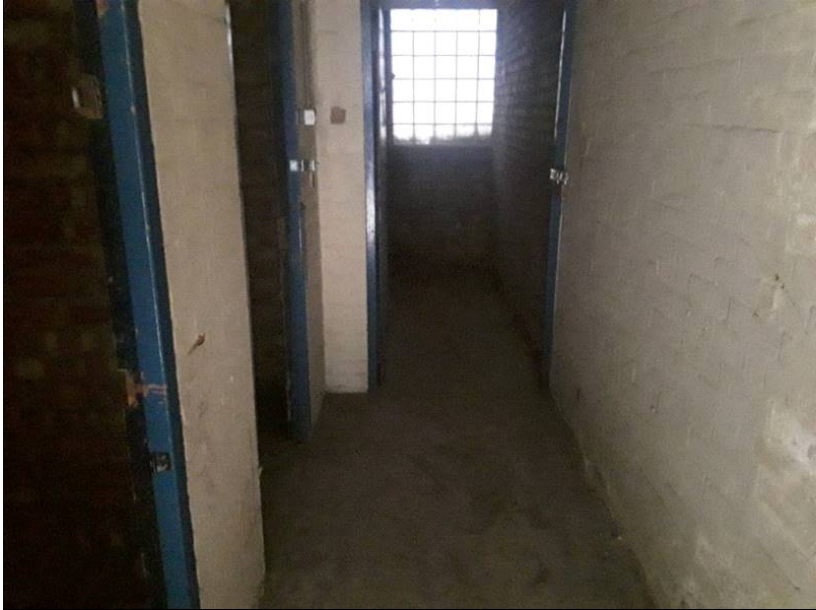
Survey Date:		Lead Surveyor		Survey Type		Floor		Analysis		
	20 Jun 2022 to 20 Jun 2022		Steve Beak		Refurbishment Survey		Z-Sub Level 1		N/A		
	Building		Room		Item				Quantity		
	Falcon Building Basement.		Sheds 7- 10		No suspect materials found				N/A		
	Sample No (S,SP,P,As)		Product Type		Surface Treatment		Condition		Accessibility		
	Visual (NS)		N/A		N/A		N/A		N/A		
	Normal Occupancy		Score	Likelihood of disturbance	Score	Exposure Potential	Score	Maintenance Activity	Score		
	Main type of activity		N/A	Location	N/A	Number of occupants	N/A	Type of Maintenance	N/A		
	Accessibility		N/A	Frequency of use	N/A	Frequency of maintenance	N/A				
	Amount		N/A	Average Time	N/A						
	Average Score		N/A	Average Score	N/A	Average Score	N/A	Average Score	N/A		
	Average of Priority		N/A								
	Material Assessment Score		N/A								
	Recommendation		No further action required

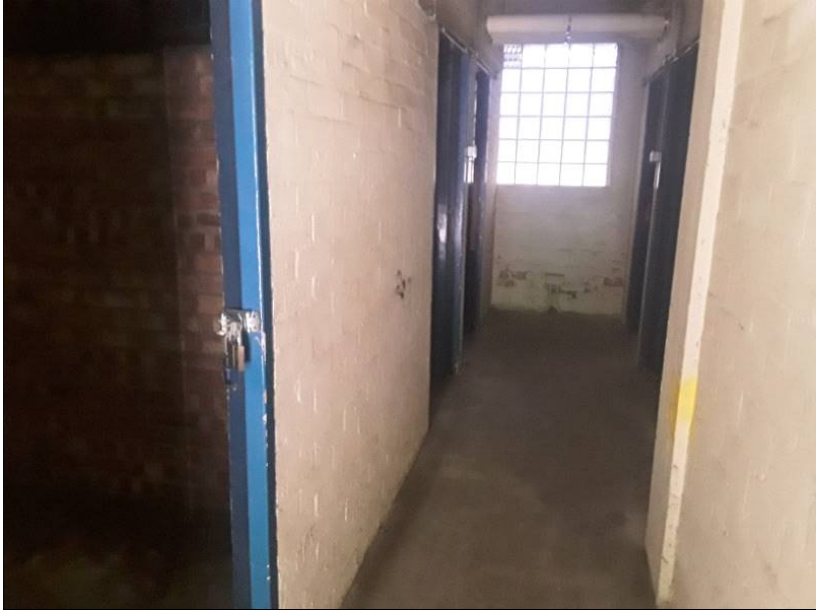
Survey Date:		Lead Surveyor		Survey Type		Floor		Analysis		
	20 Jun 2022 to 20 Jun 2022		Steve Beak		Refurbishment Survey		Z-Sub Level 1		N/A		
	Building		Room		Item				Quantity		
	Falcon Building Basement.		Sheds 11- 16		No suspect materials found				N/A		
	Sample No (S,SP,P,As)		Product Type		Surface Treatment		Condition		Accessibility		
	Visual (NS)		N/A		N/A		N/A		N/A		
	Normal Occupancy		Score	Likelihood of disturbance	Score	Exposure Potential	Score	Maintenance Activity	Score		
	Main type of activity		N/A	Location	N/A	Number of occupants	N/A	Type of Maintenance	N/A		
	Accessibility		N/A	Frequency of use	N/A	Frequency of maintenance	N/A				
	Amount		N/A	Average Time	N/A						
	Average Score		N/A	Average Score	N/A	Average Score	N/A	Average Score	N/A		
	Average of Priority		N/A								
	Material Assessment Score		N/A								
	Recommendation		No further action required

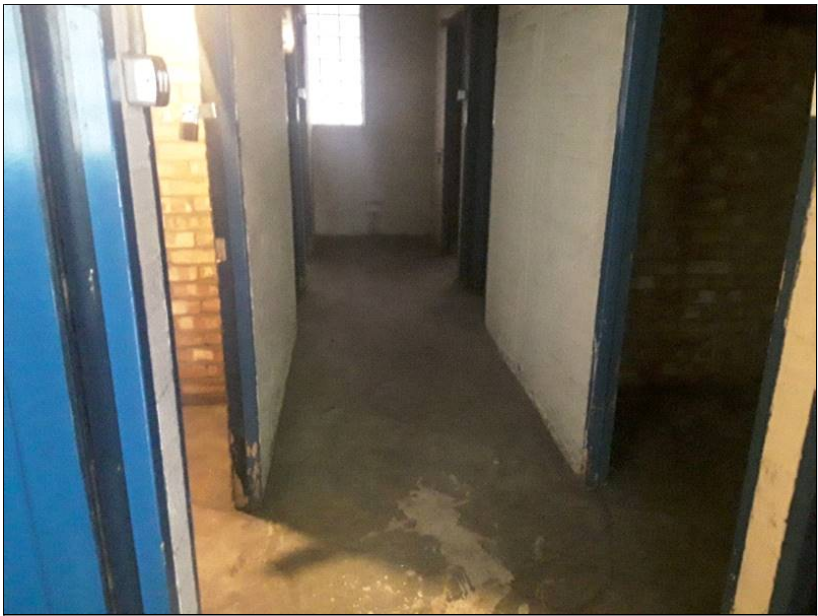
Survey Date:	Lead Surveyor	Survey Type	Floor	Analysis			
	20 Jun 2022 to 20 Jun 2022	Steve Beak	Refurbishment Survey	Z-Sub Level 1	N/A			
	Building	Room	Item		Quantity			
	Falcon Building Basement.	Sheds 17- 24	No suspect materials found		N/A			
	Sample No (S,SP,P,As)	Product Type	Surface Treatment	Condition	Accessibility			
	Visual (NS)	N/A	N/A	N/A	N/A			
	Normal Occupancy	Score	Likelihood of disturbance	Score	Exposure Potential	Score	Maintenance Activity	Score
	Main type of activity	N/A	Location	N/A	Number of occupants	N/A	Type of Maintenance	N/A
	Accessibility	N/A	Frequency of use	N/A	Frequency of maintenance	N/A		
	Amount	N/A	Average Time	N/A				
Average Score	N/A	Average Score	N/A	Average Score	N/A	Average Score	N/A	
Average of Priority	N/A							
Material Assessment Score	N/A							
Recommendation	No further action required

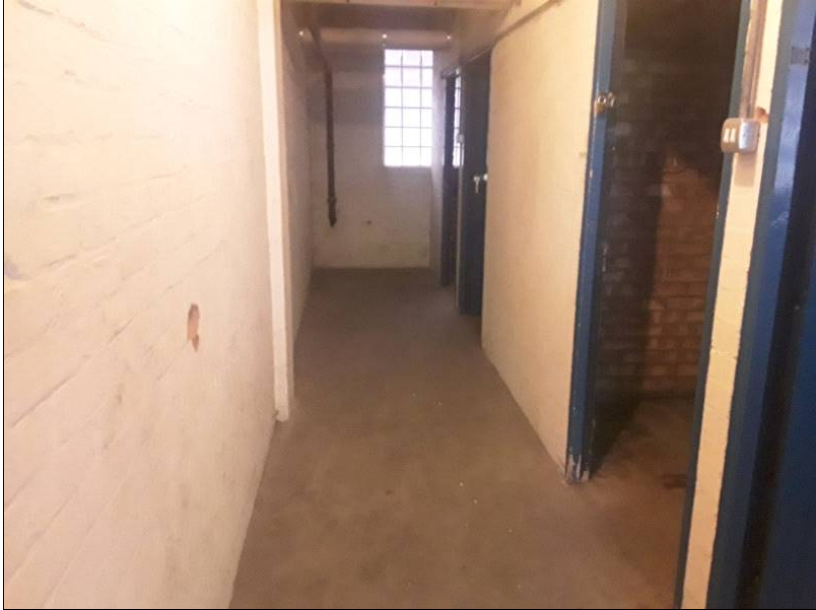
Survey Date:	Lead Surveyor	Survey Type	Floor	Analysis			
	20 Jun 2022 to 20 Jun 2022	Steve Beak	Refurbishment Survey	Z-Sub Level 1	N/A			
	Building	Room	Item		Quantity			
	Falcon Building Basement.	Sheds 25- 28	No suspect materials found		N/A			
	Sample No (S,SP,P,As)	Product Type	Surface Treatment	Condition	Accessibility			
	Visual (NS)	N/A	N/A	N/A	N/A			
	Normal Occupancy	Score	Likelihood of disturbance	Score	Exposure Potential	Score	Maintenance Activity	Score
	Main type of activity	N/A	Location	N/A	Number of occupants	N/A	Type of Maintenance	N/A
	Accessibility	N/A	Frequency of use	N/A	Frequency of maintenance	N/A		
	Amount	N/A	Average Time	N/A				
Average Score	N/A	Average Score	N/A	Average Score	N/A	Average Score	N/A	
Average of Priority	N/A							
Material Assessment Score	N/A							
Recommendation	No further action required

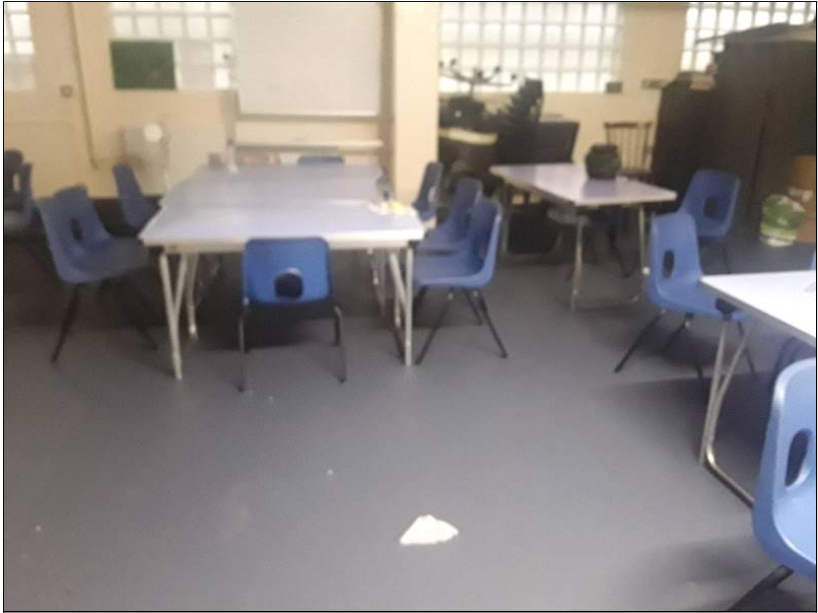
Survey Date:	Lead Surveyor	Survey Type	Floor	Analysis			
	20 Jun 2022 to 20 Jun 2022	Steve Beak	Refurbishment Survey	Z-Sub Level 1	N/A			
	Building	Room	Item		Quantity			
	Falcon Building Basement.	Class Room	No suspect materials found		N/A			
	Sample No (S,SP,P,As)	Product Type	Surface Treatment	Condition	Accessibility			
	Visual (NS)	N/A	N/A	N/A	N/A			
	Normal Occupancy	Score	Likelihood of disturbance	Score	Exposure Potential	Score	Maintenance Activity	Score
	Main type of activity	N/A	Location	N/A	Number of occupants	N/A	Type of Maintenance	N/A
	Accessibility	N/A	Frequency of use	N/A	Frequency of maintenance	N/A		
	Amount	N/A	Average Time	N/A				
Average Score	N/A	Average Score	N/A	Average Score	N/A	Average Score	N/A	
Average of Priority	N/A							
Material Assessment Score	N/A							
Recommendation	No further action required

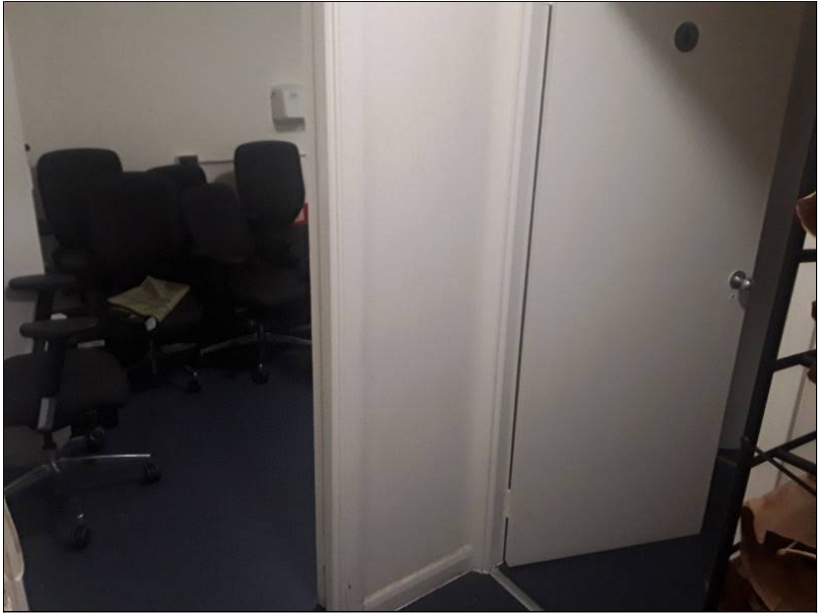
Survey Date:	Lead Surveyor	Survey Type	Floor	Analysis			
	20 Jun 2022 to 20 Jun 2022	Steve Beak	Refurbishment Survey	Z-Sub Level 1	N/A			
	Building	Room	Item		Quantity			
	Falcon Building Basement.	Office and Toilets	No suspect materials found		N/A			
	Sample No (S,SP,P,As)	Product Type	Surface Treatment	Condition	Accessibility			
	Visual (NS)	N/A	N/A	N/A	N/A			
	Normal Occupancy	Score	Likelihood of disturbance	Score	Exposure Potential	Score	Maintenance Activity	Score
	Main type of activity	N/A	Location	N/A	Number of occupants	N/A	Type of Maintenance	N/A
	Accessibility	N/A	Frequency of use	N/A	Frequency of maintenance	N/A		
	Amount	N/A	Average Time	N/A				
	Average Score	N/A	Average Score	N/A	Average Score	N/A	Average Score	N/A
	Average of Priority	N/A						
	Material Assessment Score	N/A						
	Recommendation	No further action required

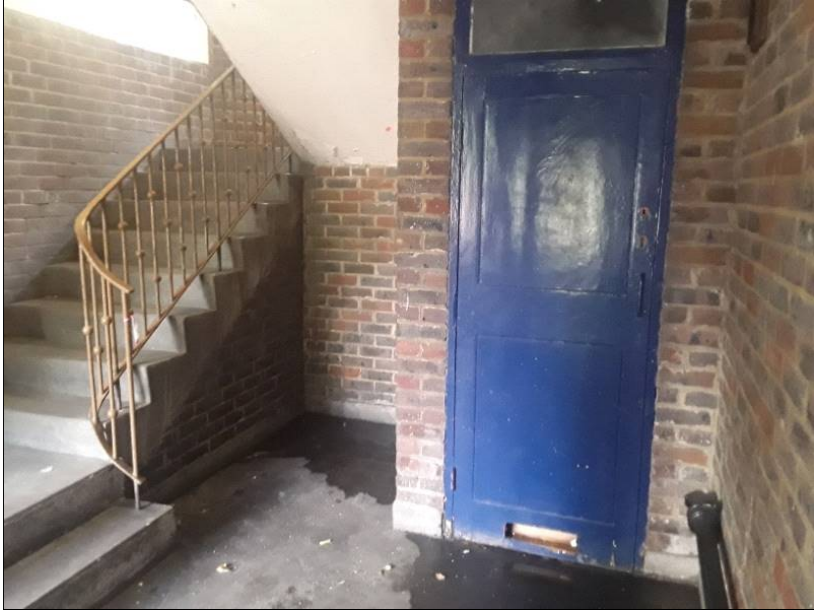
Survey Date:	Lead Surveyor	Survey Type	Floor	Analysis			
	20 Jun 2022 to 20 Jun 2022	Steve Beak	Refurbishment Survey	Z-Sub Level 1	N/A			
	Building	Room	Item		Quantity			
	Falcon Building Basement.	Cupboard 1	Inaccessible Next to stairs		N/A			
	Sample No (S,SP,P,As)	Product Type	Surface Treatment	Condition	Accessibility			
	Visual (P)	N/A	N/A	N/A	N/A			
	Normal Occupancy	Score	Likelihood of disturbance	Score	Exposure Potential	Score	Maintenance Activity	Score
	Main type of activity	N/A	Location	N/A	Number of occupants	N/A	Type of Maintenance	N/A
	Accessibility	N/A	Frequency of use	N/A	Frequency of maintenance	N/A		
	Amount	N/A	Average Time	N/A				
Average Score	N/A	Average Score	N/A	Average Score	N/A	Average Score	N/A	
Average of Priority	N/A							
Material Assessment Score	N/A							
Recommendation	Inspection Required

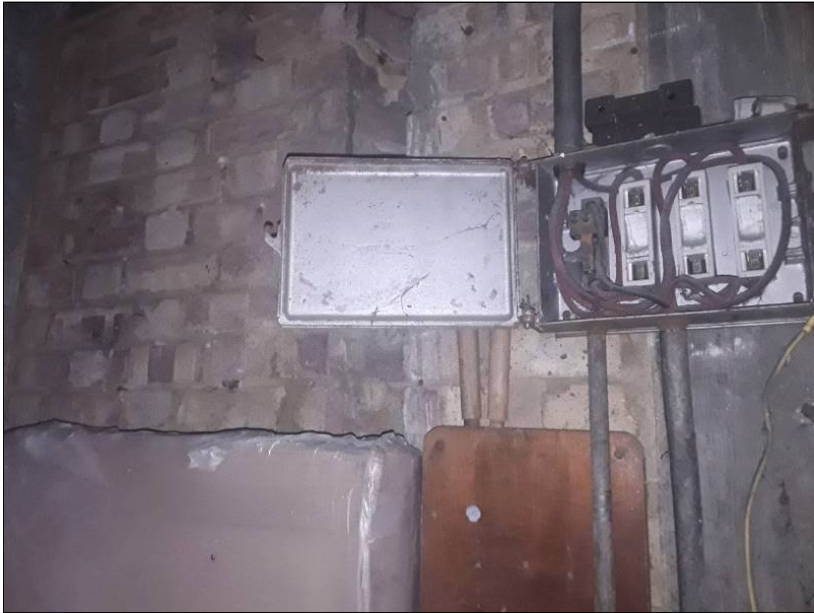
Building	Floor	Room	Item	Material	Risk assessment Score	Recommendations
Falcon Building Basement.	Z-Sub Level 1	Cupboard 2	Flashguards	Flash Guard	LOW (9)	F - Remove under controlled conditions

Survey Date:	Lead Surveyor	Survey Type	Floor	Analysis			
	20 Jun 2022 to 20 Jun 2022	Steve Beak	Refurbishment Survey	Z-Sub Level 1	Chrysotile (1)			
	Building	Room	Item		Quantity			
	Falcon Building Basement.	Cupboard 2	Flashguards Within electrical box		2no.			
	Sample No (S,SP,P,As)	Product Type	Surface Treatment	Condition	Accessibility			
	KW007265 (S)	Flash Guard (2)	Unsealed (2)	Good Condition (0)	Occasionally likely to be disturbed (1)			
	Normal Occupancy	Score	Likelihood of disturbance	Score	Exposure Potential	Score	Maintenance Activity	Score
	Main type of activity	1	Location	2	Number of occupants	0	Type of Maintenance	1
	Accessibility	1	Frequency of use	0	Frequency of maintenance	2		
	Amount	0	Average Time	0				
Average Score	1	Average Score	1	Average Score	0	Average Score	2	
Average of Priority	4							
Material Assessment Score	5							
Recommendation	Remove under controlled conditions

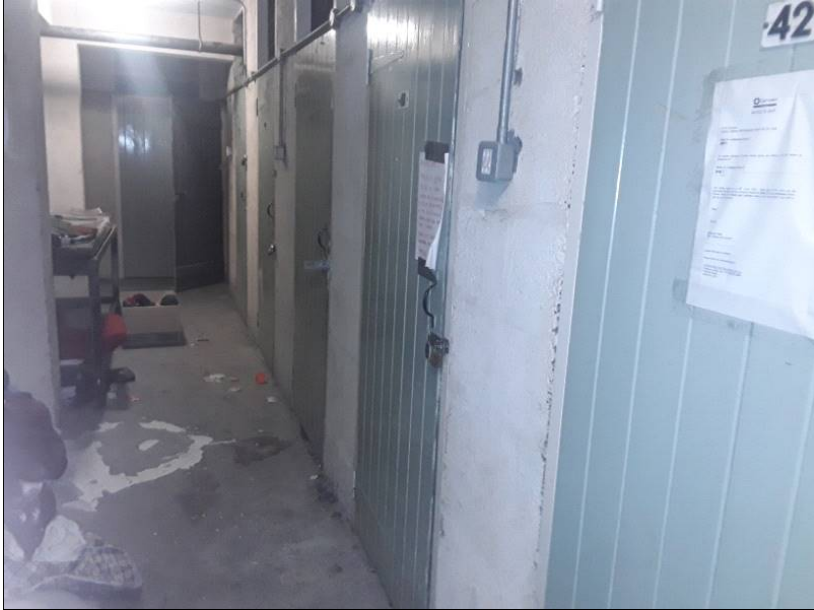
Survey Date:		Lead Surveyor		Survey Type		Floor		Analysis	
	20 Jun 2022 to 20 Jun 2022		Steve Beak		Refurbishment Survey		Z-Sub Level 1		N/A	
	Building		Room		Item				Quantity	
	Falcon Building Basement.		Sheds 29 -42		Tenants sheds Inaccessible Sheds 29-42				N/A	
	Sample No (S,SP,P,As)		Product Type		Surface Treatment		Condition		Accessibility	
	Visual (P)		N/A		N/A		N/A		N/A	
	Normal Occupancy		Score	Likelihood of disturbance	Score	Exposure Potential	Score	Maintenance Activity	Score	
	Main type of activity		N/A	Location	N/A	Number of occupants	N/A	Type of Maintenance	N/A	
	Accessibility		N/A	Frequency of use	N/A	Frequency of maintenance	N/A			
	Amount		N/A	Average Time	N/A					
Average Score		N/A	Average Score	N/A	Average Score	N/A	Average Score	N/A		
Average of Priority		N/A								
Material Assessment Score		N/A								
Recommendation		Inspection Required

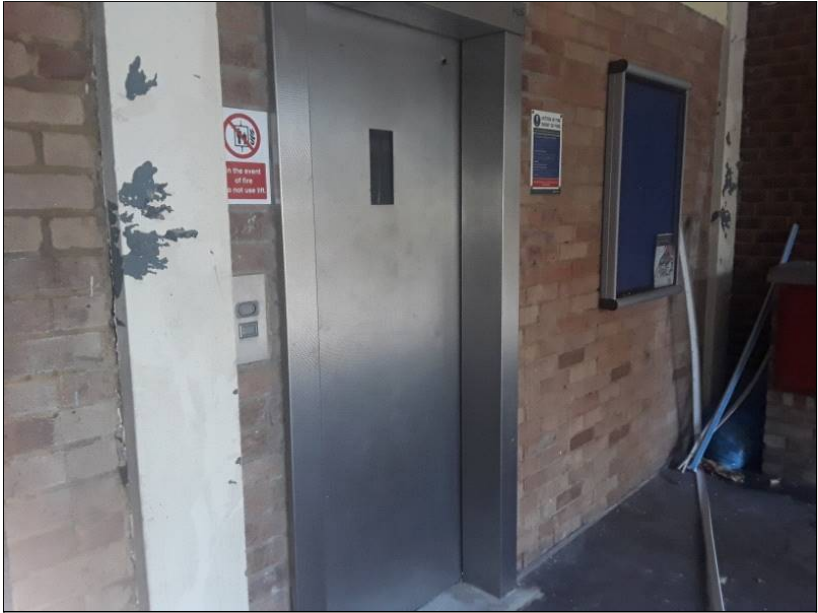
Survey Date:	Lead Surveyor	Survey Type	Floor	Analysis			
	20 Jun 2022 to 20 Jun 2022	Steve Beak	Refurbishment Survey	Z-Sub Level 1	N/A			
	Building	Room	Item		Quantity			
	Falcon Building Basement.	Liftshafts	Liftshafts Inaccessible Next to stairs		2no.			
	Sample No (S,SP,P,As)	Product Type	Surface Treatment	Condition	Accessibility			
	Visual (P)	N/A	N/A	N/A	N/A			
	Normal Occupancy	Score	Likelihood of disturbance	Score	Exposure Potential	Score	Maintenance Activity	Score
	Main type of activity	N/A	Location	N/A	Number of occupants	N/A	Type of Maintenance	N/A
	Accessibility	N/A	Frequency of use	N/A	Frequency of maintenance	N/A		
	Amount	N/A	Average Time	N/A				
Average Score	N/A	Average Score	N/A	Average Score	N/A	Average Score	N/A	
Average of Priority	N/A							
Material Assessment Score	N/A							
Recommendation	Inspection Required
