**Refurbishment Survey  
(with MA + PA)**

**Richbell Building  
New North Street  
London  
WC1N 3PH**

Report issue date:	23 Jun 2022

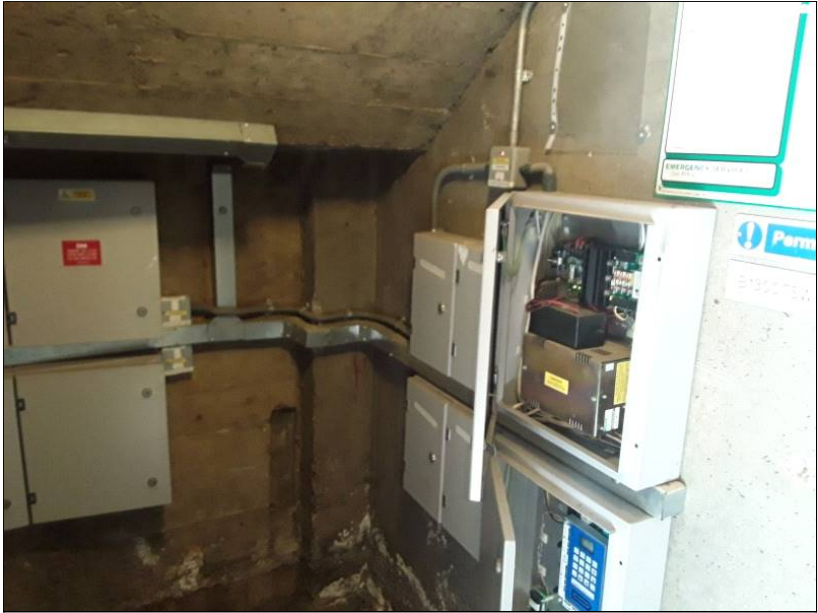
<b>Survey Date:</b>	<b>Lead Surveyor</b>	<b>Survey Type</b>	<b>Floor</b>	<b>Analysis</b>			
	21 Jun 2022 to 21 Jun 2022	Steve Beak	Refurbishment Survey	Z-Sub Level 1	N/A			
	<b>Building</b>	<b>Room</b>	<b>Item</b>		<b>Quantity</b>			
	Richbell Building	Electrical Intake Cupboard	No suspect materials found		N/A			
	<b>Sample No (S,SP,P,As)</b>	<b>Product Type</b>	<b>Surface Treatment</b>	<b>Condition</b>	<b>Accessibility</b>			
	Visual (NS)	N/A	N/A	N/A	N/A			
	<b>Normal Occupancy</b>	<b>Score</b>	<b>Likelihood of disturbance</b>	<b>Score</b>	<b>Exposure Potential</b>	<b>Score</b>	<b>Maintenance Activity</b>	<b>Score</b>
	Main type of activity	N/A	Location	N/A	Number of occupants	N/A	Type of Maintenance	N/A
	Accessibility	N/A	Frequency of use	N/A	Frequency of maintenance	N/A		
	Amount	N/A	Average Time	N/A				
<b>Average Score</b>	<b>N/A</b>	<b>Average Score</b>	<b>N/A</b>	<b>Average Score</b>	<b>N/A</b>	<b>Average Score</b>	<b>N/A</b>

<b>Average of Priority</b>	<b>N/A</b>							
<b>Material Assessment Score</b>	<b>N/A</b>							
<b>Recommendation</b>	<b>No further action required</b>

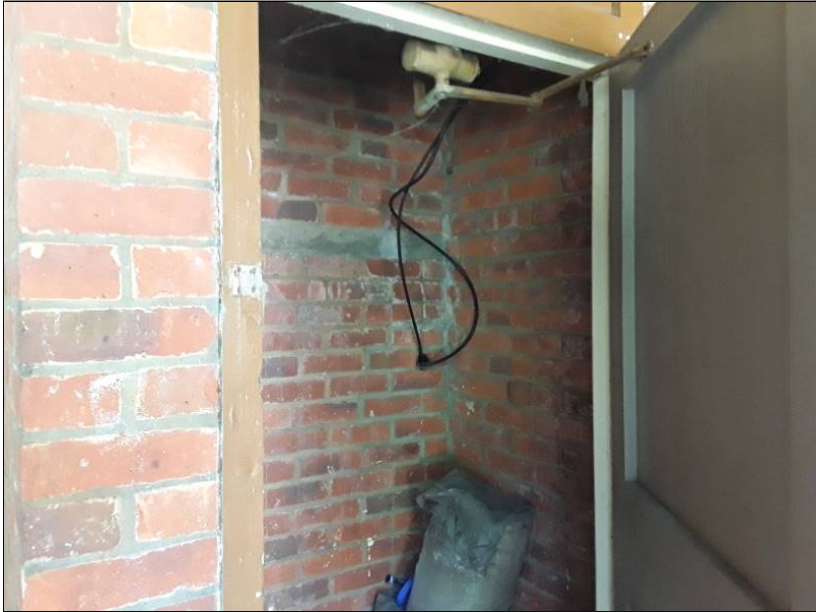
<b>Survey Date:</b>	<b>Lead Surveyor</b>	<b>Survey Type</b>	<b>Floor</b>	<b>Analysis</b>			
	21 Jun 2022 to 21 Jun 2022	Steve Beak	Refurbishment Survey	Z-Sub Level 1	N/A			
	<b>Building</b>	<b>Room</b>	<b>Item</b>		<b>Quantity</b>			
	Richbell Building	Cupboard	No suspect materials found		N/A			
	<b>Sample No (S,SP,P,As)</b>	<b>Product Type</b>	<b>Surface Treatment</b>	<b>Condition</b>	<b>Accessibility</b>			
	Visual (NS)	N/A	N/A	N/A	N/A			
	<b>Normal Occupancy</b>	<b>Score</b>	<b>Likelihood of disturbance</b>	<b>Score</b>	<b>Exposure Potential</b>	<b>Score</b>	<b>Maintenance Activity</b>	<b>Score</b>
	Main type of activity	N/A	Location	N/A	Number of occupants	N/A	Type of Maintenance	N/A
	Accessibility	N/A	Frequency of use	N/A	Frequency of maintenance	N/A		
	Amount	N/A	Average Time	N/A				
<b>Average Score</b>	<b>N/A</b>	<b>Average Score</b>	<b>N/A</b>	<b>Average Score</b>	<b>N/A</b>	<b>Average Score</b>	<b>N/A</b>

<b>Average of Priority</b>	<b>N/A</b>							
<b>Material Assessment Score</b>	<b>N/A</b>							
<b>Recommendation</b>	<b>No further action required</b>

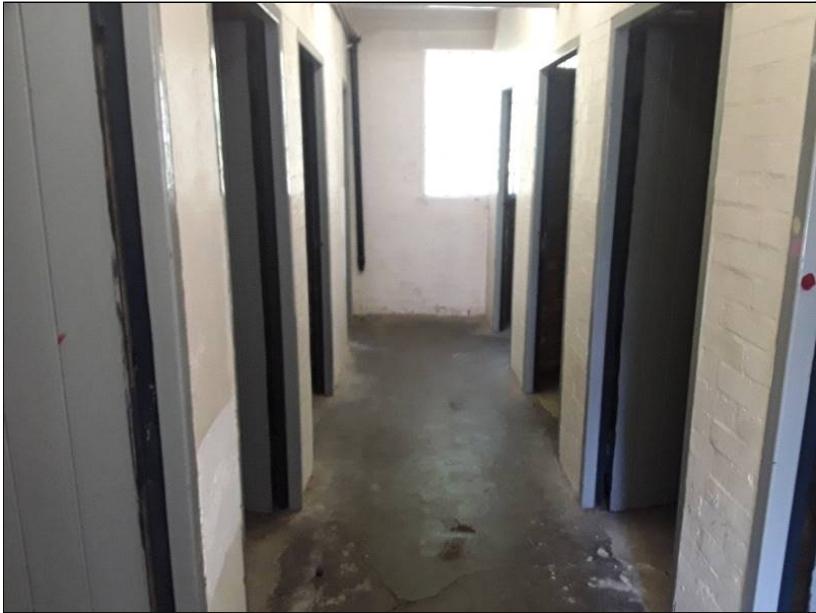
<b>Survey Date:</b>	<b>Lead Surveyor</b>	<b>Survey Type</b>	<b>Floor</b>	<b>Analysis</b>			
	21 Jun 2022 to 21 Jun 2022	Steve Beak	Refurbishment Survey	Z-Sub Level 1	N/A			
	<b>Building</b>	<b>Room</b>	<b>Item</b>		<b>Quantity</b>			
	Richbell Building	Sheds 9-18	No suspect materials found		N/A			
	<b>Sample No (S,SP,P,As)</b>	<b>Product Type</b>	<b>Surface Treatment</b>	<b>Condition</b>	<b>Accessibility</b>			
	Visual (NS)	N/A	N/A	N/A	N/A			
	<b>Normal Occupancy</b>	<b>Score</b>	<b>Likelihood of disturbance</b>	<b>Score</b>	<b>Exposure Potential</b>	<b>Score</b>	<b>Maintenance Activity</b>	<b>Score</b>
	Main type of activity	N/A	Location	N/A	Number of occupants	N/A	Type of Maintenance	N/A
	Accessibility	N/A	Frequency of use	N/A	Frequency of maintenance	N/A		
	Amount	N/A	Average Time	N/A				
<b>Average Score</b>	<b>N/A</b>	<b>Average Score</b>	<b>N/A</b>	<b>Average Score</b>	<b>N/A</b>	<b>Average Score</b>	<b>N/A</b>

<b>Average of Priority</b>	<b>N/A</b>							
<b>Material Assessment Score</b>	<b>N/A</b>							
<b>Recommendation</b>	<b>No further action required</b>

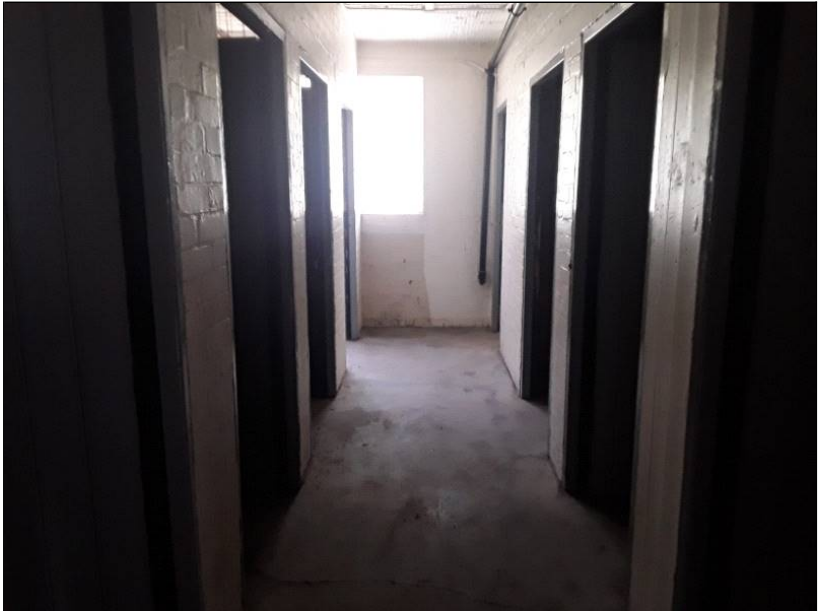
<b>Survey Date:</b>	<b>Lead Surveyor</b>	<b>Survey Type</b>	<b>Floor</b>	<b>Analysis</b>			
	21 Jun 2022 to 21 Jun 2022	Steve Beak	Refurbishment Survey	Z-Sub Level 1	N/A			
	<b>Building</b>	<b>Room</b>	<b>Item</b>		<b>Quantity</b>			
	Richbell Building	Sheds 19-28	No suspect materials found		N/A			
	<b>Sample No (S,SP,P,As)</b>	<b>Product Type</b>	<b>Surface Treatment</b>	<b>Condition</b>	<b>Accessibility</b>			
	Visual (NS)	N/A	N/A	N/A	N/A			
	<b>Normal Occupancy</b>	<b>Score</b>	<b>Likelihood of disturbance</b>	<b>Score</b>	<b>Exposure Potential</b>	<b>Score</b>	<b>Maintenance Activity</b>	<b>Score</b>
	Main type of activity	N/A	Location	N/A	Number of occupants	N/A	Type of Maintenance	N/A
	Accessibility	N/A	Frequency of use	N/A	Frequency of maintenance	N/A		
	Amount	N/A	Average Time	N/A				
<b>Average Score</b>	<b>N/A</b>	<b>Average Score</b>	<b>N/A</b>	<b>Average Score</b>	<b>N/A</b>	<b>Average Score</b>	<b>N/A</b>

<b>Average of Priority</b>	<b>N/A</b>							
<b>Material Assessment Score</b>	<b>N/A</b>							
<b>Recommendation</b>	<b>No further action required</b>

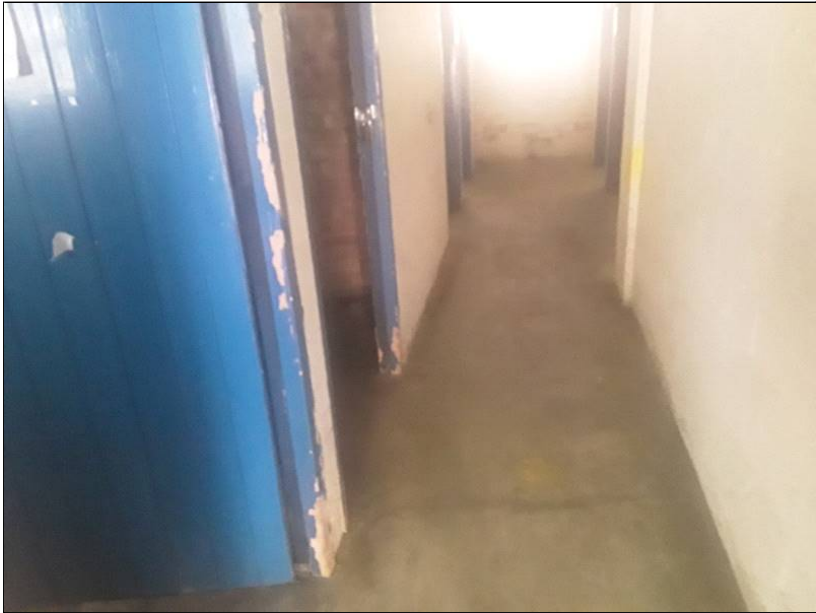
<b>Survey Date:</b>	<b>Lead Surveyor</b>	<b>Survey Type</b>	<b>Floor</b>	<b>Analysis</b>			
	21 Jun 2022 to 21 Jun 2022	Steve Beak	Refurbishment Survey	Z-Sub Level 1	N/A			
	<b>Building</b>	<b>Room</b>	<b>Item</b>		<b>Quantity</b>			
	Richbell Building	Sheds 1-8	No suspect materials found		N/A			
	<b>Sample No (S,SP,P,As)</b>	<b>Product Type</b>	<b>Surface Treatment</b>	<b>Condition</b>	<b>Accessibility</b>			
	Visual (NS)	N/A	N/A	N/A	N/A			
	<b>Normal Occupancy</b>	<b>Score</b>	<b>Likelihood of disturbance</b>	<b>Score</b>	<b>Exposure Potential</b>	<b>Score</b>	<b>Maintenance Activity</b>	<b>Score</b>
	Main type of activity	N/A	Location	N/A	Number of occupants	N/A	Type of Maintenance	N/A
	Accessibility	N/A	Frequency of use	N/A	Frequency of maintenance	N/A		
	Amount	N/A	Average Time	N/A				
<b>Average Score</b>	<b>N/A</b>	<b>Average Score</b>	<b>N/A</b>	<b>Average Score</b>	<b>N/A</b>	<b>Average Score</b>	<b>N/A</b>

<b>Average of Priority</b>	<b>N/A</b>							
<b>Material Assessment Score</b>	<b>N/A</b>							
<b>Recommendation</b>	<b>No further action required</b>

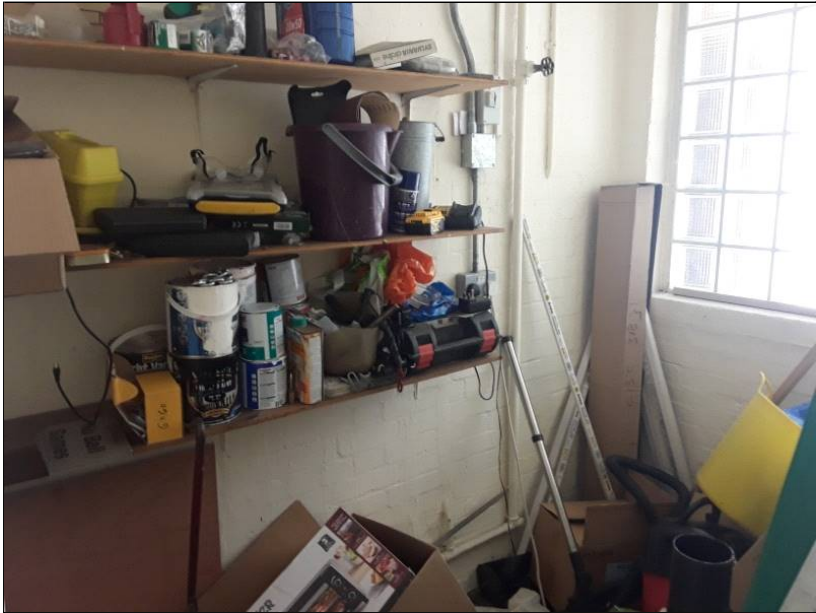
<b>Survey Date:</b>	<b>Lead Surveyor</b>	<b>Survey Type</b>	<b>Floor</b>	<b>Analysis</b>			
	21 Jun 2022 to 21 Jun 2022	Steve Beak	Refurbishment Survey	Z-Sub Level 1	N/A			
	<b>Building</b>	<b>Room</b>	<b>Item</b>		<b>Quantity</b>			
	Richbell Building	Store Room 1	No suspect materials found		N/A			
	<b>Sample No (S,SP,P,As)</b>	<b>Product Type</b>	<b>Surface Treatment</b>	<b>Condition</b>	<b>Accessibility</b>			
	Visual (NS)	N/A	N/A	N/A	N/A			
	<b>Normal Occupancy</b>	<b>Score</b>	<b>Likelihood of disturbance</b>	<b>Score</b>	<b>Exposure Potential</b>	<b>Score</b>	<b>Maintenance Activity</b>	<b>Score</b>
	Main type of activity	N/A	Location	N/A	Number of occupants	N/A	Type of Maintenance	N/A
	Accessibility	N/A	Frequency of use	N/A	Frequency of maintenance	N/A		
	Amount	N/A	Average Time	N/A				
<b>Average Score</b>	<b>N/A</b>	<b>Average Score</b>	<b>N/A</b>	<b>Average Score</b>	<b>N/A</b>	<b>Average Score</b>	<b>N/A</b>

<b>Average of Priority</b>	<b>N/A</b>							
<b>Material Assessment Score</b>	<b>N/A</b>							
<b>Recommendation</b>	<b>No further action required</b>

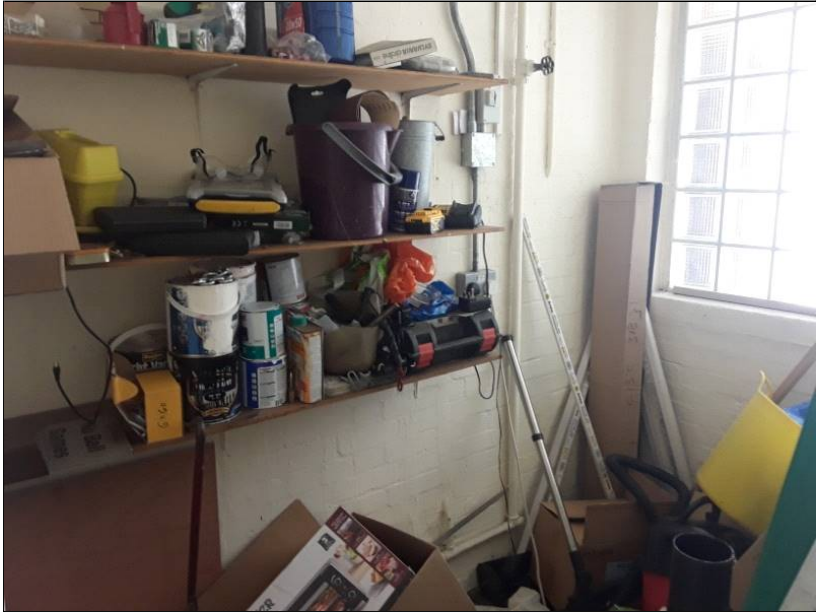
<b>Survey Date:</b>	<b>Lead Surveyor</b>	<b>Survey Type</b>	<b>Floor</b>	<b>Analysis</b>			
	21 Jun 2022 to 21 Jun 2022	Steve Beak	Refurbishment Survey	Z-Sub Level 1	N/A			
	<b>Building</b>	<b>Room</b>	<b>Item</b>		<b>Quantity</b>			
	Richbell Building	Store Room 2	No suspect materials found		N/A			
	<b>Sample No (S,SP,P,As)</b>	<b>Product Type</b>	<b>Surface Treatment</b>	<b>Condition</b>	<b>Accessibility</b>			
	Visual (NS)	N/A	N/A	N/A	N/A			
	<b>Normal Occupancy</b>	<b>Score</b>	<b>Likelihood of disturbance</b>	<b>Score</b>	<b>Exposure Potential</b>	<b>Score</b>	<b>Maintenance Activity</b>	<b>Score</b>
	Main type of activity	N/A	Location	N/A	Number of occupants	N/A	Type of Maintenance	N/A
	Accessibility	N/A	Frequency of use	N/A	Frequency of maintenance	N/A		
	Amount	N/A	Average Time	N/A				
<b>Average Score</b>	N/A	<b>Average Score</b>	N/A	<b>Average Score</b>	N/A	<b>Average Score</b>	N/A	
<b>Average of Priority</b>	N/A

<b>Material Assessment Score</b>	N/A							
<b>Recommendation</b>	No further action required
