## Tree Survey & Management Plan

Fitzroy Square  
London  
W1T 6EF

Fitzroy Square Committee

AS/MF/080/22

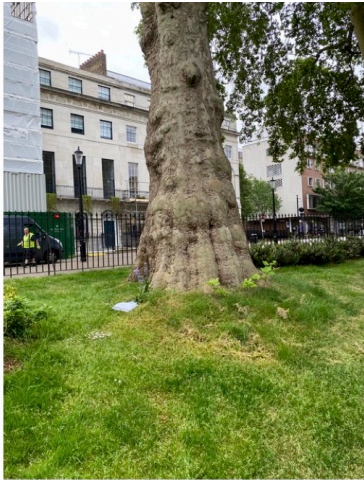
Tree T8 as viewed to the east

T8	London plane	20	1520	5 6 4 5	M	F	F	Even distribution of buttress roots with exception of to north. To north open cavity with kretschmaria deusta fruiting bodies in early stages of colonisation. Reaction wood to west, limited to east and main buttress adjacent to decay where tested with sounding mallet showing poor density; remainder of buttress sound. Main branch framework reduced within past 12-18 months throughout to give compact form in response to decay pocket.	No action required at present	/	M
T9	London plane	18	1600	8 6 6 6	M	F	F	Lean to north east. Sounding mallet shows even distribution of sound at base. Open cavity to west at 8m; occluding. Open cavity to south on secondary leader at 10m; occluding. Reduced to give compact branch framework at 8-18m within past 12 months.	No action required at present	/	M
T10	Purple plum	6	180	3 3 3 3	SM	F	G	Ornamental form. Upper crown reverting to root stock.	Remove reversion growth from upper crown to restore Purple plum form throughout. Prune to balance maximum 1m branch lengths	L	L

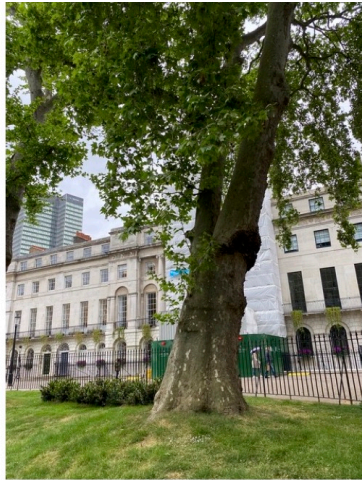
Tree T7 as viewed to the north east

Tree No.	Species	Height (m)	Stem Diameter (mm)	Crown Spread NESW (m)	Age Class	Structural Condition	Vitality	Comments	Recommendations	Work Priority Rating	Inspection Frequency
T7	London plane	26	1360	6 11 10 8	M	F	F	Accentuated buttress roots to west with lean to east. Base tested with sounding mallet with even density on all sides. Bifurcation at 3m height with co-dominant stems and sound union. Absent crown to north due to proximity of T8 to north. Bracing (cobra) at 16m from north east leader to eastern crown; slack. Eastern crown developing over-extended form in mid crown. Lowered vigour to upper crown notably to north. Additionally steel bracing from western to eastern leader; taught.	Remove major deadwood Crown lift to 6m height removing maximum sub 25mm diameter branches Crown reduce over-extended lateral spread to east / south-east - where required only - by up to 2.5m branch lengths to maximum 15m height to draw in over-extended laterals and balance with remainder of crown	M	M

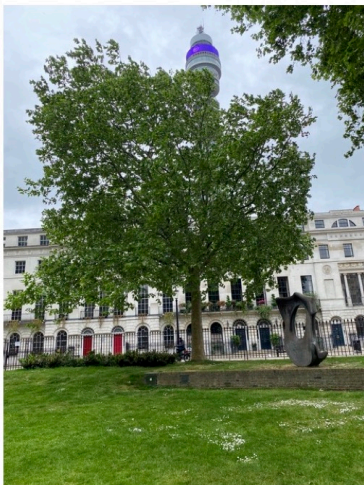
Tree T5 as viewed to the south

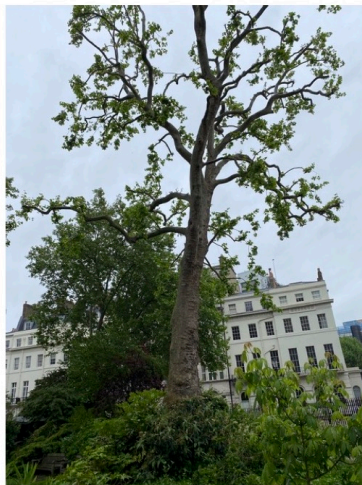
Tree T9 - crown reduced form as viewed to north west

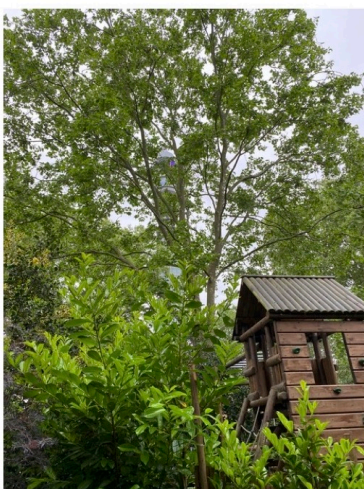
Tree T12 as viewed to the south from entrance / shed area

T11	London plane	16	710	8 7 6 7	SM	G	G	Lean to north. Sound at base where tested with sounding mallet. Balanced crown developing; dominant to north. Low growth developing to 4m.	Crown lift to 5m height removing maximum sub 25mm diameter branches	M	M
T12	London plane	15	490	5 7 6 6	SM	G	F	Initial lean to east. Balanced crown developing. Low vigour to south. Compost heap on rootplate.	No action required at present	/	M

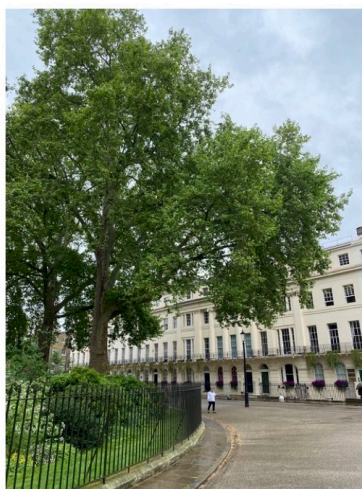
Tree T11 as viewed to the west from the highway

T11	London plane	Crown lift to 5m height removing maximum sub 25mm diameter branches

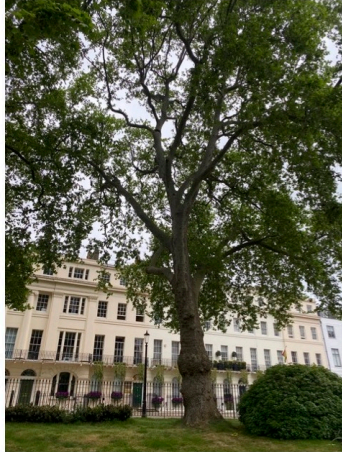
Tree T2 as viewed to the north west

Tree No.	Common Name	Tree Works
T2	London plane	Remove major deadwood Crown reduce over-extended lateral spread to north / north west - where required only - by up to 2.5m branch lengths to maximum 15m height to draw in over-extended laterals and balance with remainder of crown Crown lift to 6m height removing maximum sub 25mm diameter branches
T3	London plane	Remove major deadwood Crown lift to 6m height removing maximum sub 25mm diameter branches
T4	London plane	Remove major deadwood Crown lift to 6m height removing maximum sub 25mm diameter branches
T5	London plane	Crown lift to 5m height removing maximum sub 25mm diameter branches
T6	London plane	Remove major deadwood Crown lift to 6m height removing maximum sub 25mm diameter branches and epicormic growth to this height
T7	London plane	Remove major deadwood Crown lift to 6m height removing maximum sub 50mm diameter branches Crown reduce over-extended lateral spread to east / south-east - where required only - by up to 2.5m branch lengths to maximum 15m height to draw in over-extended laterals and balance with remainder of crown

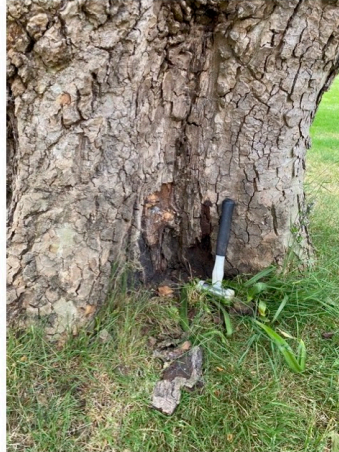
Area of decay / bark dieback historic to the tree (T2) at base to south

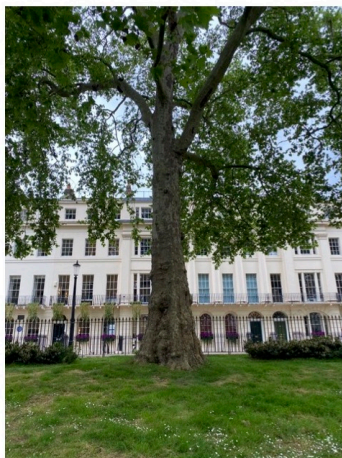
Tree T3 as viewed to the west

T3	London plane	26	1420	10 9 10 10	M	G	G	Evenly distributed buttress roots at base. Straight main stem with crown break/branch framework developed from 6-7m height. Bifurcation at 9m sound. Cable bracing at 13m height from western leader to south west; bracing is slack. Improved density of crown to west and lower crown. Low growth developing to 3-4m. Absent lower northern crown from historic crown lifting. Historic management includes crown lifting, thinning and selective reduction to west.	Remove major deadwood Crown lift to 6m height removing maximum sub 25mm diameter branches	M	M
T4	London plane	27	1490	8 10 12 9	M	F	G	Accentuated buttress to east and west. Gannoderma spp fungal fruiting body within southern buttress at ground level with significant reaction wood surrounding to east and west. Where tested with sounding mallet, even sounding throughout. Main stem bifurcates at 4.5m height with dominant western leader. Steel bracing at 10m height between 2 main stems; appears taught. Absent lower northern crown from T3 adjacent to north. Low growth developing to 3m height. Lowering vigour developing within upper western crown likely associated with Massaria disease of London Plan. Historically crown lifted/ thinned/selectively reduced notably to west.	Remove major deadwood Crown lift to 6m height removing maximum sub 25mm diameter branches	M	M

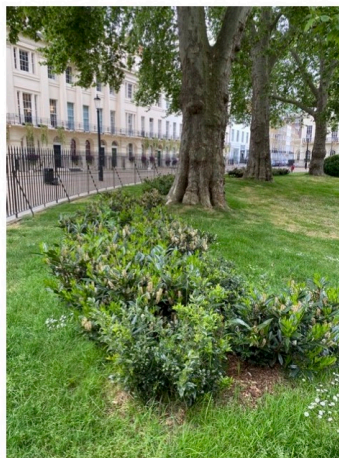
Trees T2-T4 as viewed to the north

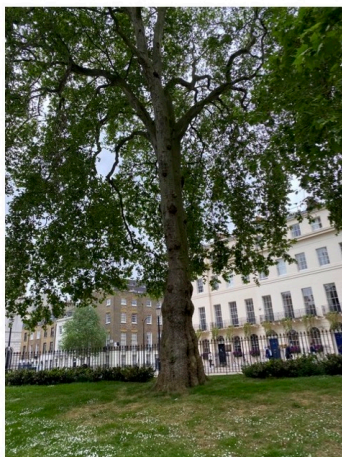
Tree T4 as viewed to the south west

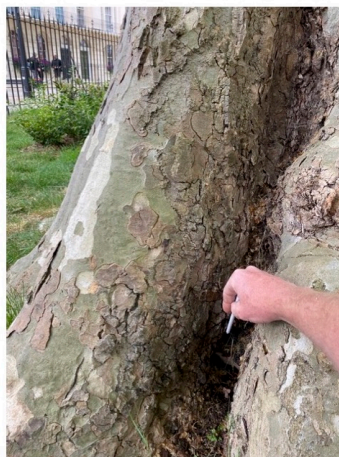
Area of decay with *Ganoderma* spp fruiting body at base to west of T4; good reaction growth surrounds point of decay / fungus

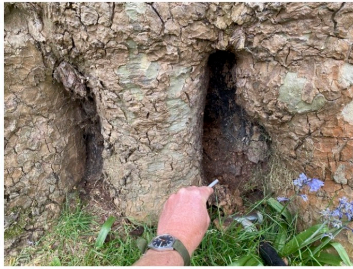
Tree T8 - Kretschmaria deusta fruiting bodies in early stages of colonisation within decayed northern buttress

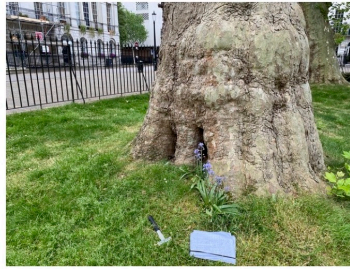
Tree T8 - Base of tree and area of decay viewed to south; tree is crown reduced (within past 12 months)

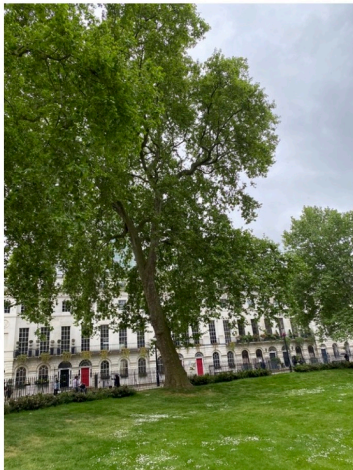
Tree T6 as viewed to south

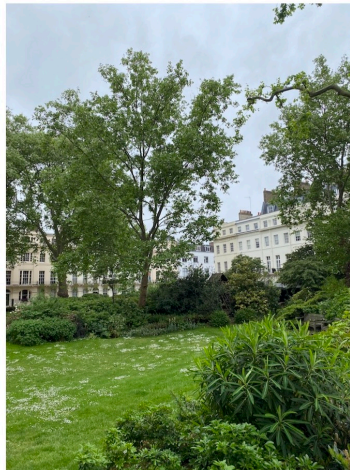
Tree T12 as viewed to the west within centre of square

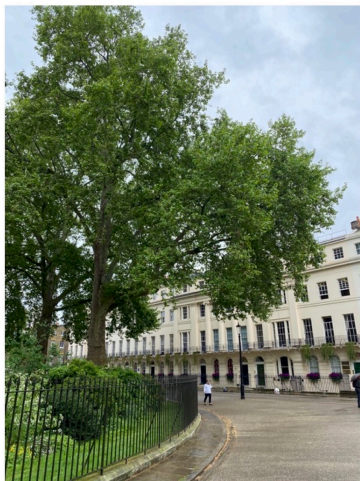
Over-extended north west crown of tree T2 at approximately 9-16 metres height

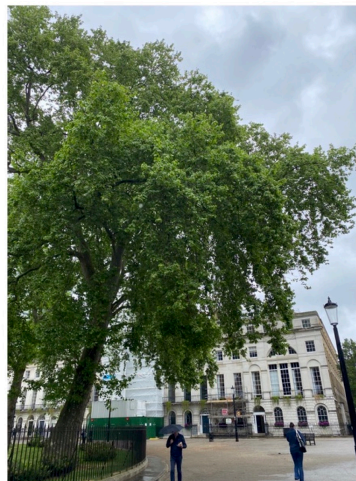
Over-extended south west crown of tree T7 at approximately 8-16 metres height
