# Arboricultural Appraisal Report

**CTC Reference:** 15081

**Property:** 104 Haverstock Hill,  
London,  
NW3 2BD

To survey and assess a large holm oak and other vegetation in the front garden of 104 Haverstock Hill and determine whether it could potentially affect the property; specifically to assess the risk of damage or injury to persons or property. This includes indirect damage due to clay shrinkage subsidence by the abstraction of soil moisture or direct damage by mechanical failure of the physical action of aerial parts or the roots.

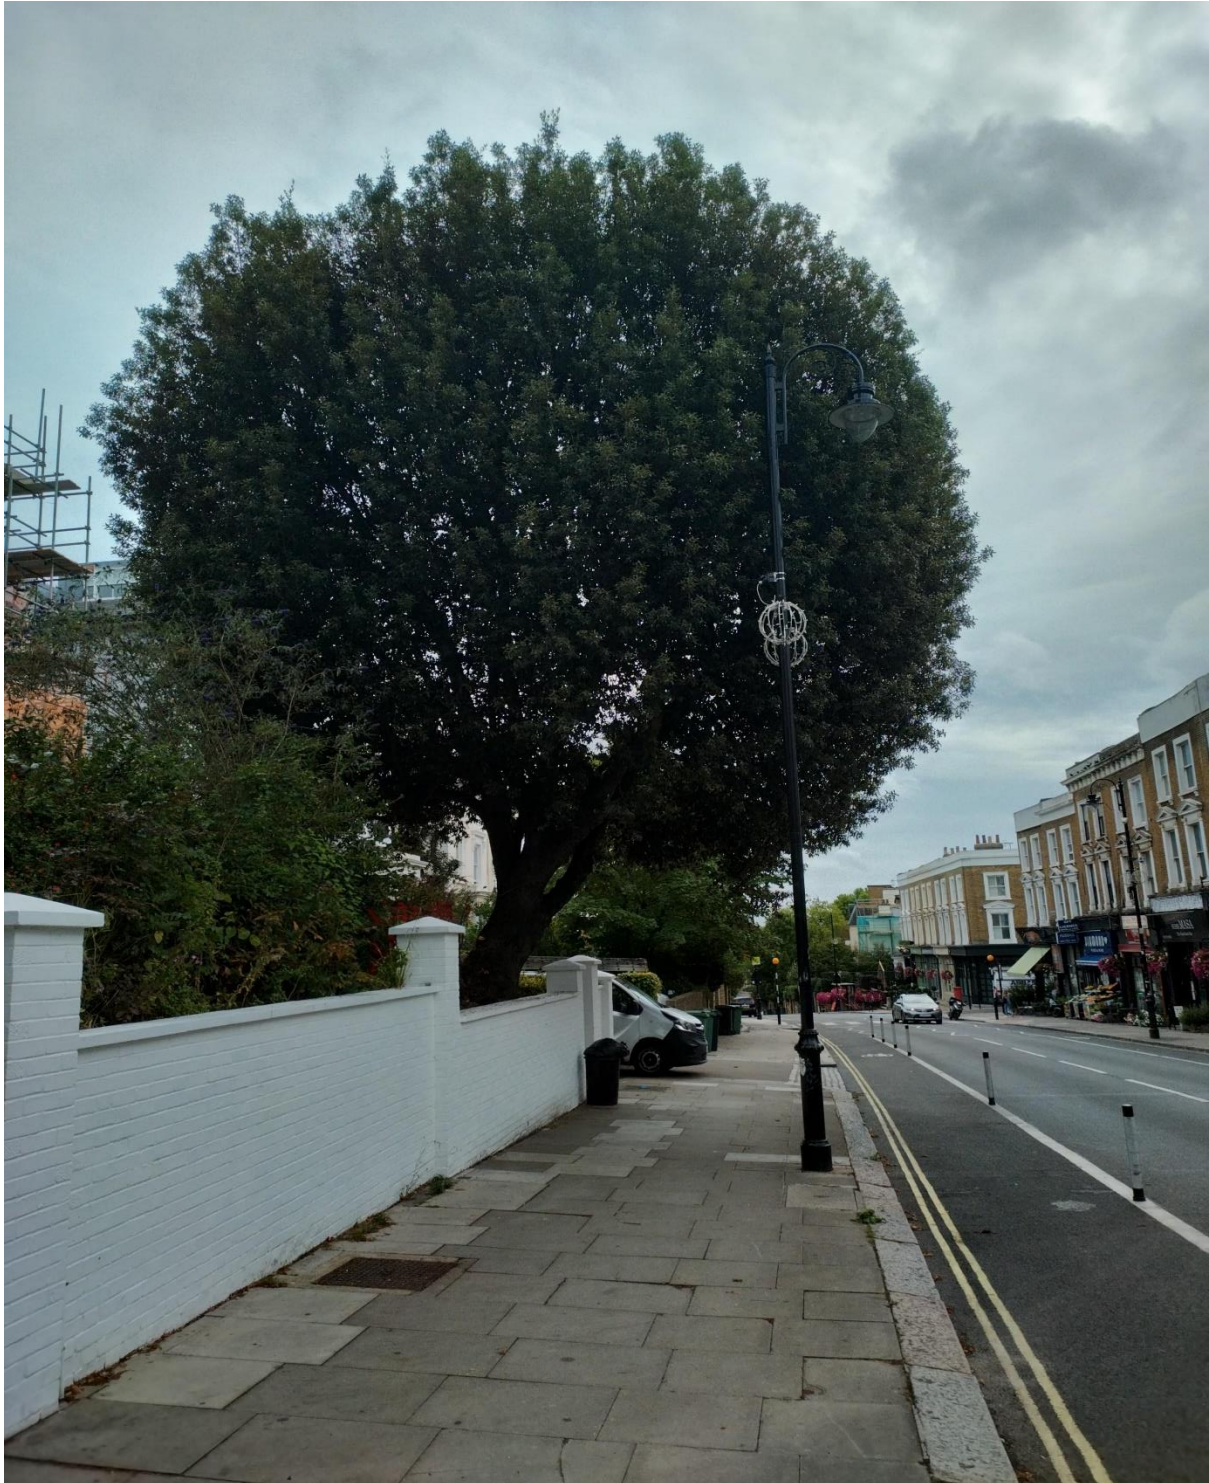
**Photo 1** – T73 Holm oak

| Tree No. | Species | Age Class | Approx. Height (m) | Dia. (DBH) | Condition | Growth Potential | Dist. to Building (m) |
|---|---|---|---|---|---|---|---|
| 73 | Holm oak (Quercus ilex) (Photo 1) | M | 19M | 62 | Fair | Low | 1230cm (house)<br>7cm (new wall)<br>360cm (gate pier) |
| Defects: | | Crown: too large for site, growing into light,<br>Stem: leaning towards road,<br>Roots: no defects visible, | | | | | |

According to the NHBC Standard 2010 Holm oak is a High water demand species which can attain a mature height of 16m. Their zone of influence is calculated as 125% of their maximum height and so this would be 20m. Since T1 is located 12.3m from the house and much closer to the walls and paving then they are all within the zone of influence of the tree. The Kew data shows that 75% of subsidence cases caused by oak occurred when the tree was within 13m of the property. Again this means the tree is a potential risk to both the house and the walls and surfaces.

Based on the information above I would conclude that the damage to the walls and front of the house (steps and portico) is likely to have been caused by the indirect action of roots (subsidence). Due to the proximity, size and water demand of the Holm oak this is likely to be the primary cause. SG3 is also likely to be contributing due to its close proximity and the large size of shrubs.

| Tree No. | Species | Ownership | Priority | Protection | Pruning Cycle (yrs) | Recommendation | Indicative cost |
|---|---|---|---|---|---|---|---|
| 73 | Holm oak | C | 2 | TPO | 2 | Crown reduce by 3m | £950 |

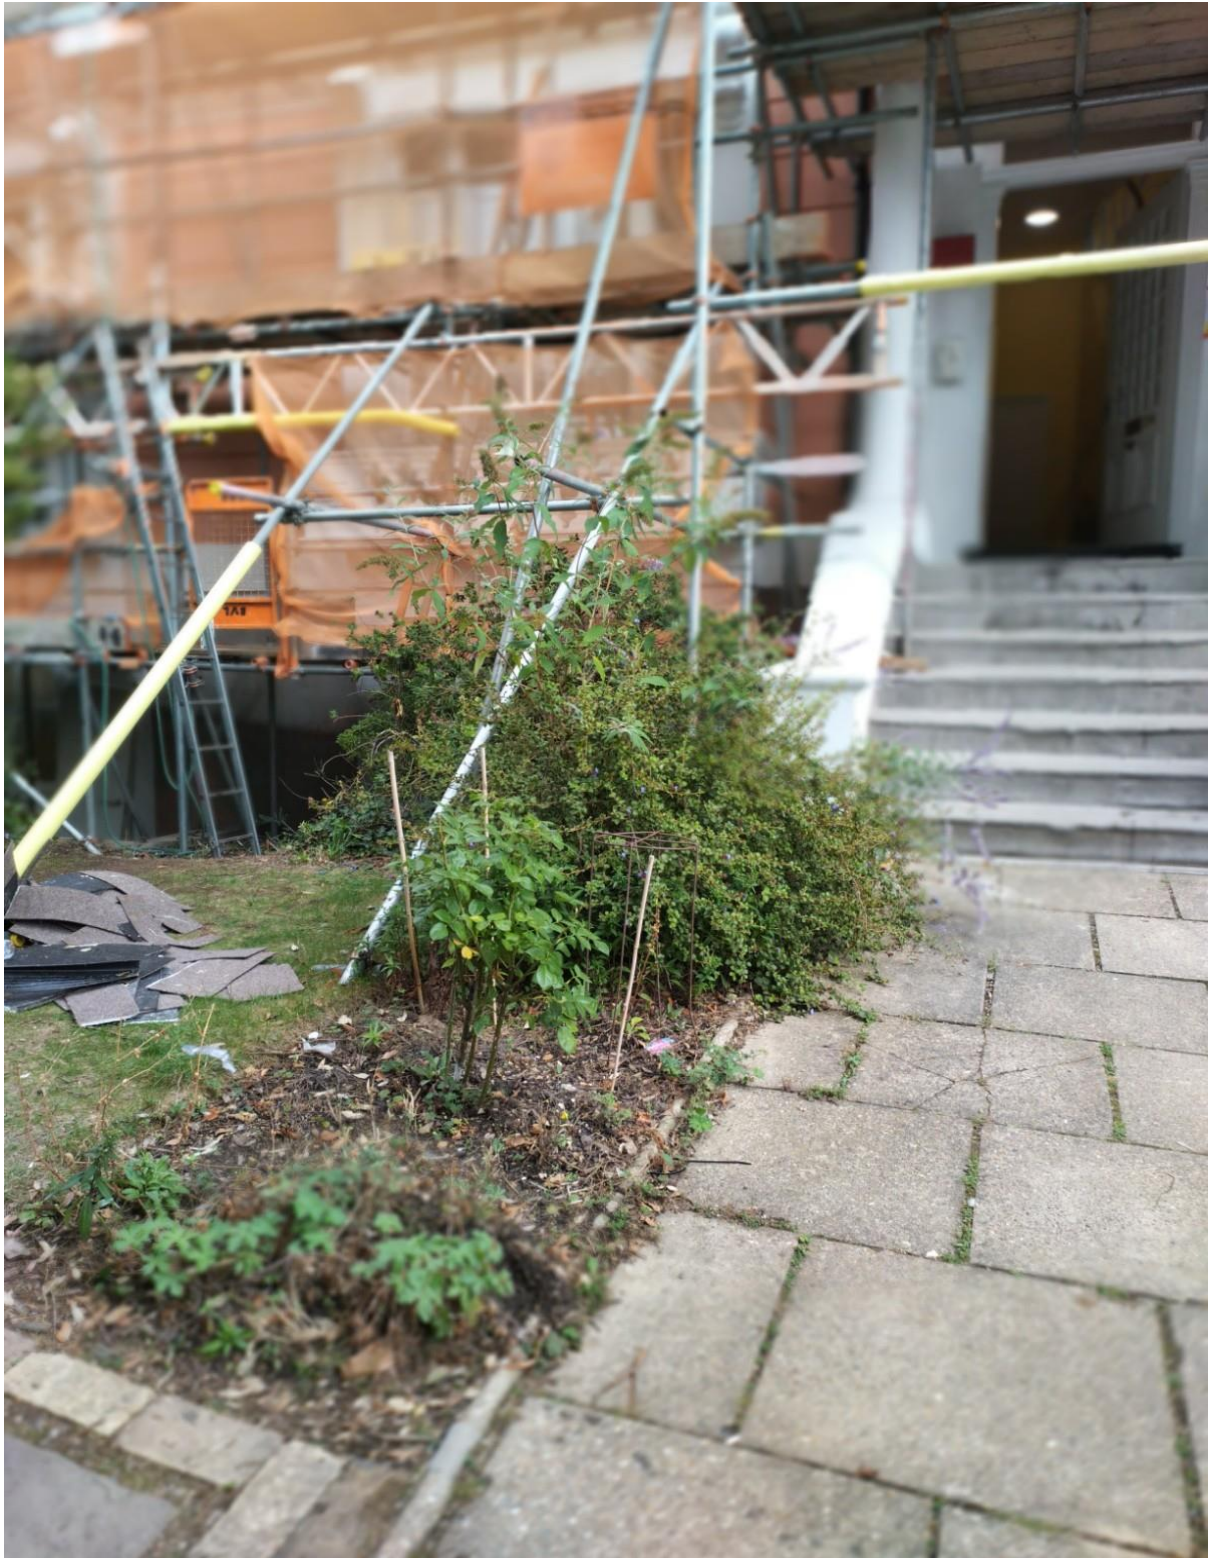
| Tree No. | Species | Age Class | Approx. Height (m) | Dia. (DBH) | Condition | Growth Potential | Dist. to Building (m) |
|---|---|---|---|---|---|---|---|
| SG1 | Mixed species (Hebe/ Euonymous/ Cotoneaster) (Photo 2) | M | 1M | 5 | Fair | Medium | 230cm (house) |

| Tree No. | Species | Ownership | Priority | Protection | Pruning Cycle (yrs) | Recommendation | Indicative cost |
|---|---|---|---|---|---|---|---|
| SG1 | Mixed species | C | 2 | CA | 1 | Remove all shrubs within 2m of house. Trim remainder | £150 |

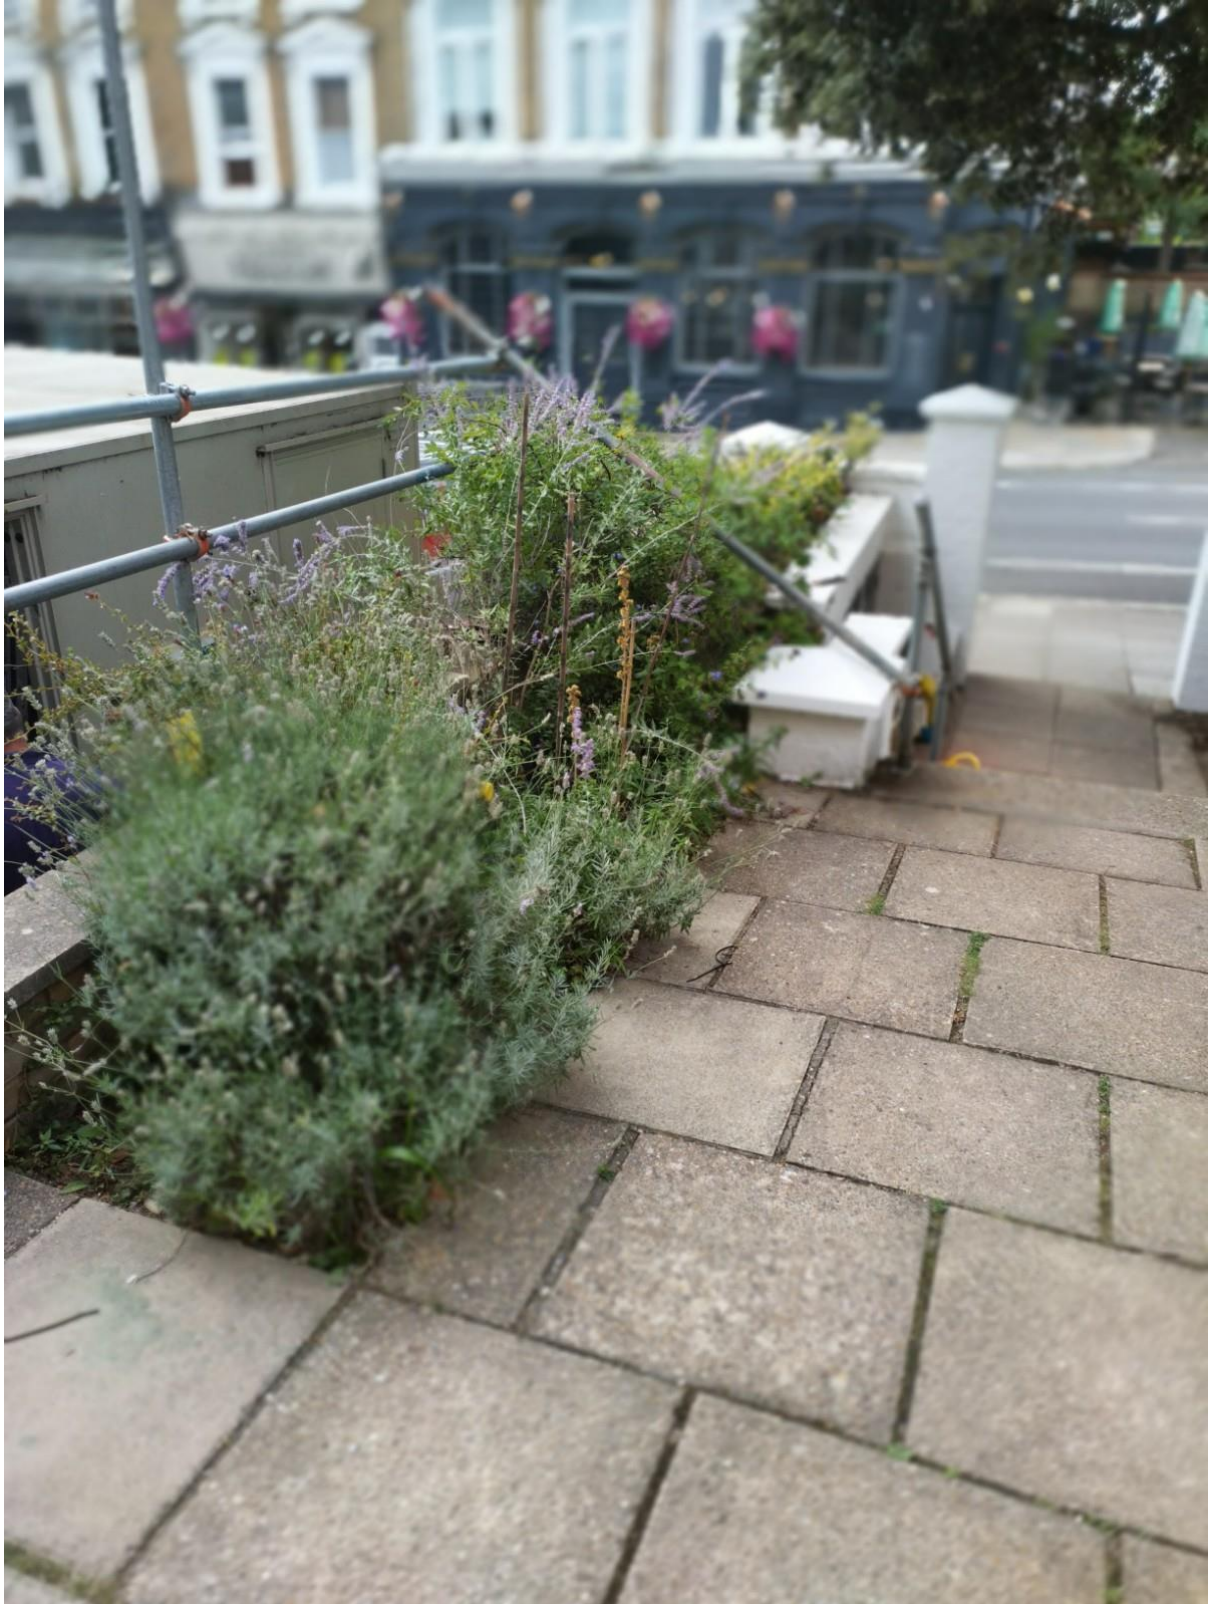
**Photo 3** – SG2

| Tree No. | Species | Age Class | Approx. Height (m) | Dia. (DBH) | Condition | Growth Potential | Dist. to Building (m) |
|---|---|---|---|---|---|---|---|
| SG2 | Mixed species (Lavender/ Euonymous) (Photo 3) | M | 1.5M | 5 | Fair | Medium | 520cm (house) |

| Tree No. | Species | Ownership | Priority | Protection | Pruning Cycle (yrs) | Recommendation | Indicative cost |
|---|---|---|---|---|---|---|---|
| SG2 | Mixed species | C | 2 | CA | 1 | Remove all shrubs within 2m of house. Trim remainder | £150 |

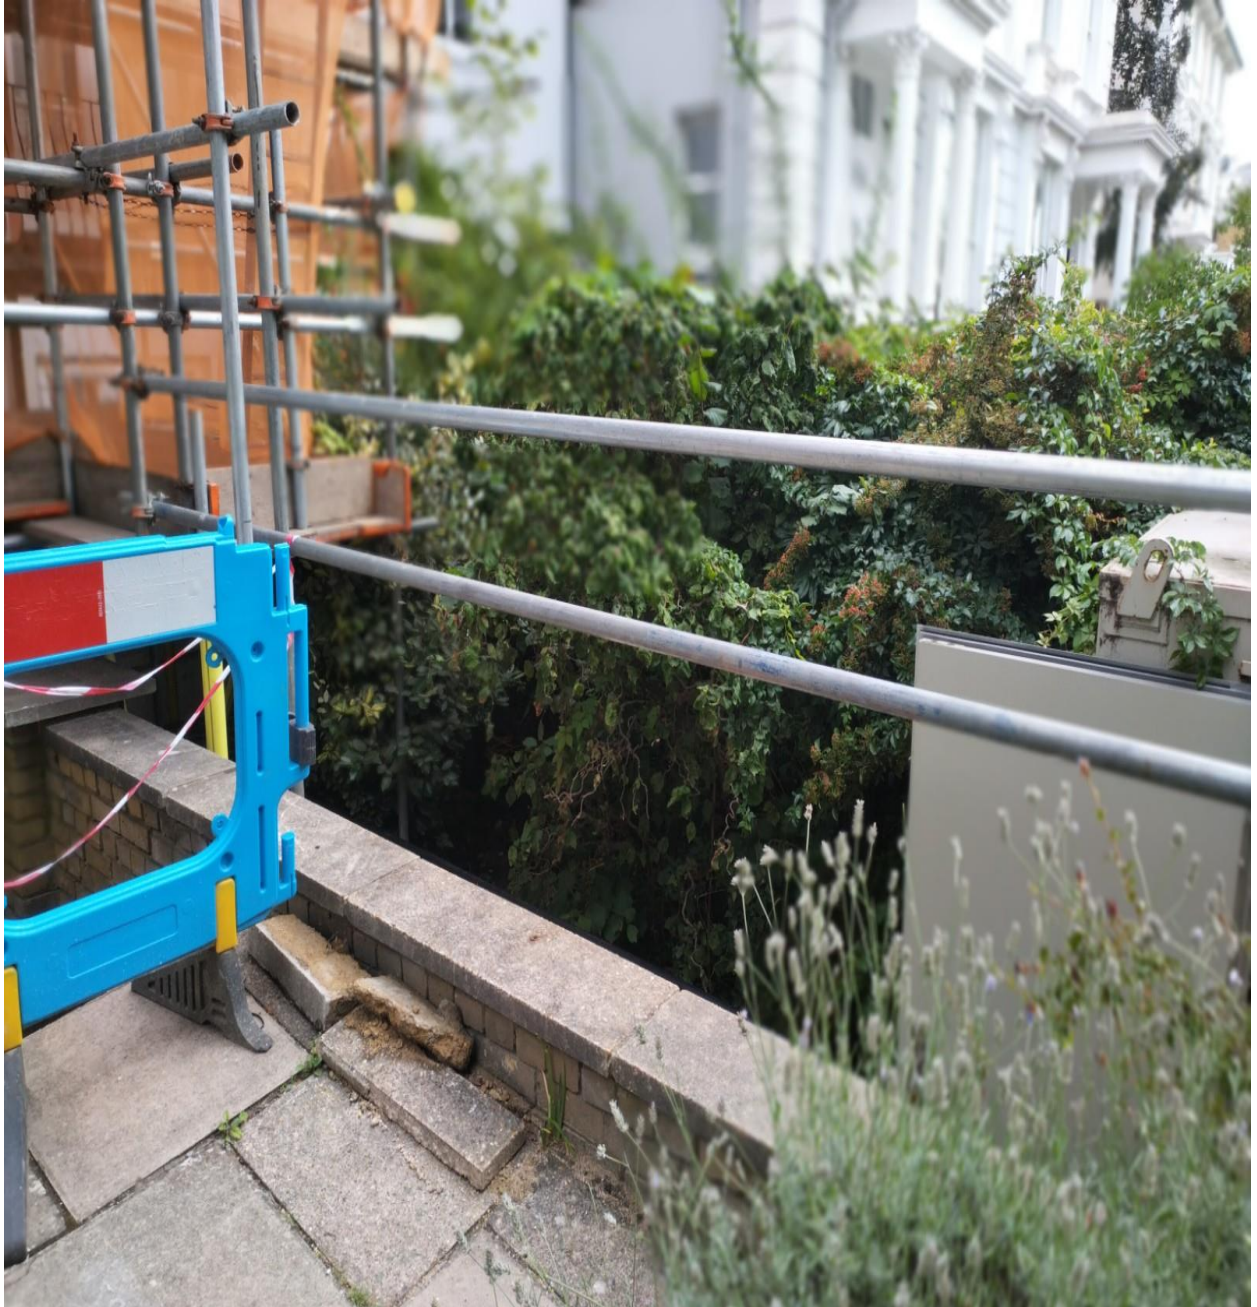
**Photo 4** – SG3

| Tree No. | Species | Age Class | Approx. Height (m) | Dia. (DBH) | Condition | Growth Potential | Dist. to Building (m) |
|---|---|---|---|---|---|---|---|
| SG3 | Mixed species (Corkscrew hazel, Forsythia/ Mahonia, Ivy) (Photo 4) | M | 3.5M | 5-10 | Fair | Medium | 260cm (house) |
| Defects: | | Crown: too large, obstructing path | | | | | |

Nither the Kew root data or the NHBC standard provide information on shrubs. However, the shrub groups are in much closer proximity to the house than the Holm oak and although smaller will still be actively translocating water and removing it from the surrounding soil – thereby contributing to the volumetric change. The shrubs in SG3 are larger in height and area.

| Tree No. | Species | Ownership | Priority | Protection | Pruning Cycle (yrs) | Recommendation | Indicative cost |
|---|---|---|---|---|---|---|---|
| SG3 | Mixed species | C | 2 | CA | 1 | Remove all shrubs. | £500 |

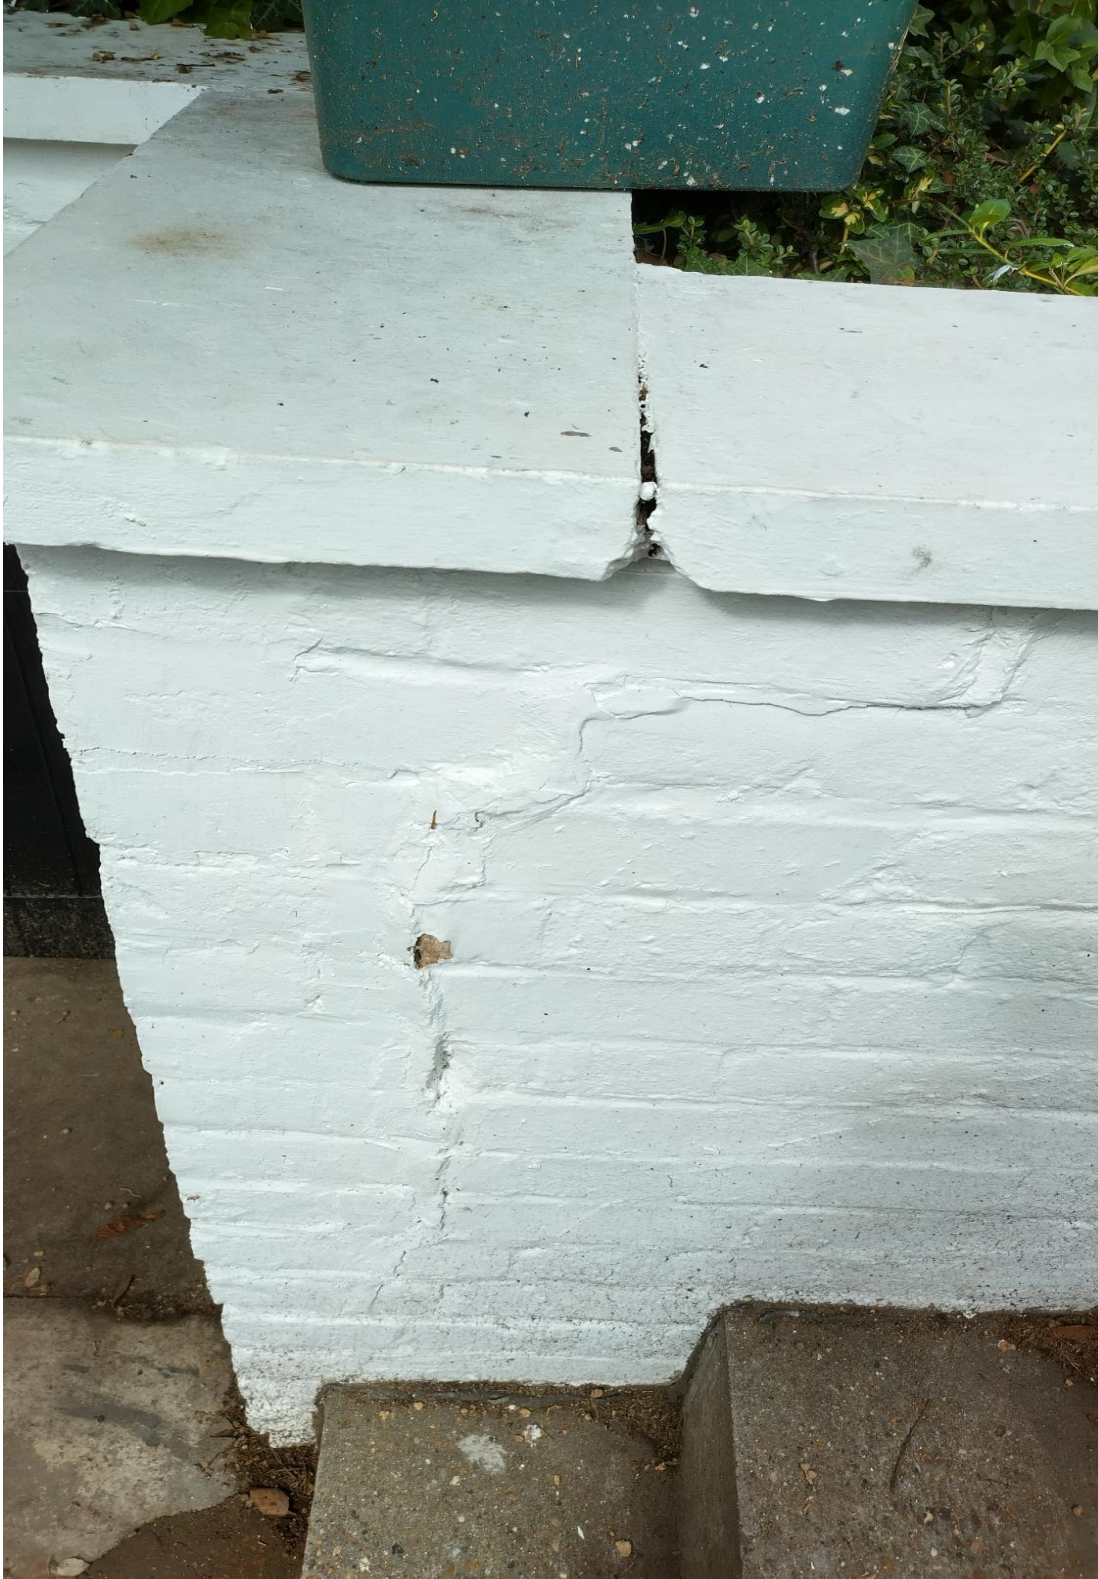
- Cracking to front garden walls, but not the new front boundary wall (Photo 5),
- Cracking to right side gate pier to boundary wall (Photo 6),
- Surface damage/cracks (Photo 7),
- Damage to front portico and steps (Photo 8 and 9),

The pattern of damage is consistent with volumetric changes in the soil. The cracks to the walls and surfaces could be resulting from differential downwards movement. The movement of the portico and stairs away from the building is typical of subsidence damage where there are differing depths of foundations again resulting in differential movement.

**Photo 5** – Wall damage 1

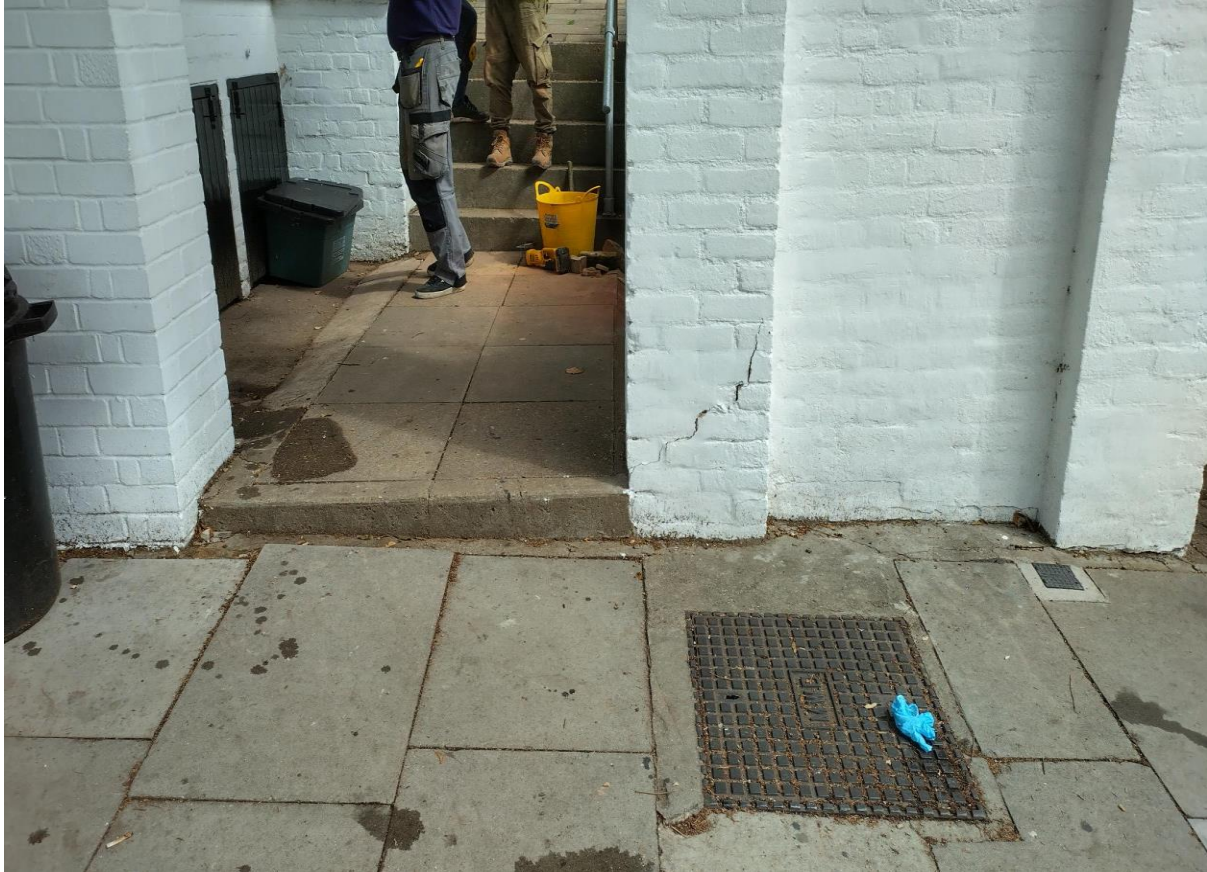
**Photo 6**– Wall damage/gate pier (2)

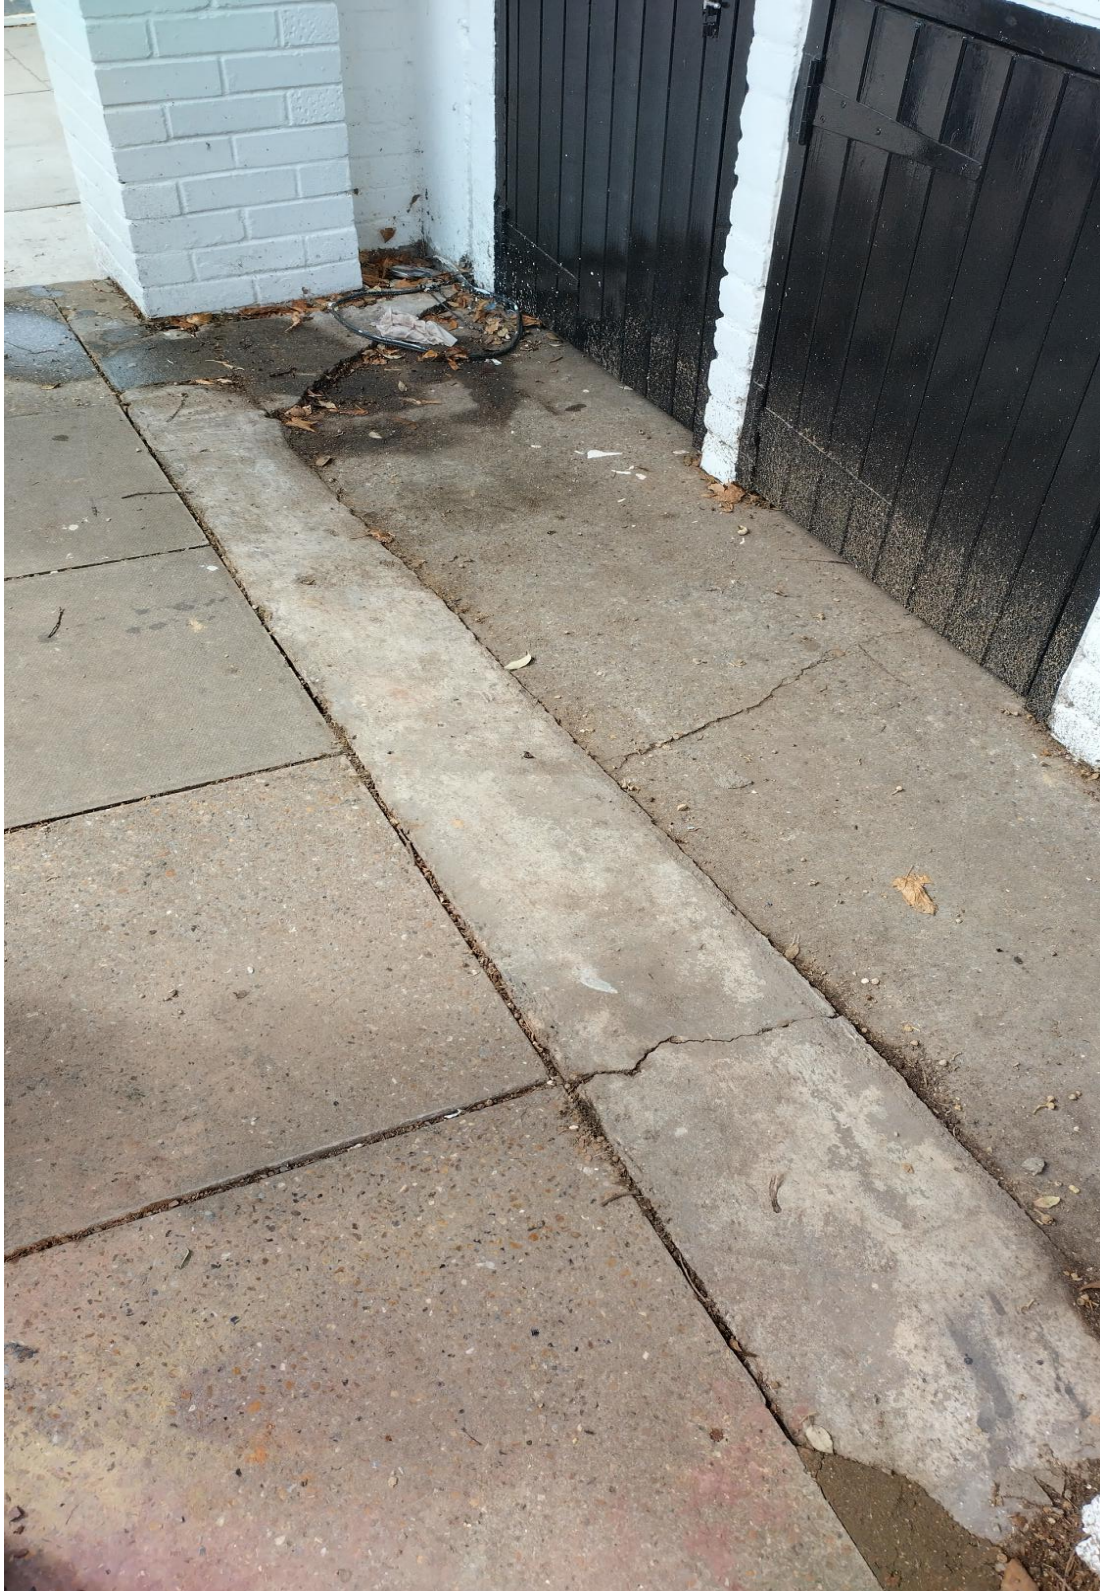
**Photo 7** - Surface damage

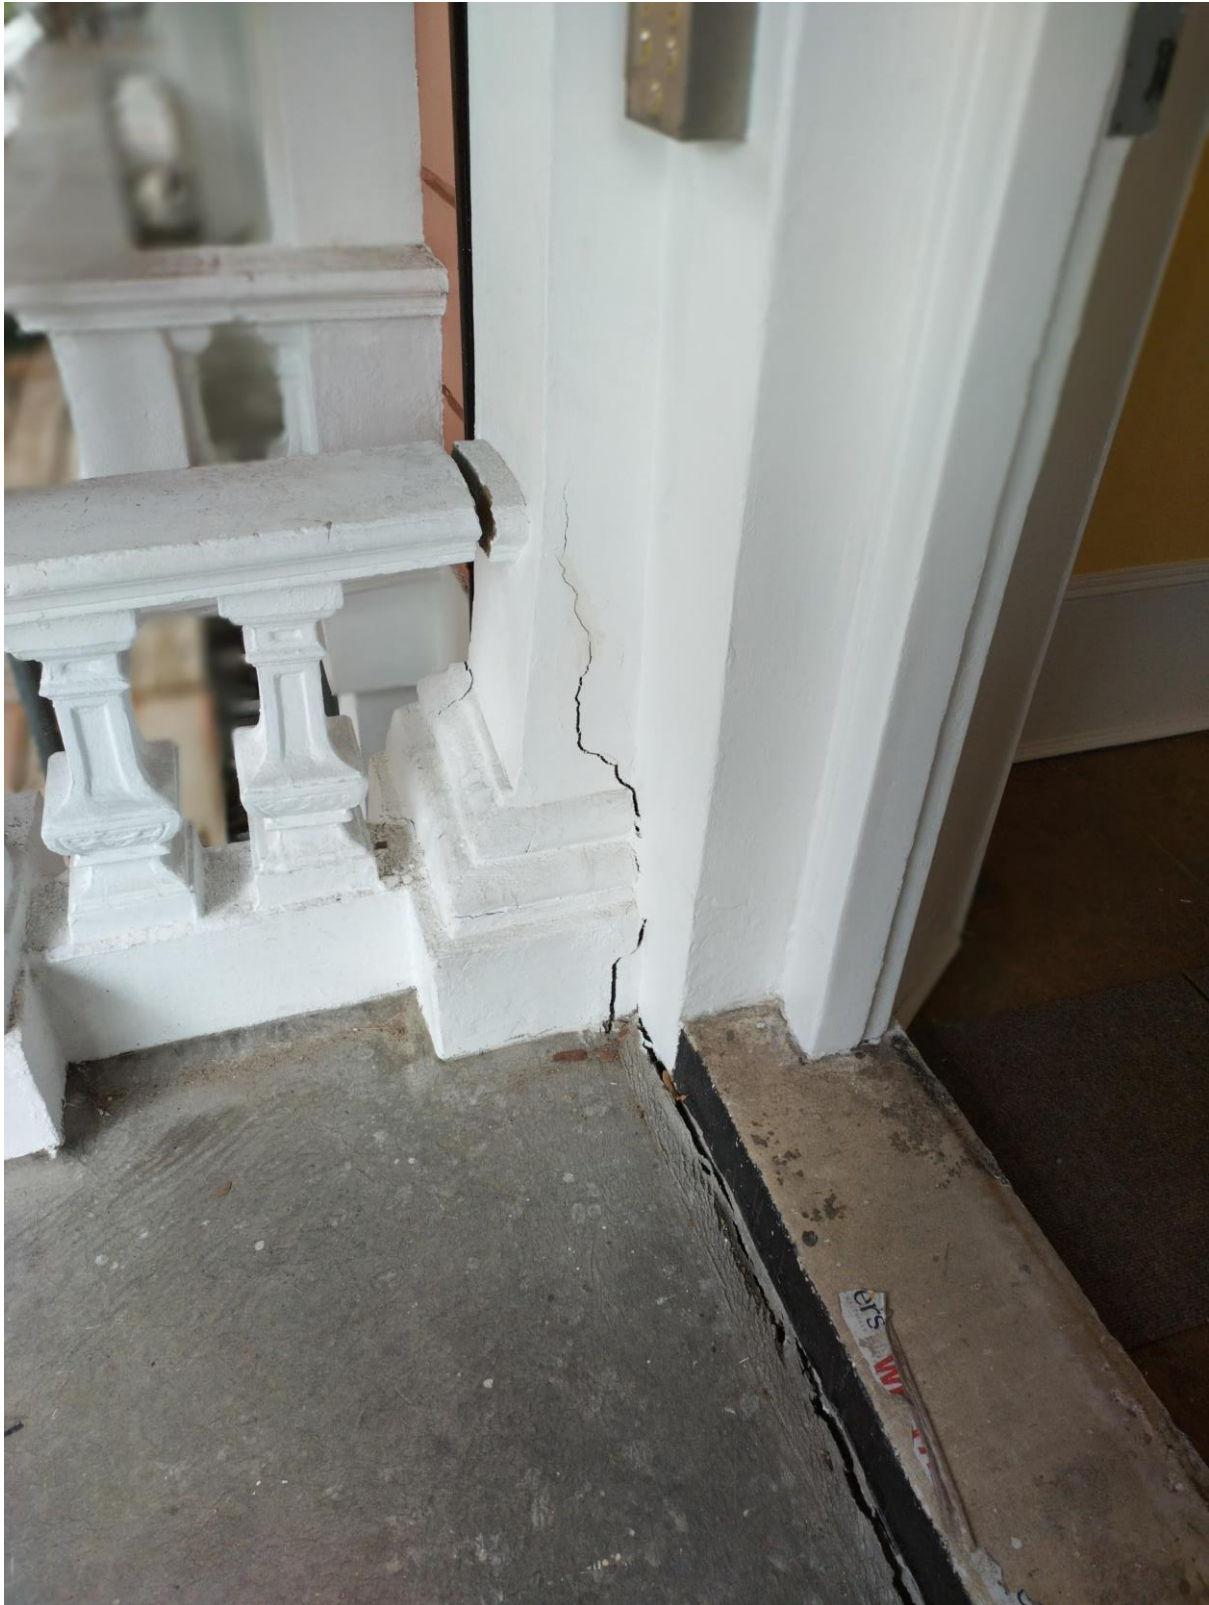
**Photo 8** – Portico Damage

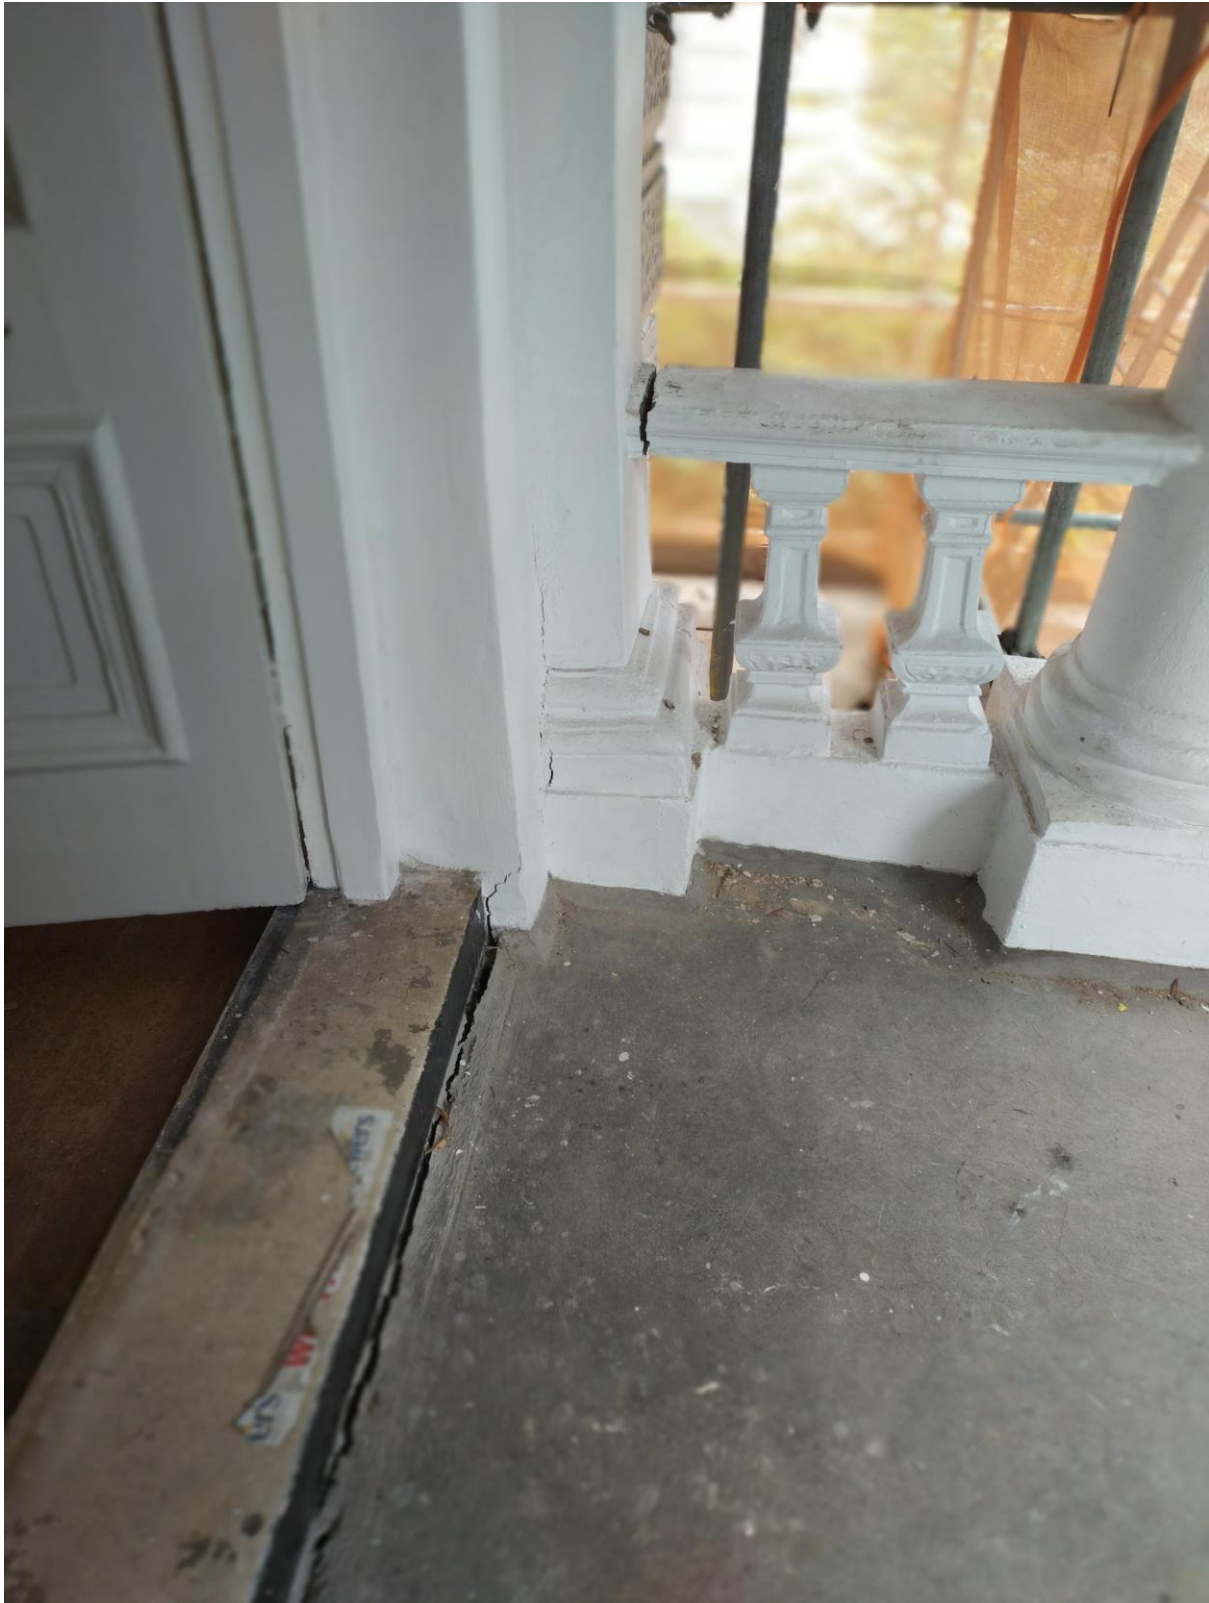
**Photo 9** – Step damage
