32 Aberdare Gardens NW6

**Reasons for tree work (amended 17/02)**

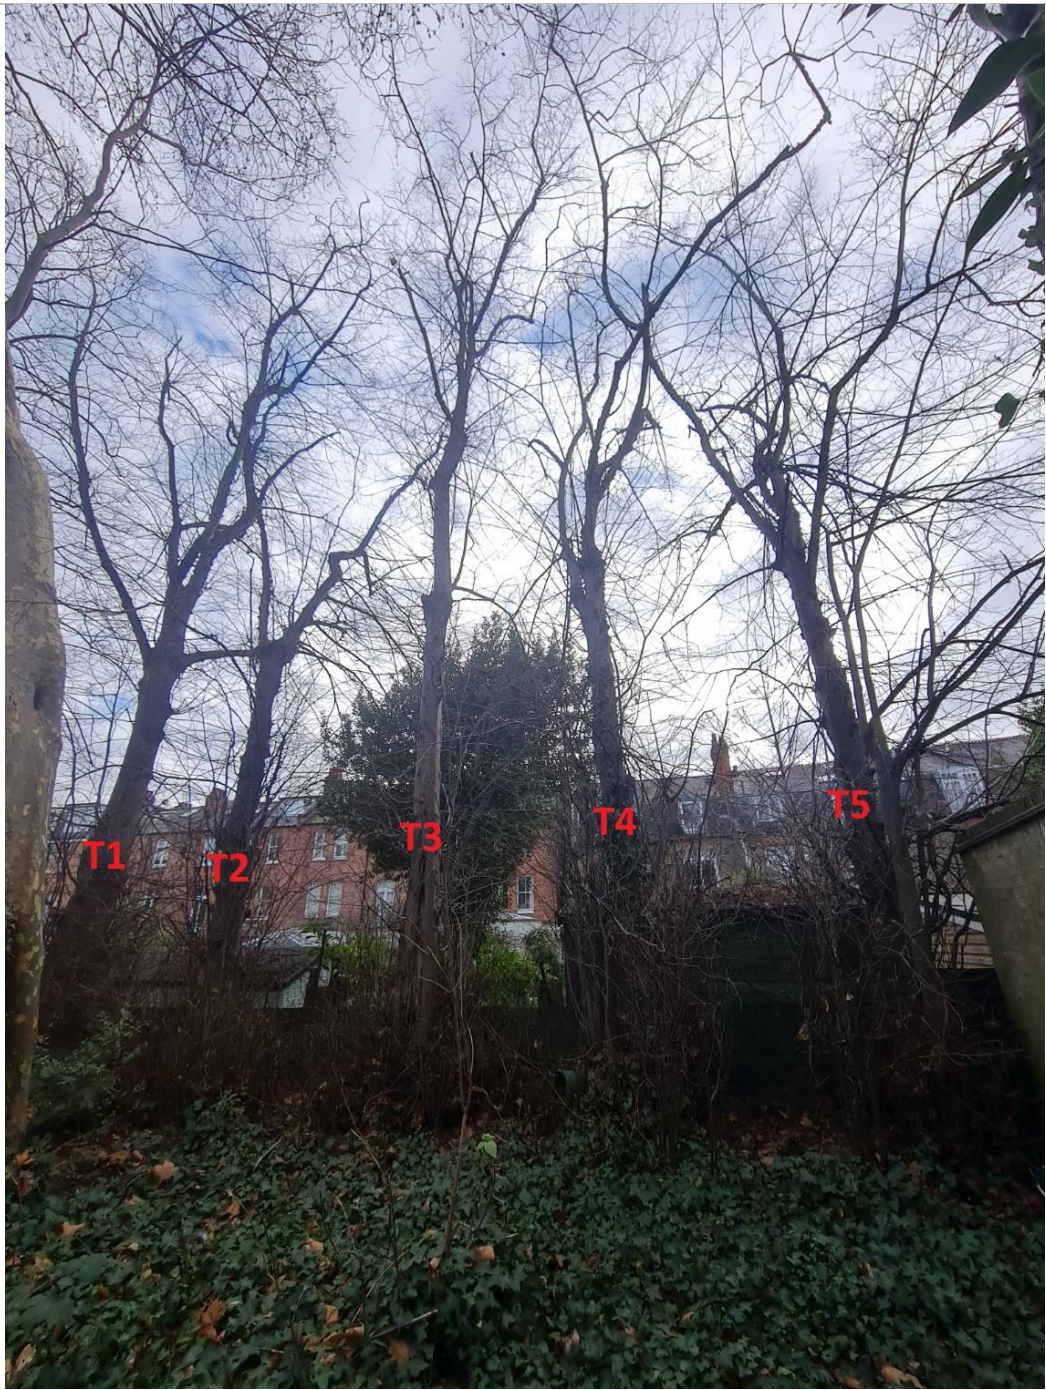
T1-T5  
Lime

**T1 Lime (Removal)** – Causing damage/collapse of 3<sup>rd</sup> party wall. Needs to be removed to facilitate rebuild and removal of roots. Images have been added to the portal

**T2 Lime (Removal)**- Causing damage/collapse of 3<sup>rd</sup> party wall. Needs to be removed to facilitate rebuild and removal of roots. Images have been added to the portal

**T3 Lime (Removal)** – This tree has a significant decay column at the base and needs to be removed due to damage to 3<sup>rd</sup> party wall. Needs to be removed to facilitate rebuild and removal of roots.

**T4 Lime (Removal)** – Causing damage to 3<sup>rd</sup> party wall. Needs to be removed to facilitate rebuild and removal of roots.

**T5 Lime** – Good tree management

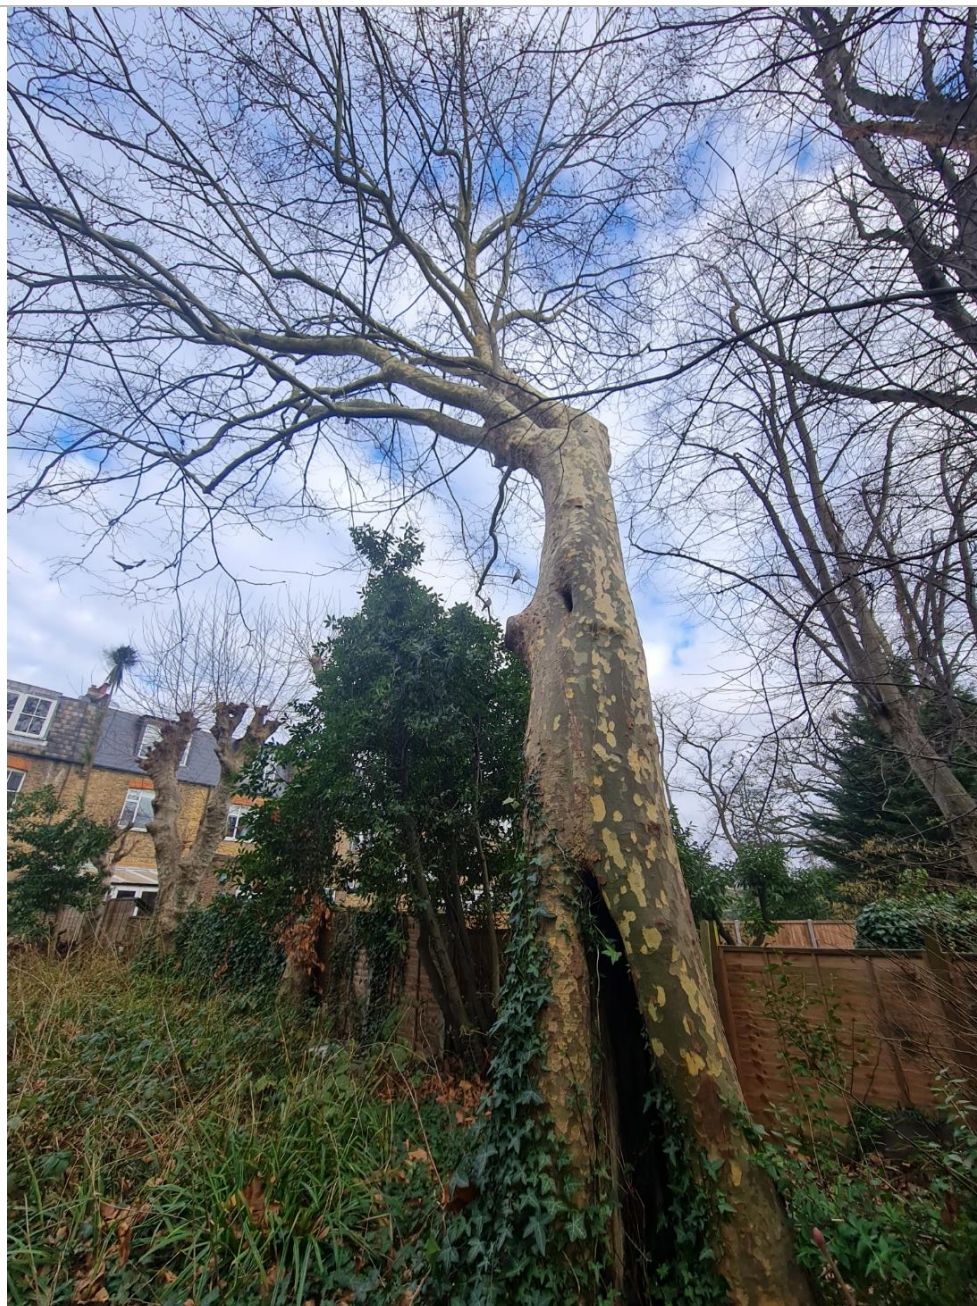
T6  
London  
Plane

**T6 London Plane (Removal)** – Asymmetrical crown with a large section of the crown over a third-party garden. Very large decay column. Approx 60% of trunk hollow. Probed to a depth of at least 1 meter below ground level. Decay extends approx. 7 meters up the stem which can be partially seen on the below images. A heavy reduction was considered, but then discarded due to the very poor access to the tree. As the tree worsens over time, there is no MEWP or crane access to facilitate the cyclical works required to re-pollard, or for its removal once it is at a point where it is no longer safe to climb. At present, we are just about happy to climb with minimal rigging. In the event of the tree failing, the potential damage to third party property and life is extreme.

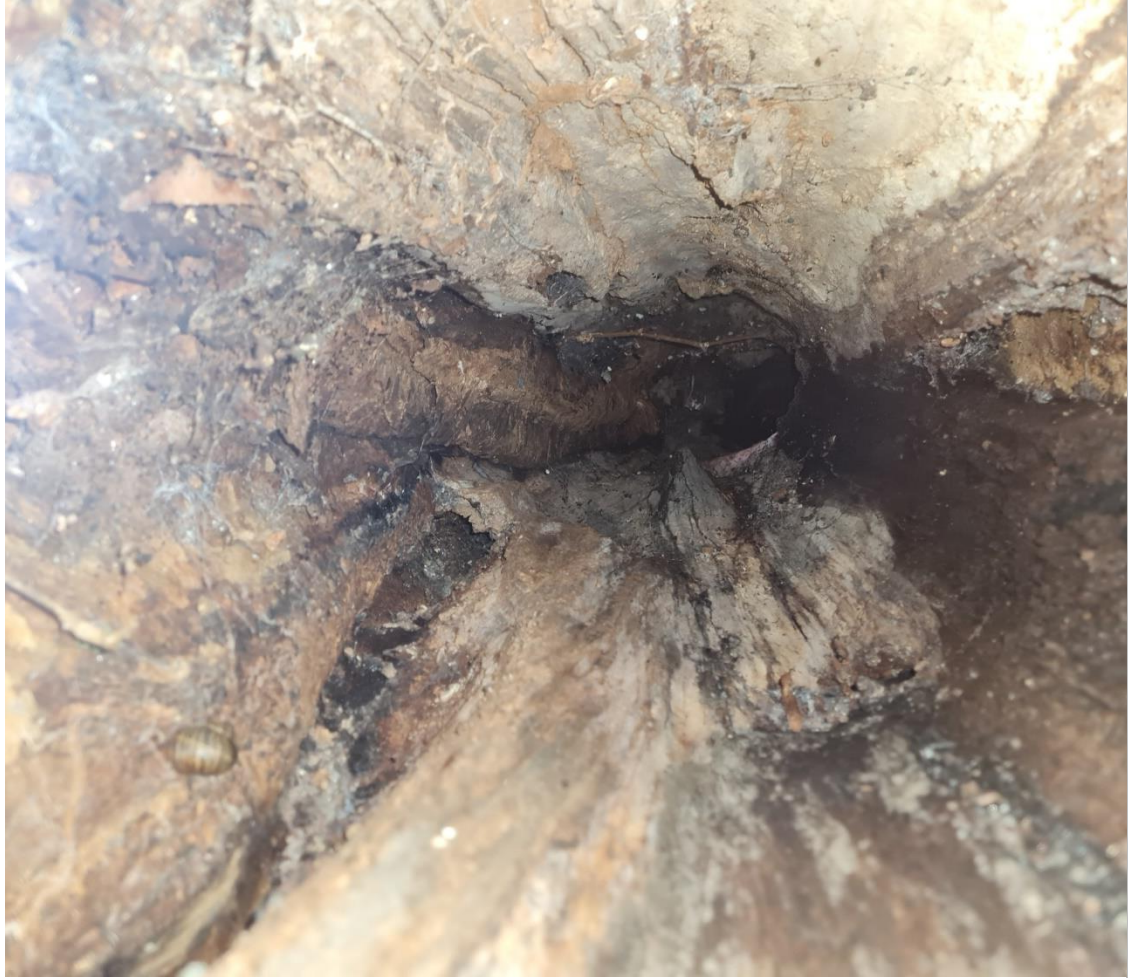
Internal  
image of  
T6,  
looking  
up
