Arboricultural Report

75 Albert Street
Camden Town
London
NW1 7LX

Ref: 36298(f2)
DLG-SN-22-004445

Site Visit Date:
23rd September 2022
Report Date:
26th January 2023

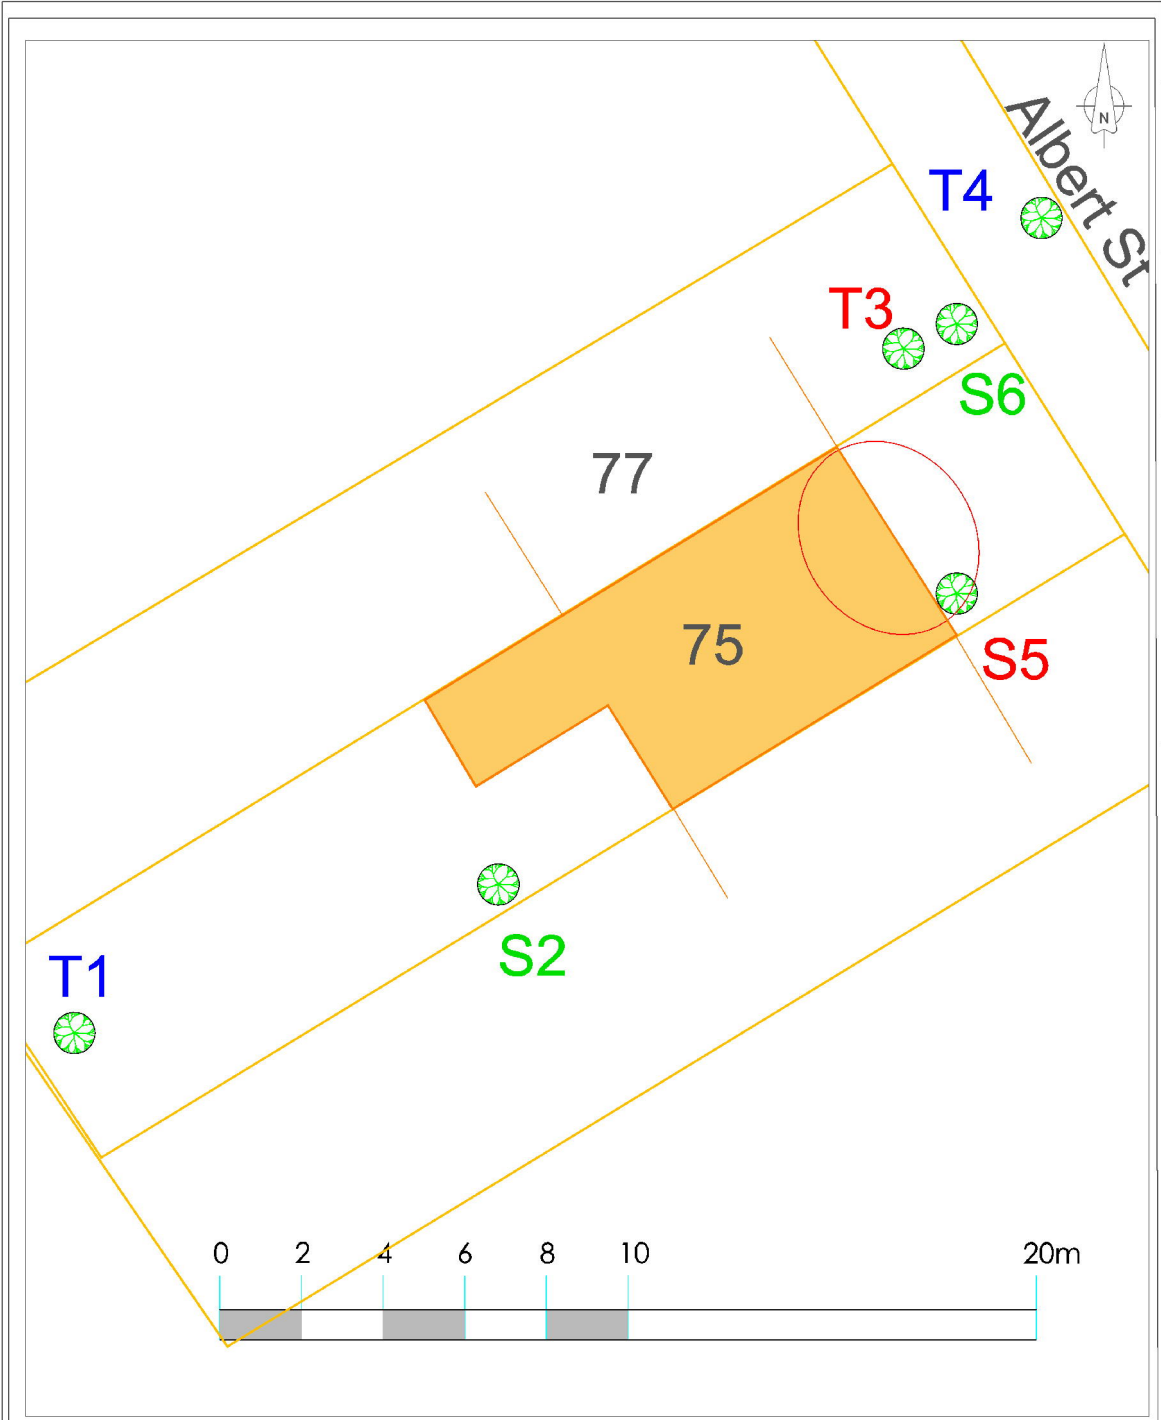
Figure Number: 1 Rev: A

Areas of damage
noted

Title: Tree & shrub locations

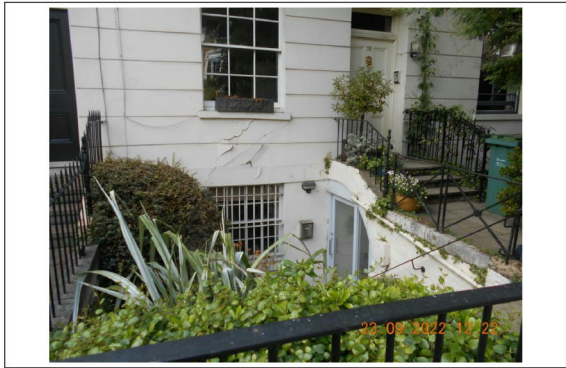
Figure 2: Front of property with S5 pyracantha.

- 6.1 At this stage removal of the mimosa T3 and the pyracantha S5 are recommended. Monitoring post their removal and into the summer of 2023 is recommended to confirm property stability is achieved. However, if there is ongoing seasonal movement then the role of the plane tree will have to be examined.

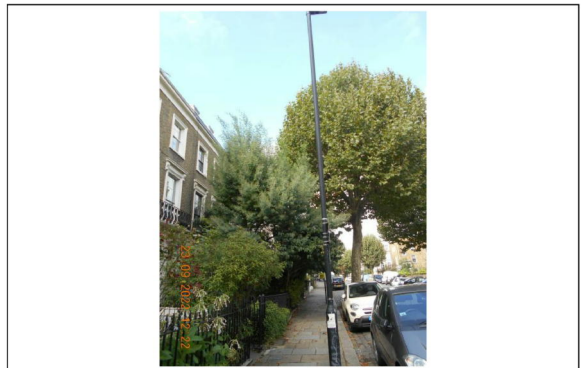
Figure 3: T3 in front of property with street tree T4.

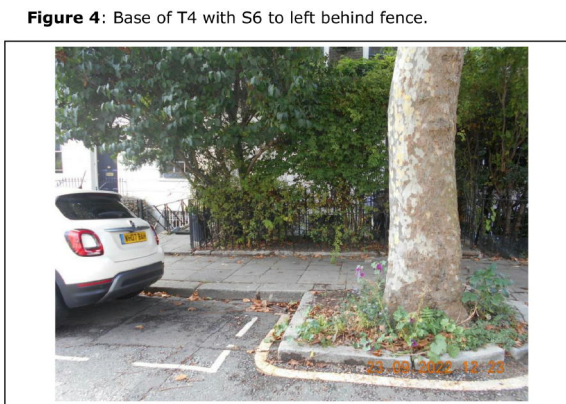
Figure 4: Base of T4 with S6 to left behind fence.

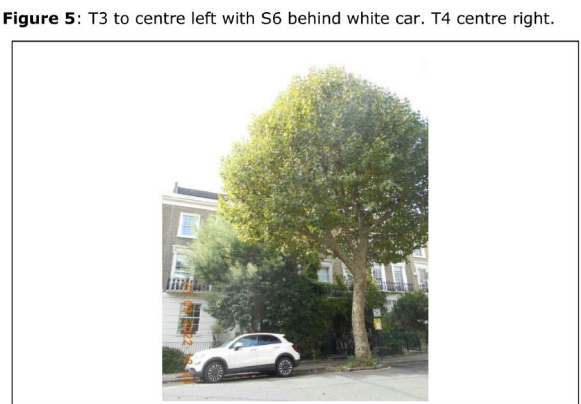
Figure 5: T3 to centre left with S6 behind white car. T4 centre right.
