## Engineers Report

**Risk Address** 75 Albert Street  
Camden Town  
London  
NW1 7LX

**360 Reference** DLG-SN-22-004445

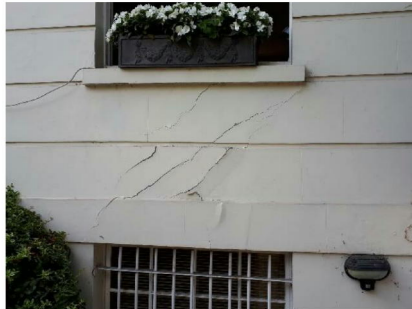
Cracking Above Basement Window

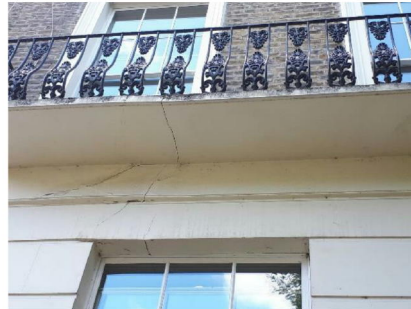
Cracking Above Ground Floor Window

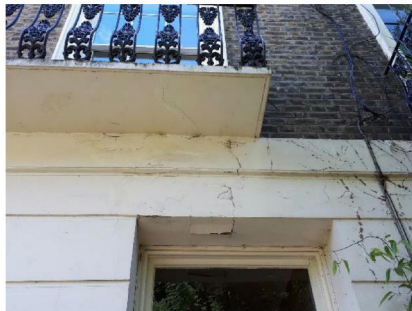
Cracking Above Front Door

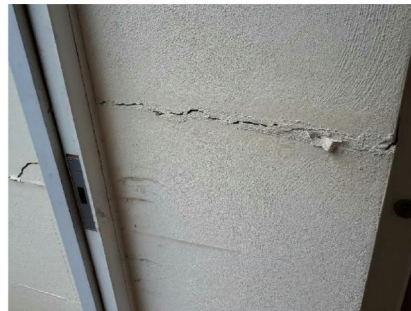
Cracking at Basement Level

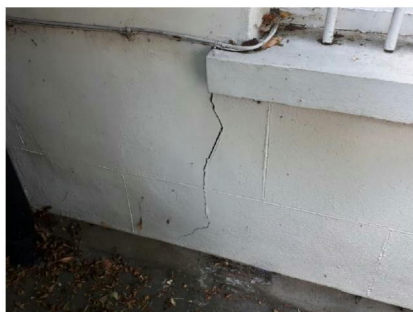
Cracking Below Basement Window

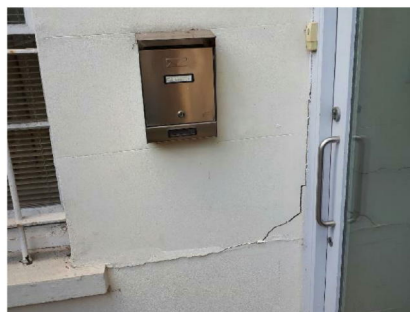
Cracking Adjacent to Basement Door

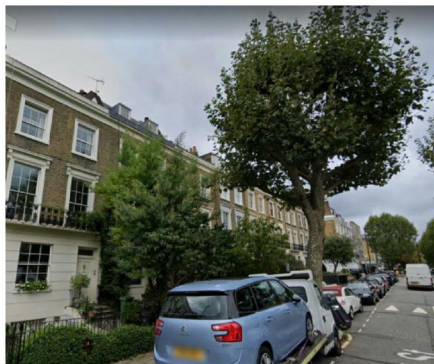
Vegetation – October 2020

There is Mimosa tree in the front garden of No. 77 and this is approximately 6 metres tall and within 3 metres. In the public footpath there is also a large Broadleaf tree (possibly a London Plane) and this is estimated to be 10 metres tall and within 6 metres. It is understood that a Fig tree was removed from the insured's front garden as part of the previous claim.

The damage will stabilise as the clay rehydrates over the winter and spring and hopefully some of the cracking will close up. However, there is a high risk of further damage occurring during future dry periods of weather and therefore it is recommended that the moisture demand of the vegetation is reduced – ideally the removal of both the Mimosa and the London Plane.
