Issue date: 19/01/2023

Monitoring visit 3 of 4

### Monitoring Plus Report

| <b>Address</b><br>75 Albert Street<br>Campden Town<br>London<br><br>NW1 7LX | | <b>Suspected reason</b><br>to be advised | <b>Monitoring type</b><br>levels & cracks |

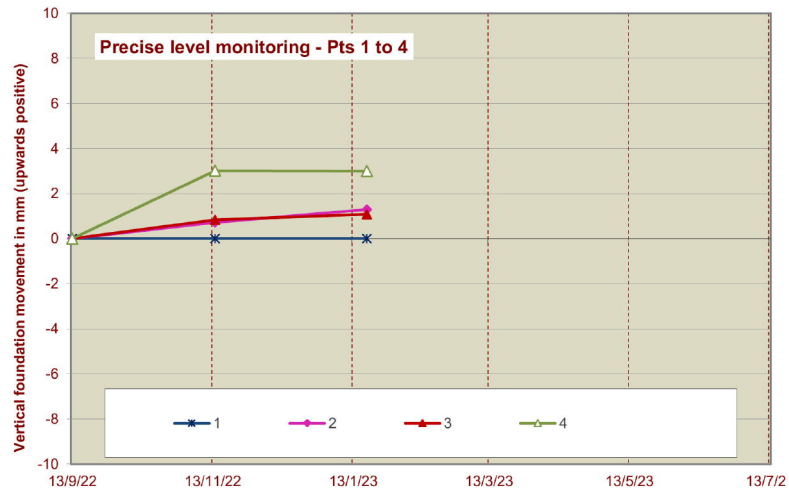
### Precise level monitoring related to Point 1

| <b>Comment</b><br>Max move 3.0 mm<br>Focal area Pts 4, | | <b>Feedback from last visit</b><br>no feedback for this visit | |

| 4 | -1296.68 | <b>0.0</b> | -1293.67 | <b>3.0</b> | -1293.68 | <b>3.0</b> | | #N/A | | #N/A |

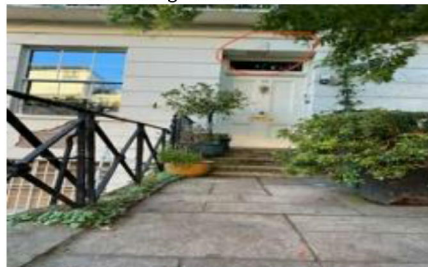
| Crack A n/a too high . See photo attached | | <b>Sketch showing location of monitoring points</b><br><p>FRONT ELEVATION</p> <p>TBM: front of No.73, next to the lamp post on footpath</p> | |

Crack A-too high and not safe
