CCTV REPORT FOR: 75 ALBERT STREET

CAMPDEN TOWN

LONDON NW1 7LX

Site Visit: 22-Aug-22 Report Date: 14-Oct-22

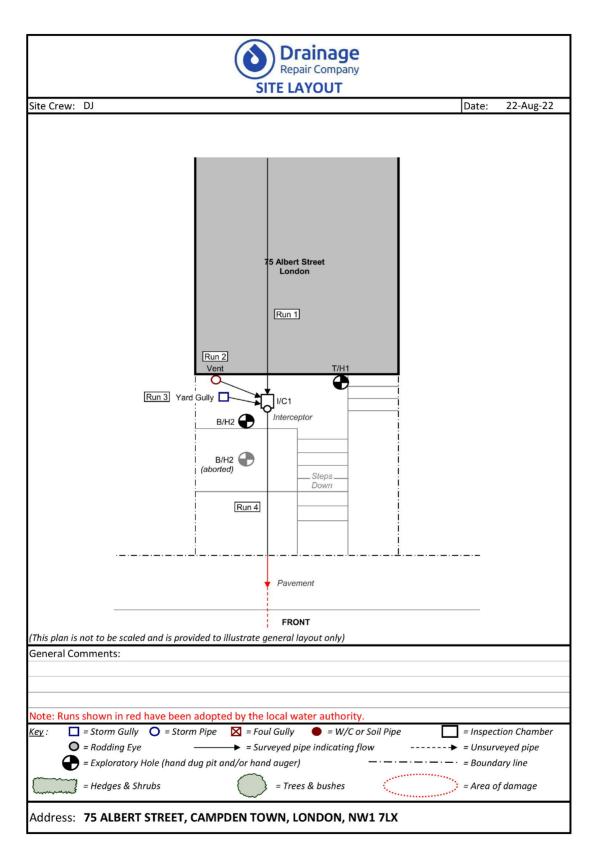
CCTV S	URVEY DETA	AILS		
Site Crew:	DJ				Date:	22-Aug-22
<u>RUN:</u> 1	Pipe Dia. (mm): 150	System:	Foul Water	Made of:	Glazed	Clay
From:	I/C1	Inv (m): 1.00	Upstream	To: I/C2		Inv (m):
Metres	Fa	ults / Defects		Rei	marks

0.00				At I/C1		
				Start of liner repair		
6.70				End of liner repair		
8.50	No Visible Defects			At I/C2		
				End of survey		
RUN: 2	Pipe Dia. (mm): 100	System:	Foul Water	Made of:	Glazed	Clay
From:	I/C1	Inv (m): 1.00	Upstream	To: Vent		Inv (m):
Metres	Fa	ults / Defects		Rei	marks

0.00				At I/C1		
0.40	Medium Displaced Joint					
0.70	Circumferential Crack 1	2 to 12 o'clock				
0.80	Medium Displaced Joint	:				
				At top of rest bend to	vent

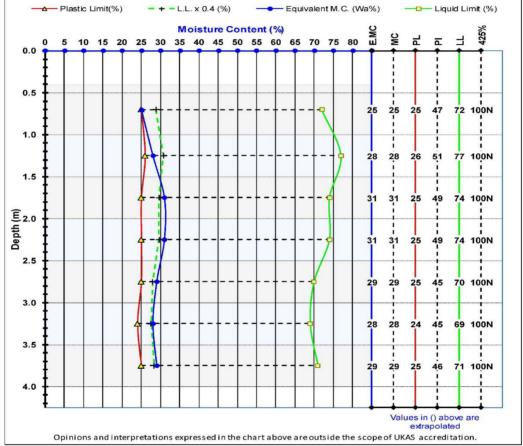
Depth	Depth	1 - JNC of house & basement	Plasticity	Volu	me Change
T (m)	B (m)	Brief Soil Description	(BS 5930)	M.PI	(BRE 240)
0.4	1	Stiff brown slightly sandy CLAY with rare medium gravel	V. high CV	47%	High
1	1.5	Stiff brown slightly sandy CLAY with rare medium gravel	V. high CV	51%	High
1.5	2	Stiff brown slightly sandy CLAY	V. high CV	49%	High
2	2.5	Stiff brown slightly sandy CLAY with rare medium gravel	V. high CV	49%	High
2.5	3	Very stiff brown slightly sandy CLAY with occasional medium gravel	High CH	45%	High
3	3.5	Very stiff brown slightly sandy CLAY with occasional medium gypsum	High CH	45%	High
3.5	4	Very stiff brown slightly sandy/silty CLAY with occasional medium gypsum	V. high CV	46%	High
