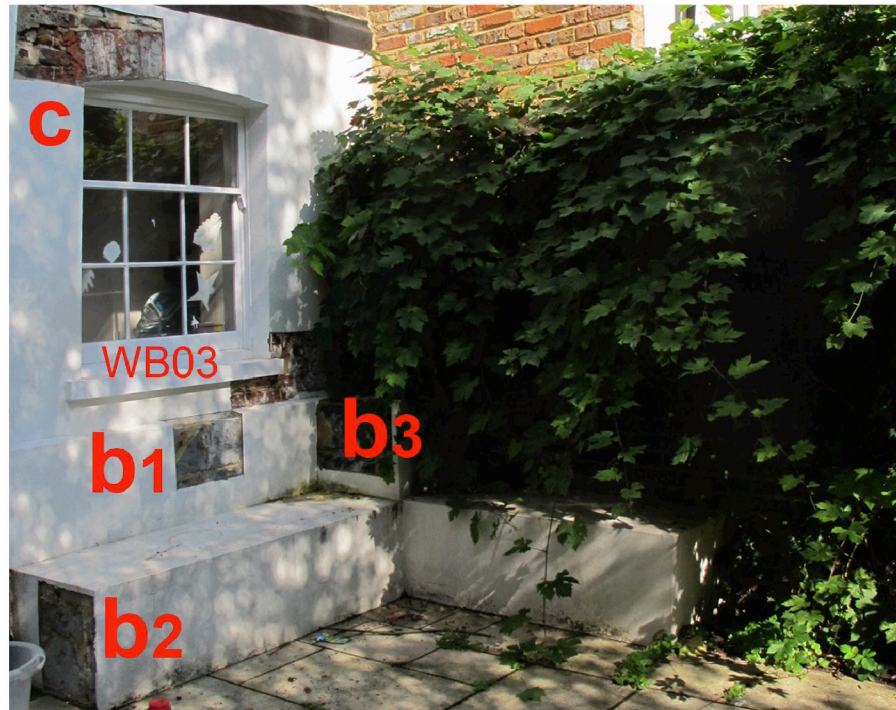
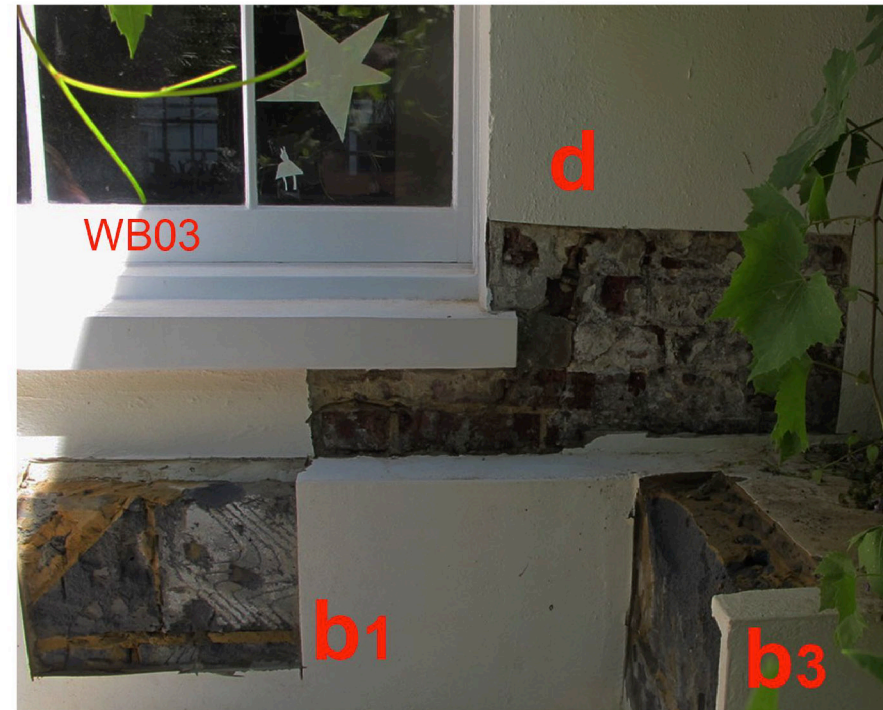
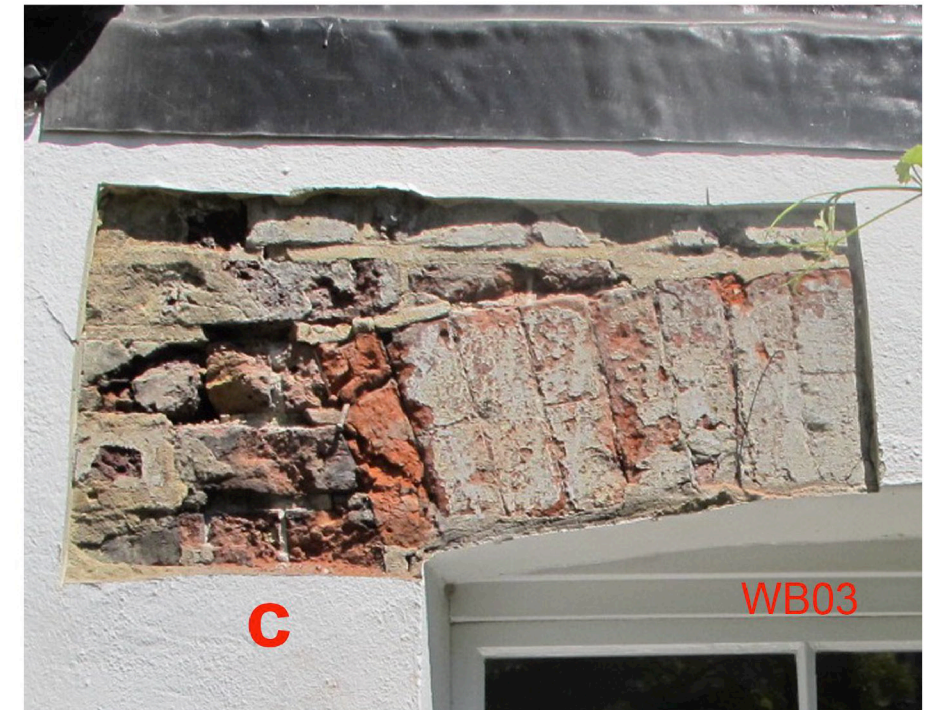
02. HISTORIC FABRIC OPENING UP AT WINDOW W B 0 3

Inspection area **c** and **d** reveals the original soldier arch above window **WB03** and original brick apron below. This confirms that there was no original door opening as found under **WB04** despite the **1936 Town Plans 1:1056 (2686) 4th Edition** surveying an external closet extension in this location. The original masonry fabric revealed in these areas together with the **WB04** area suggests the original brickwork was exposed, although now significantly damaged by the 20th Cen. Portland cement render coat to repair and leave exposed.

Inspection area **b1**, **b2** and **b3** reveals the 20th Cen. construction of the external terrace seating in concrete blockwork and Portland Cement render finish.

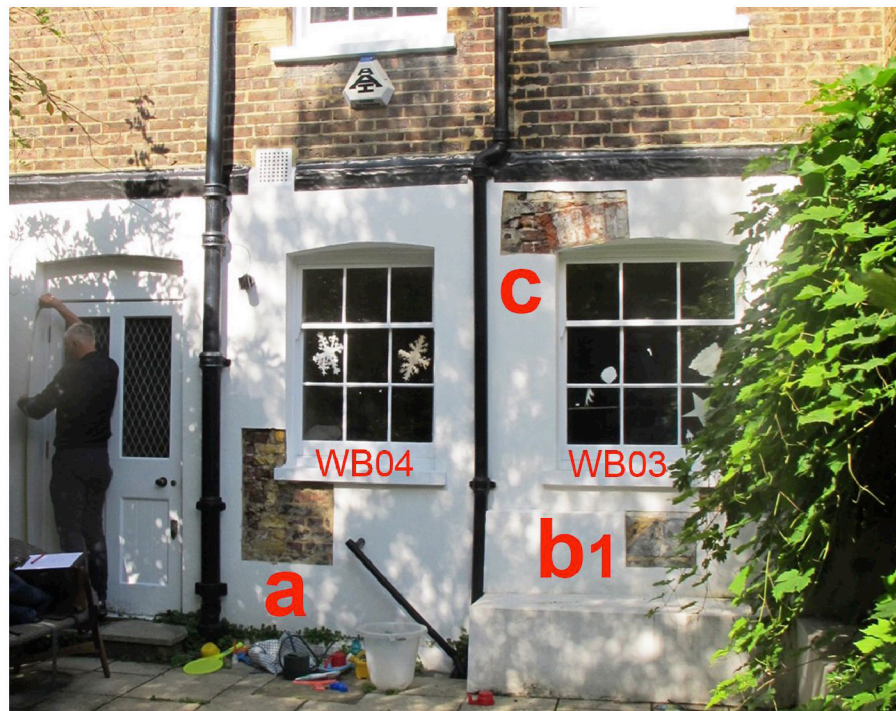
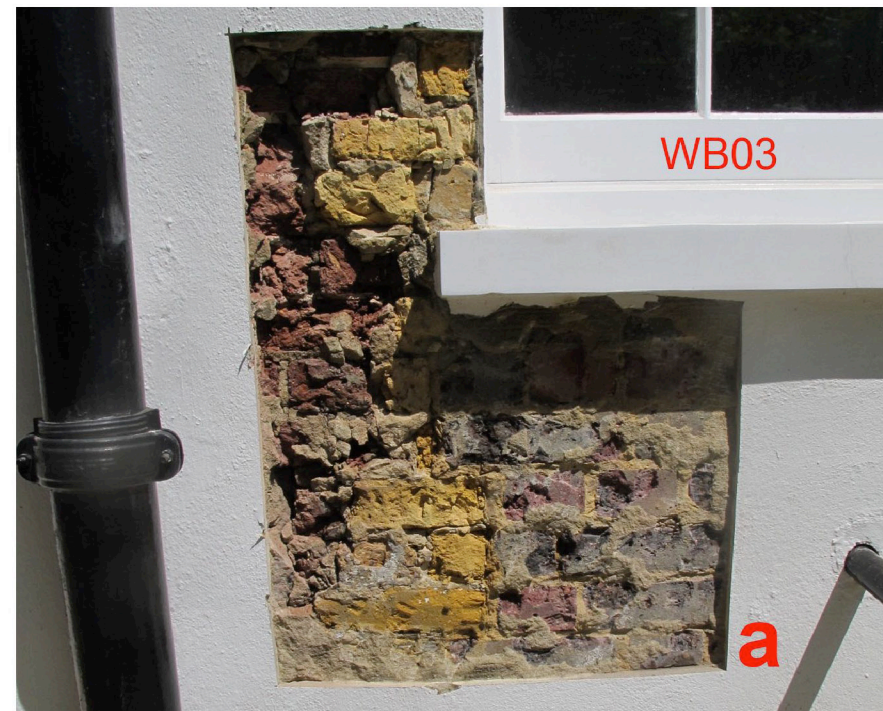
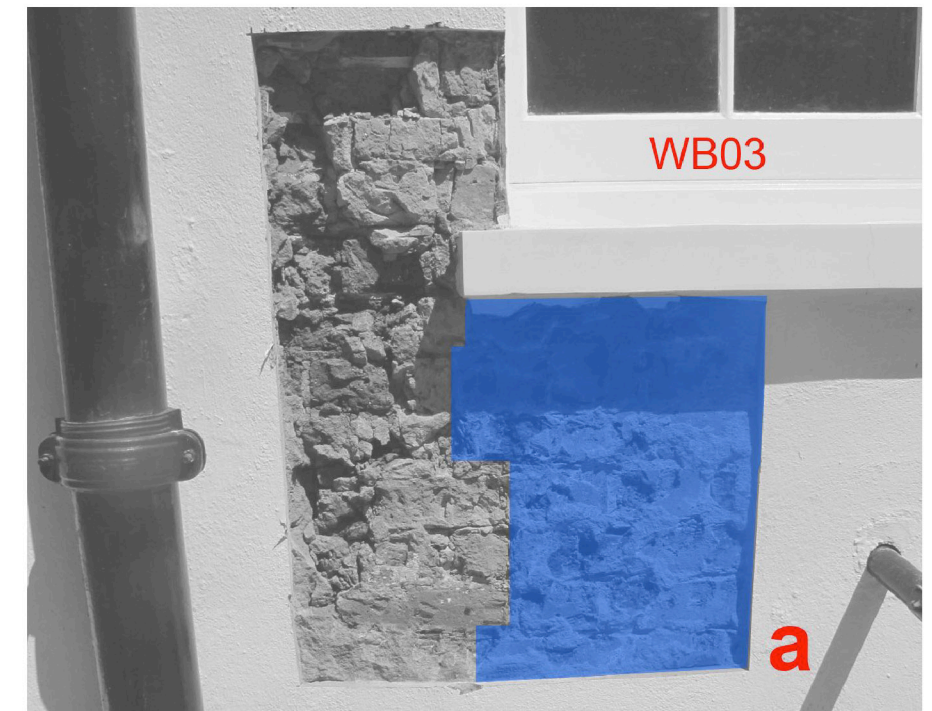
01. HISTORIC FABRIC OPENING UP AT WINDOW W B 0 4

Inspection area **a** below window **WB04** revealed evidence of an original door opening with the current brickwork apron highlighted in blue (far right image) likely to be 19th century alteration with the original brick to the left of the London Stock brick reveals the original structural opening. A closet extension in this location is recorded on the **1871 Publication / Town Plans 1:1056 (2686) - 1st Edition** as well as on drainage drawings submitted for planning approval in 1938 (ref: E6/1128/137054)
