THE BRITISH MUSEUM
BUILDING FABRIC PHASE 6

REPAIRS TO WEST AND EAST RESIDENCES EXTERNAL STAIRS

DESIGN AND ACCESS STATEMENT INCORPORATING HERITAGE STATEMENT
FEBRUARY 2023 REV_P04

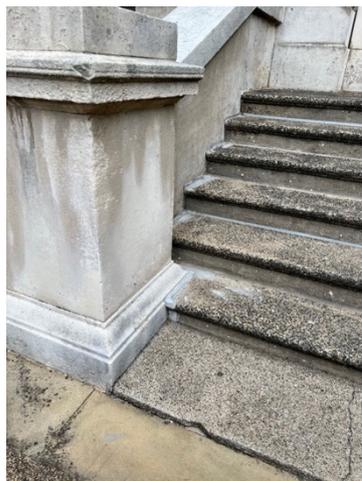
Stair 06: External entrance stair with cementitious topping and cracking (Left) Underside of external entrance stair showing signs of corrosion to support beams and damp, weathered and degraded stone soffit (Right)

These are stone stairs re-surfaced with a cementitious exposed aggregate topping. This topping in some locations has minor cracking and open joints and water is able to penetrate into the stone below causing various kinds of water damage and deterioration to the stone treads below.

- Sampling of the composition of the 'granolithic' topping and of the stone steps for petrographical analysis. (The stairs are noted on Smirke's drawings as Portland stone but have the appearance of a sandstone.)
- Pointing and sealing of cracks and open joints in the topping.
- Removal of cement repairs and modern impervious paint from soffits, conservation stone repair easing back water traps which have formed.
- Consolidation of friable soffit surfaces by applying a breathable lime-based 'shelter coat' or breathable mineral paint.
- Cleaning back corrosion on the iron beams to bare metal, re-priming and redecorating
- In two cases, exposing the end bearings of the cast iron beams support beams to treat the corrosion as above, then rebuilding the brickwork around the beam ends.

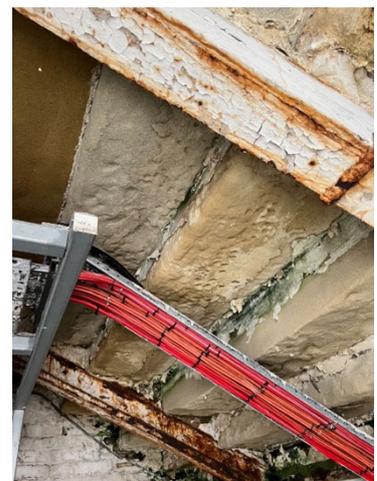
These stairs are each supported by a pair of cranked cast iron beams which in some locations is showing evidence of corrosion caused by the moisture present in the stone above.

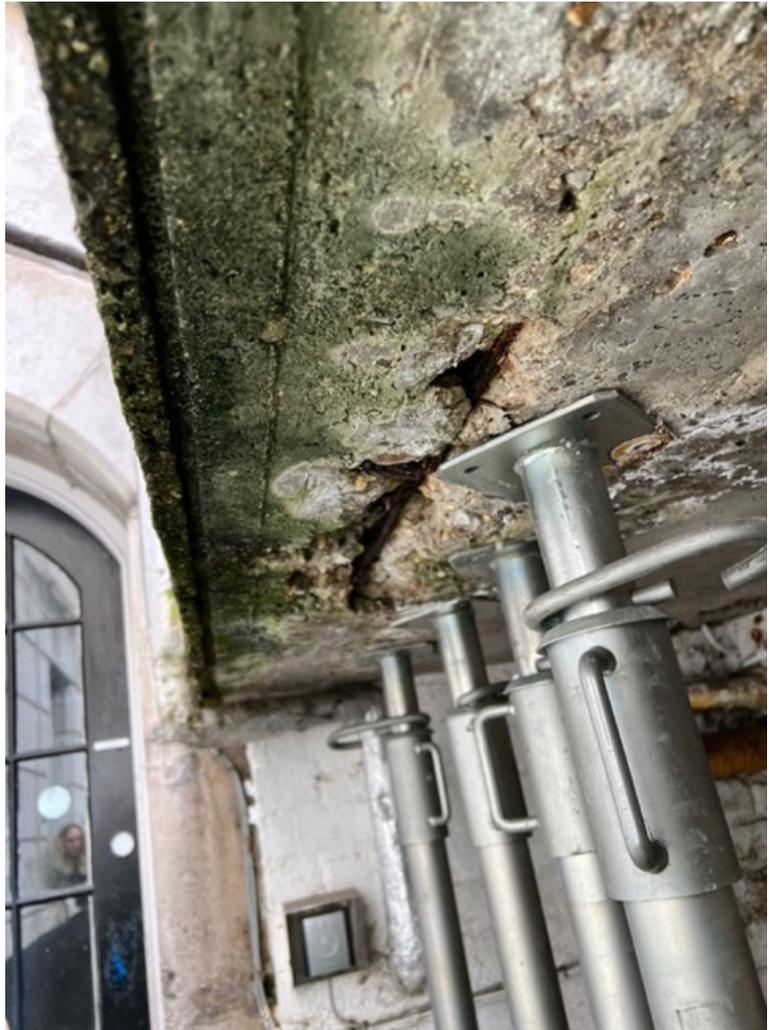
Stair 05 (Left): Soffit of reinforced concrete stair, spalled concrete, exposed reinforcement, stair has emergency propping.

These concrete stairs are now deteriorating due to moisture penetration into the slabs causing reinforcement to corrode and expand. At Stair 05, concrete has spalled off the soffit exposing the reinforcement bar. This stair has been taken out of use due to the possibility of structural failure and the landing has been propped.

- Treat reinforcement with a proprietary corrosion inhibitor product
- Treat concrete with a proprietary protective coating product
- In the case of stair 05, the insertion of a new steel beam below the landing spanning along the long side to provide additional structural support to the landing. The new beam would be supported on angle brackets attached to existing brickwork and not built-in to the masonry. This new beam will not be visible from the Museum Forecourt.

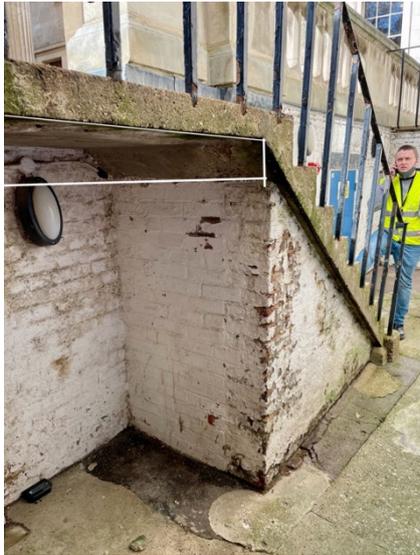
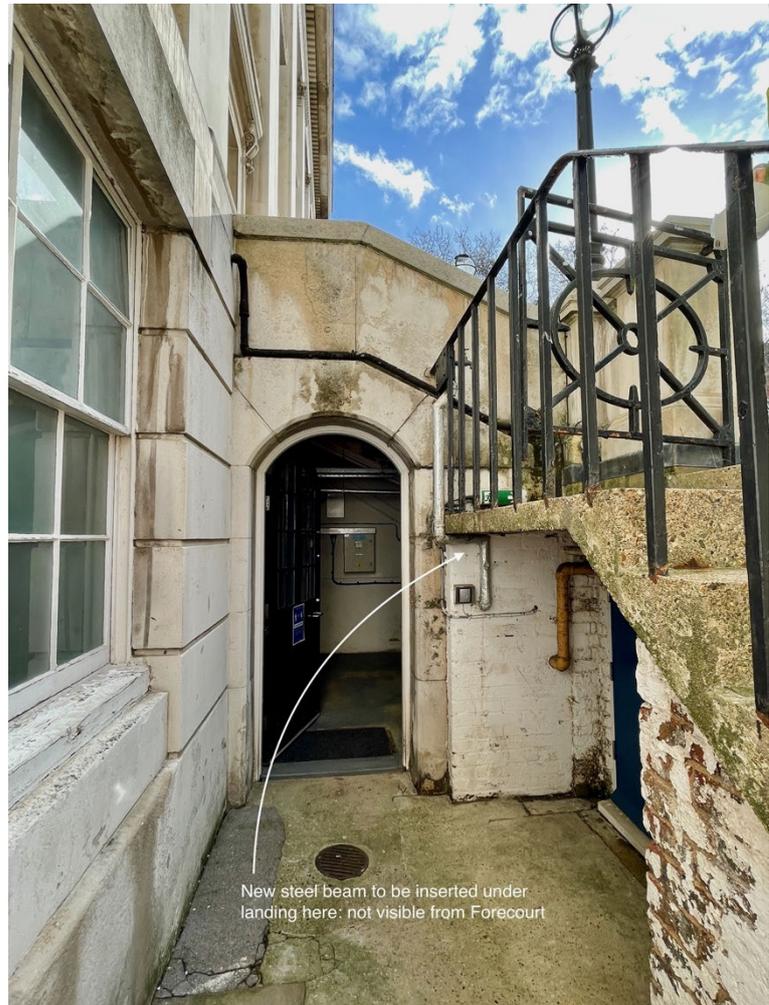
Stair 05 (Left and Above) insertion of new beam not visible from Forecourt

The new steel beam at stair 05 has been proposed for structural stability and safety. This beam will not be visible by members of the public from the Forecourt as it is located underneath the stair landing and facing onto the back of the Level 1 lightwell. The steel is being offered up from below to support the existing concrete landing and this installation is substantially reversible without significant damage to adjacent construction.
