**BRITISH MUSEUM.  
BUILDING FABRIC PHASE 6**

**EAST AND WEST RESIDENCE STAIRCASE REPAIR**

**Schedule of Works**

Document No. 649-DJA-SH-A-00001

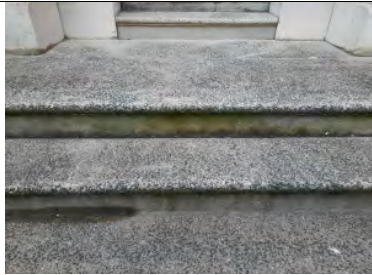
Number/ Image	Comment/ Location
001/139

<p>Cleaning required generally to remove algae from steps.</p>

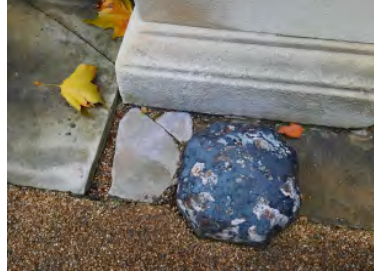
001/147

<p>Cracked and missing stone flag. Drop edge crates hazard. Remove failed stone and piece in new stone slab cut to match correctly bedded and lime pointed.</p>

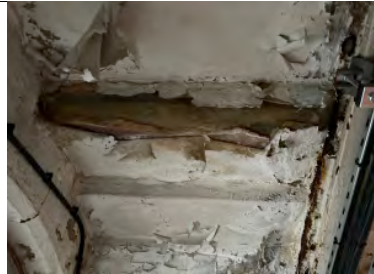
001/196

<p>Generally remove loose stone/plaster from soffit of third step. See general note for shelter coat or lime render.</p>

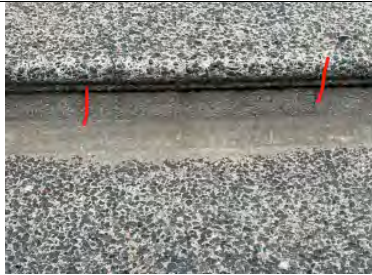
Number/ Image	Comment/ Location
001/221

<p>Resin repair 2 No. cracks to riser.</p>

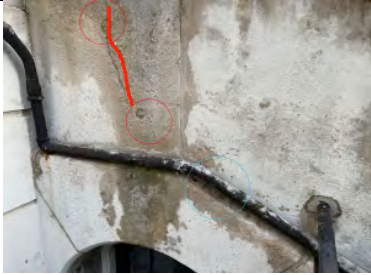
<b>Stair 6</b>	
001/032

<p>Review removal of de laminating, stone faces, repair 2 No. Inclusions and cracks with matched lime mortar.</p>

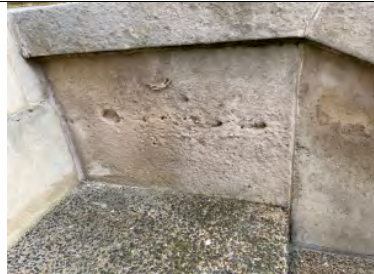
001/047

<p>Line Mortar point to inclusions in balustrade wall.</p>

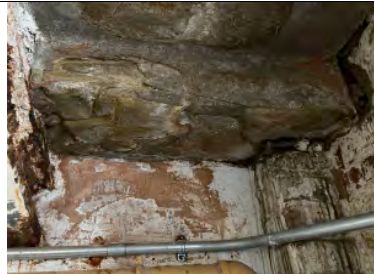
001/148

<p>Repair crack, as indicated on engineers, drawings, carefully remove cementitious finish and review substrate. See general note for shelter coat or lime render.</p>

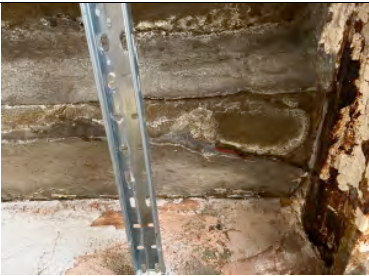
Number/ Image	Comment/ Location
001/149	<p>Carefully, remove cementitious finish and review substrate. See general note for shelter coat or lime render.</p>

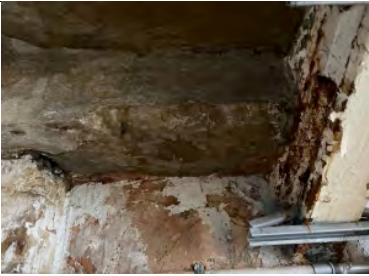
001/150	<p>Carefully remove cementitious facing to back face of riser, stabilise stone. Review substrate. See general note for shelter coat or lime render.</p>

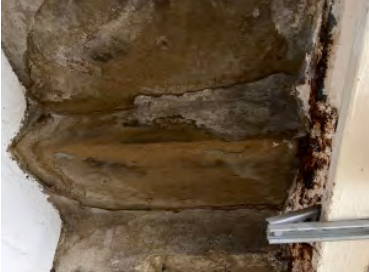
001/151	<p>Carefully, remove cementitious, finish to back face of riser, stabilise stone. Review substrate. See general note for shelter coat or lime render.</p>

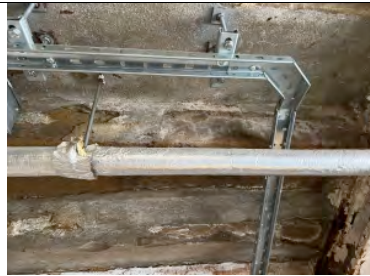
Number/ Image	Comment/ Location
001/152	<p>Carefully, remove cementitious finish from face of riser, stabilise stone. Review substrate. See general note for shelter coat or lime render.</p>

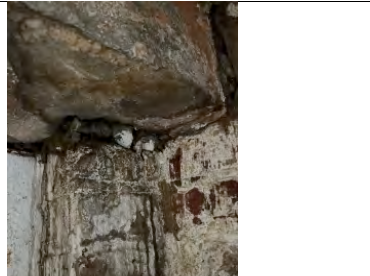
001/153	<p>Carefully, remove loose stone and mortar and point in bedding with lime mortar.</p>

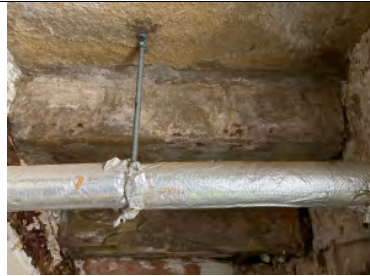
001/154	<p>Carefully, remove cementitious finish to the underside of Stone tread and riser and review substrate. See general note for shelter coat or lime render.</p>

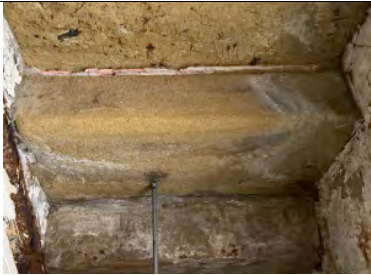
Number/ Image	Comment/ Location
001/155

Carefully remove infill material to joint pack and finish with lime mortar.

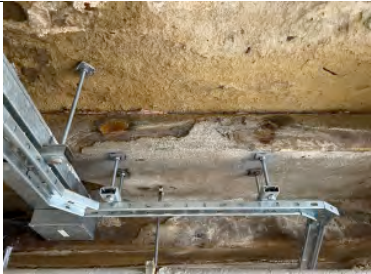
001/156

Review integrity of concrete repair with structural engineer with a view to replacing with more breathable lime finish. Rake out joint to step above and re-point with lime mortar. See general note for shelter coat or lime render.

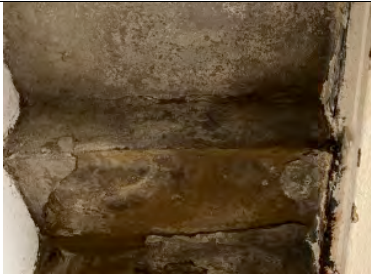
001/157

Carefully, remove cementitious finish to step. See general note for shelter coat or lime render.

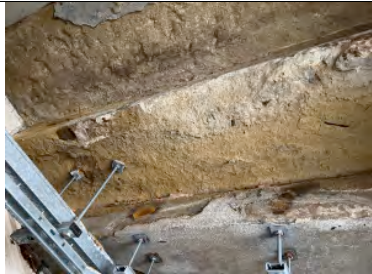
001/159

Release services fixings to permit work, carefully, remove and de-scale, loose sections of stone. See general note for shelter coat or lime render.

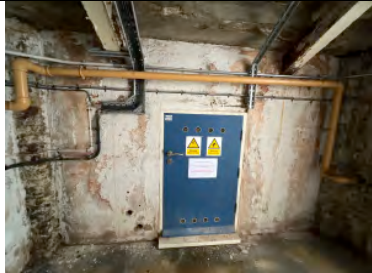
001/165

<p>Remove debonding flaking paint to rear wall, remove areas of gypsum plaster, re-plaster using lime, decorate with either breathable mineral paint or lime wash. Repair 4 No. holes through wall.</p>

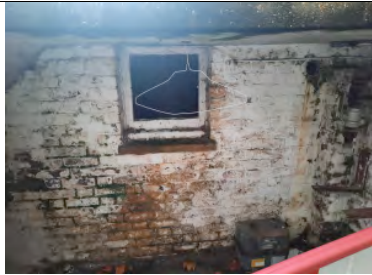
Number/ Image	Comment/ Location
001/084

<p>Does window require glazing replacement confirm with British Museum. Frame to be repaired and repainted allow for installing fire rated cement board in line of glass.</p> <p>Remove redundant gas meter.</p> <p>Review with client clearing out a vault area</p>

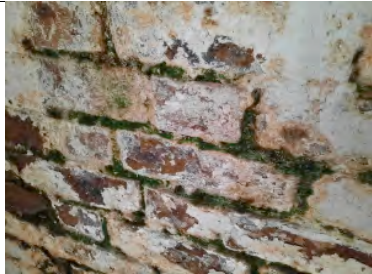
001/086

<p>Carefully remove paintwork from brick wall beneath steps and review masonry for any mortar and brick repairs.</p>

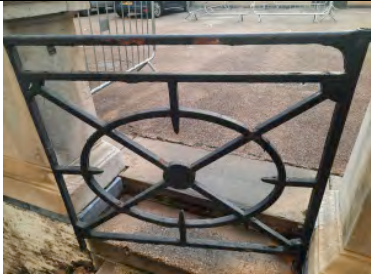
<p>Remove loose and flaking paintwork from iron gate, treat for rust and redecorate.</p>

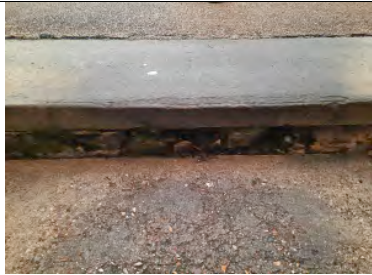
Number/ Image	Comment/ Location
001/108

<p>Lime, mortar and repair to base and bed joint of top stone step.</p>

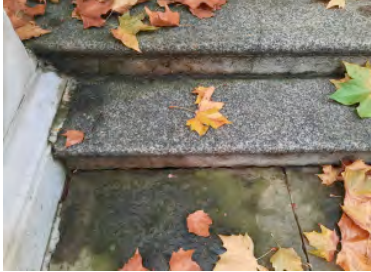
001/119

Repair cracking, stair surfacing. Point open joints in stone paving with lime mortar. Form neat 10mm chase in cementitious topping and apply sealant pointing between steps and stone

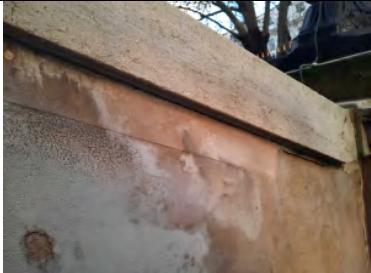
001/124

<p>Lime mortar repair to balustrade.</p>

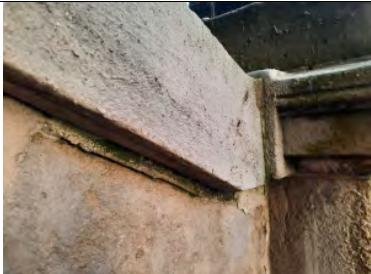
001/125

<p>Rake out and re-point open joints with lime mortar.</p>

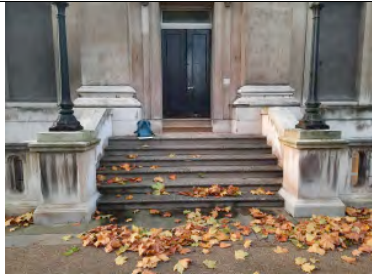
Number/ Image	Comment/ Location
001/126

<p>Generally clean to remove algae build-up.</p>

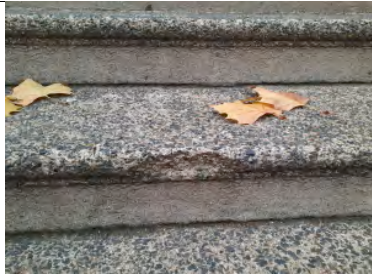
001/127

<p>Locally cut out damaged cementitious topping to depth sufficient to make nosing repair. Splay edges to ensure stability.</p>

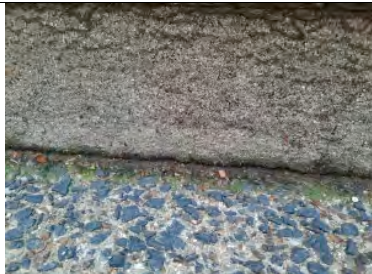
001/128

<p>Open joints in cementitious topping, Cut out 10mm chase in cementitious facings for sealant with chamfered upper surface.</p>

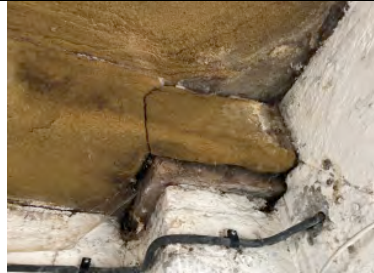
001/167

<p>Crack repair as engineers, drawings. Rake out open joints in soffit and pier and re-point with lime mortar. Remove areas of flaking stone, and consolidate.</p>

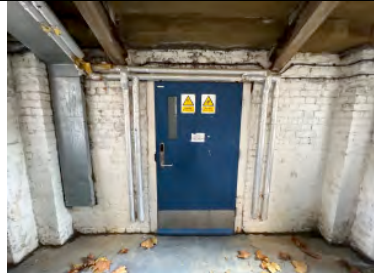
001/168

<p>Rake out and re-point at junction between top of brick and underside of steps, recommend removal of existing paint finish (chemical poultice) and reapplication of breathable paint. Point in doorframe top right-hand side, re-point approximately six perp. ends.</p>

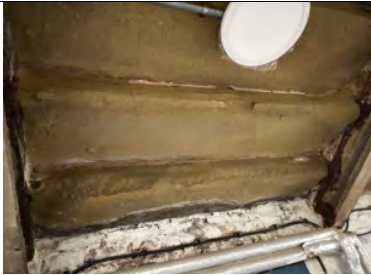
Number/ Image	Comment/ Location
001/169

Second step is, showing loss of section on soffit and riser review a structural engineer carefully remove delaminating stone sections at outer quoin rake out and re-point junction to step above. See general note for shelter coat or lime render.

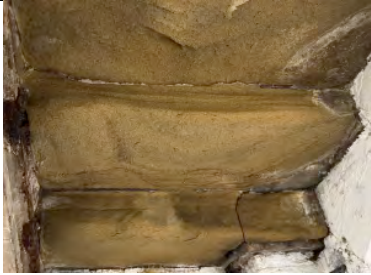
001/170

Second step, showing weathering and loss of section to underside, rake out and re-point to step below, step above and to adjacent walls and steel support beam. See general note for shelter coat or lime render.

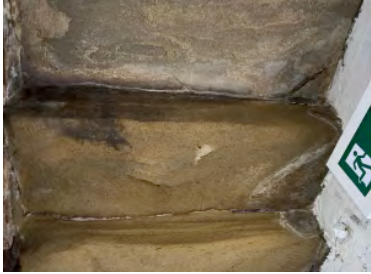
001/171

Third step, remove loose, friable sections of stone. See general note for shelter coat or lime render.

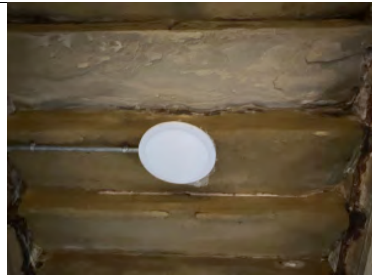
001/172

Remove loose, flaking sections of stone; rake out joint to step above. See general note for shelter coat or lime render.

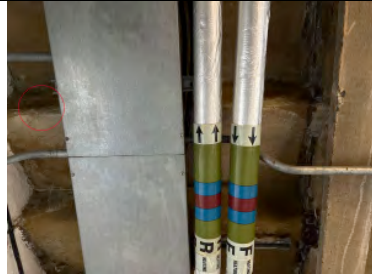
001/173

Work around plumbing services, and electrical tray, remove cementitious base, Mortar repair inclusions to rear riser. See general note for shelter coat or lime render.

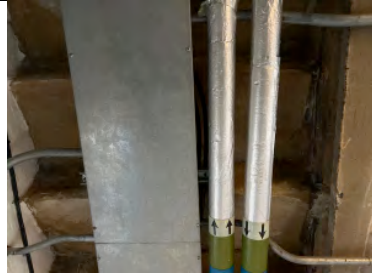
001/174

Work around plumbing services, and electrical tray, remove cementitious base. Mortar repair inclusions to rear riser. See general note for shelter coat or lime render.

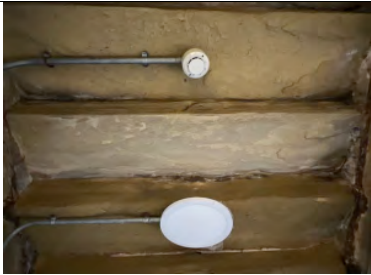
Number/ Image	Comment/ Location
001/175

Carefully, remove loose, flaking and delaminating stone lime mortar repair to rear face of riser, point joints to step above. See general note for shelter coat or lime render.

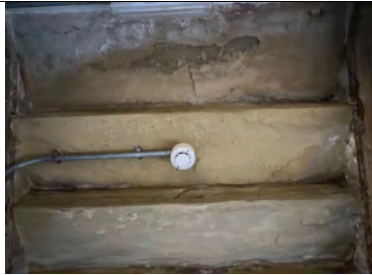
Number/ Image	Comment/ Location
001/178

Release, fire detector head to allow repair works, remove delaminating sections of stone, apply shelter coat, rake out, and re-point at junction with landing above. See general note for shelter coat or lime render.

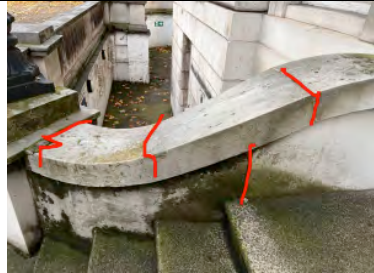
001/063	<p>Remove fractured stone and cut in indent stone repair.</p>

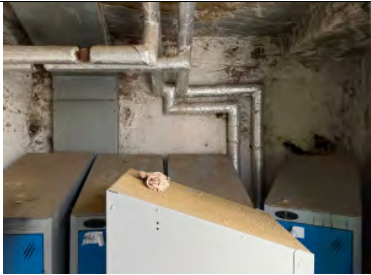
Number/ Image	Comment/ Location
001/183

Carefully remove paint to rear wall, carry out any masonry repairs, redecorate using breathable mineral paint or limewash.

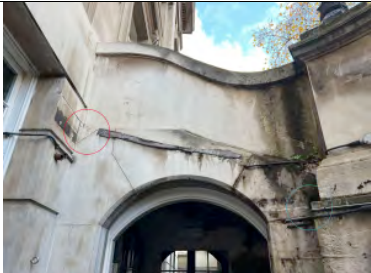
001/191

Repair, cracking flanking, Stonewall, remove adhesive tapes, rake out and re-point voussoir joint and pointing around 3No. services, penetrations. Remove organic growth

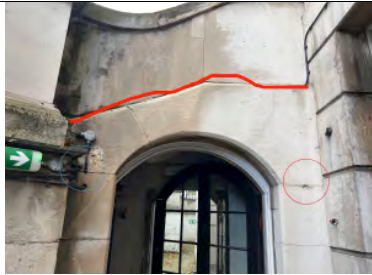
Number/ Image	Comment/ Location
001/192

Re-point, joint at bottom of balustrade, re-point 3 No. Services holes and 1 No. damaged stone.
