job
<b>British Museum Phase 6 Fabric Repairs Staircases</b>

title
Repairs to Stair 8

dtg. no.	rev.
<b>1910/20/09</b>	<b>A</b>

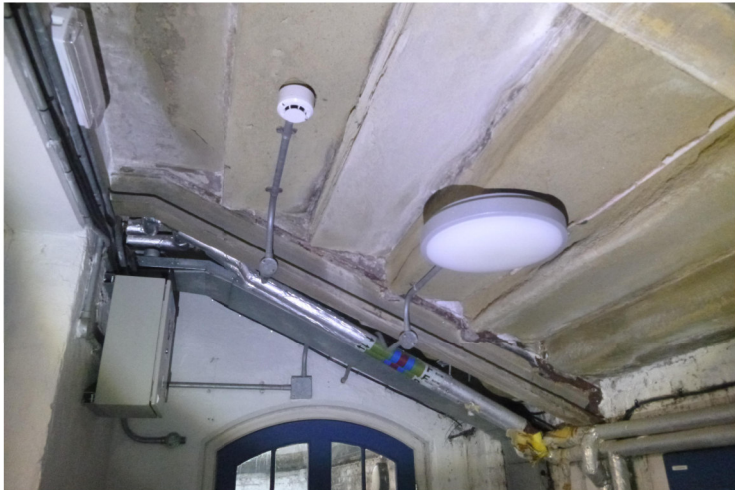
VIEW 19

Note water ingress in this area
