**Project**  
 25 Chester Terrace  
 London, NW1 4ND  
**Drawing**  
 Existing  
 Lower Ground Floor Plan

Date	Scale	Drawn
Oct 22	1:50@A3	CS
drwg. no		Rev.
GHV-100		-

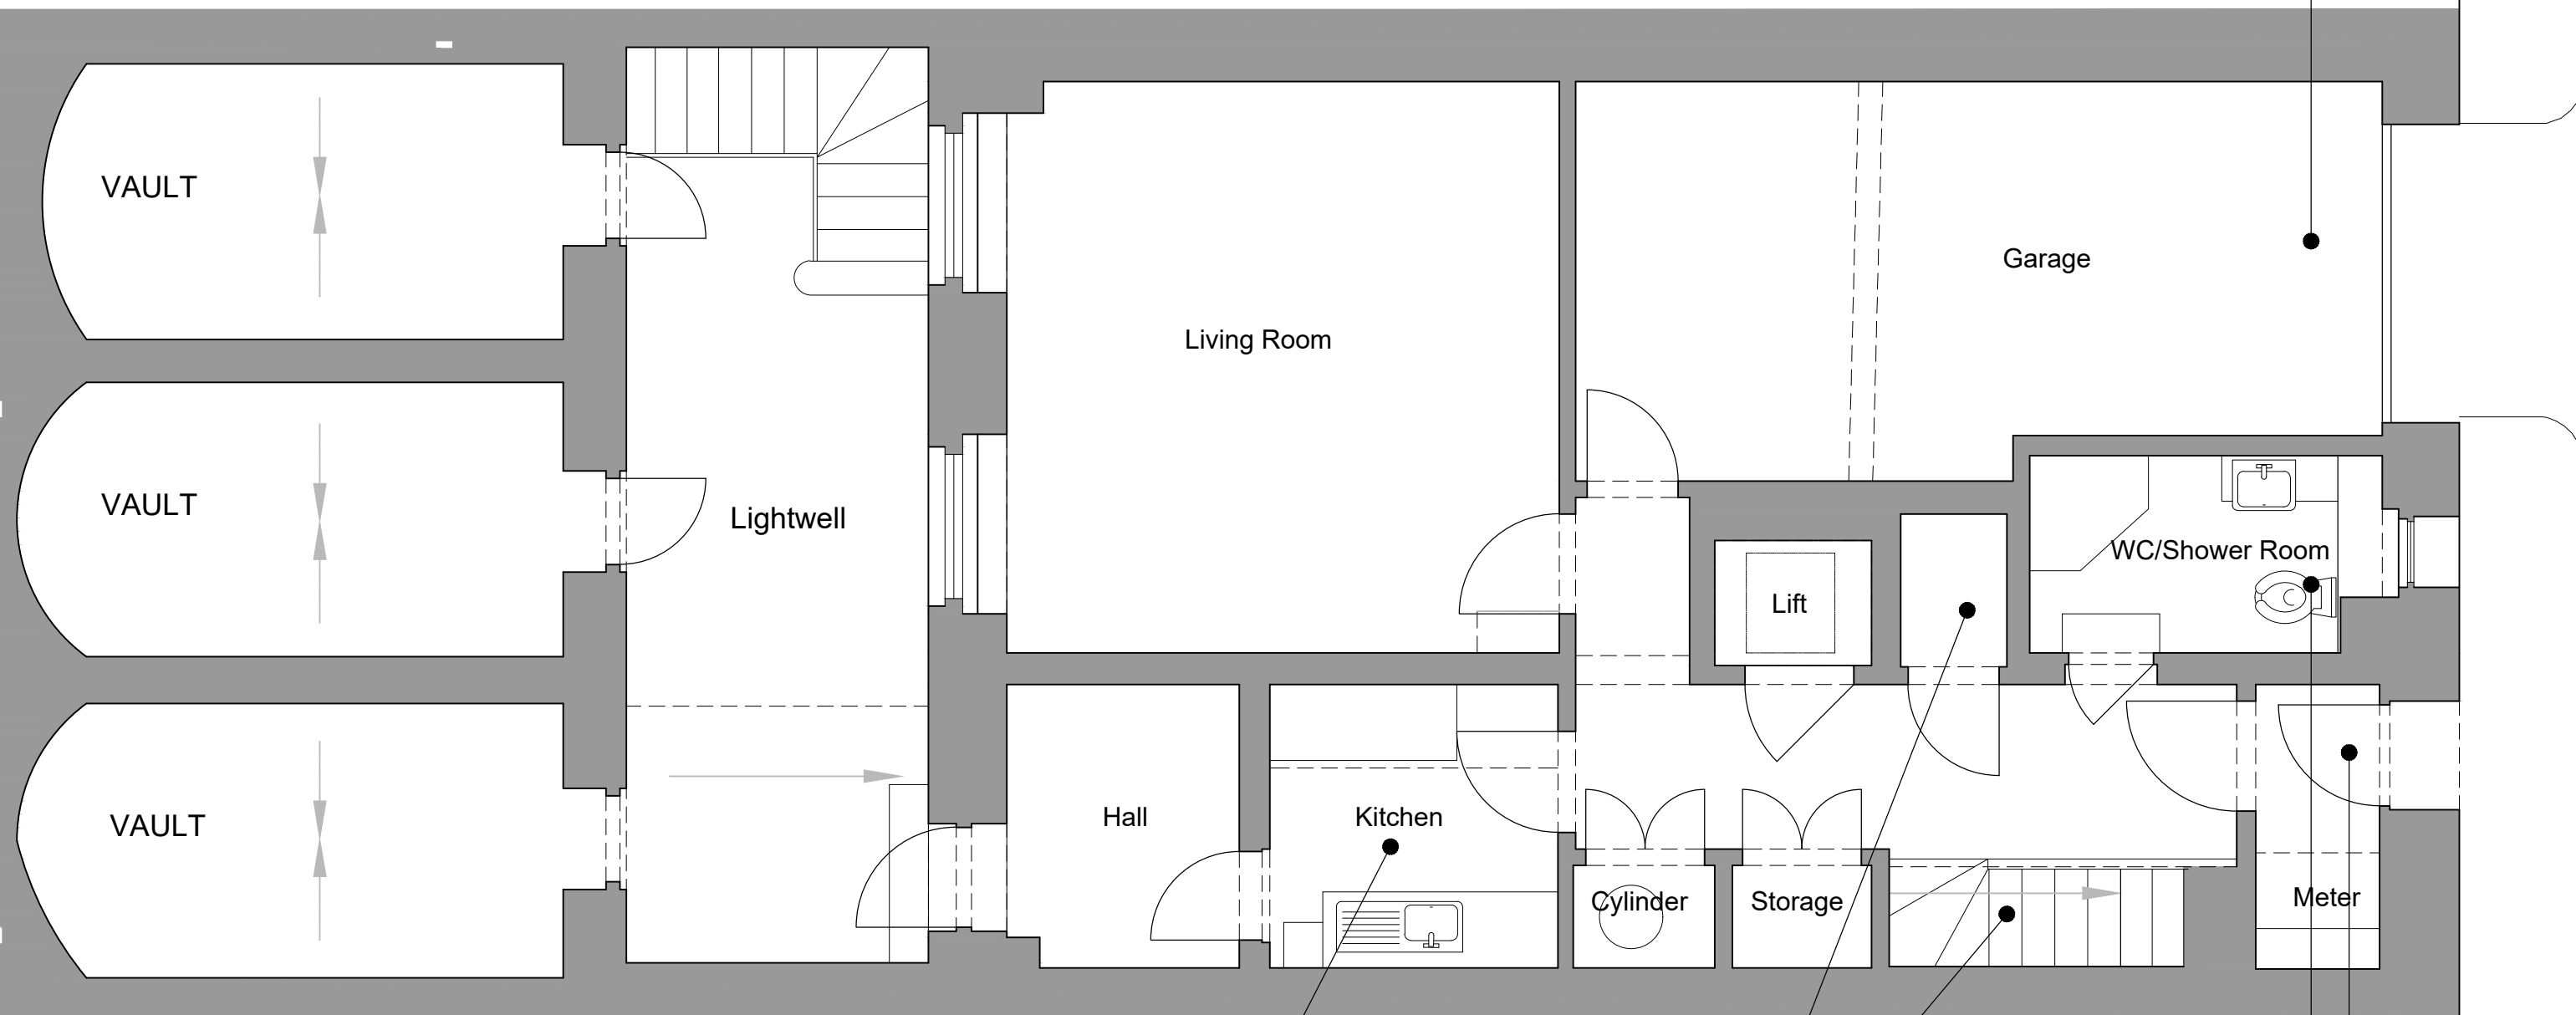
Concrete floor, asbestos sticker on ceiling, part of tiles mixture of brick and plastered walls, hallway peeling paint work to skirting concrete floor, feels damp. Plasterboard ceiling above

Kitchen at the front with quarry tiled floor, boxing for warm heating correction and vinyl floor

Cupboard next lift lowered ceiling with warm air vent above raised floor. Flush door to lift cupboard in front of stairs has distribution boards and what looks like another incoming electrical main further cupboard how old cylinder flush doors

Timber staircase to lower ground floor cupboard damp under the stairs

Raised floor tiles, plasterboard ceiling with mildew at rear wall and damp. Metal window with security grill air brick to rear wall. Single pendant light flush door.

Rear lobby to back door FLBA door with very small single glaze light above single pendant light. Evidence of damp to rear wall, quarry tiled floor sat lower boxing to gas and electrical meters and electrical head. Flush door to lobby.
