Drawing Name
Existing Internal Elevations Window Stack 05

Drawing Number
BW125 - BW - ## - XX - DR - E3005

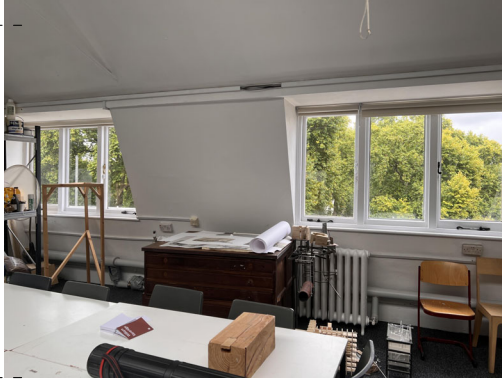
W.03.03

Modern casement window.
Lowest significance.
No related detail of historic interest.
No related detail of interest.
Non original dormer (widened pre-existing).

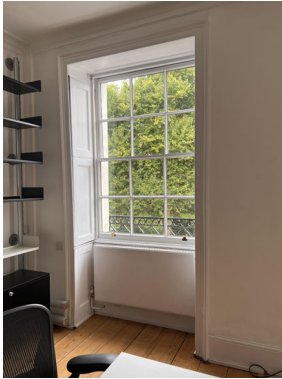
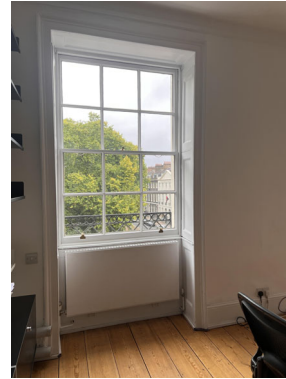
W.02.05

Weighted sash
6 panel sashes
OK condition

1920s window without horns.
Shutter boxes fixes with panelling below.
Medium to high significance.

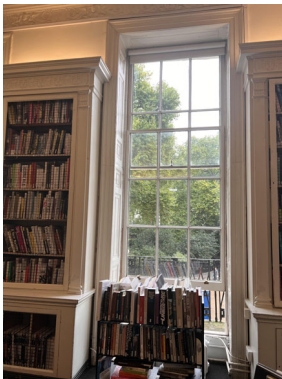
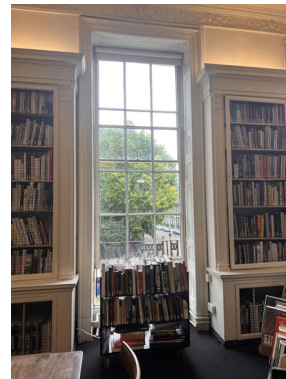
W.01.05

Weighted sash
6 over 9 panel sashes
Painted shutters
Manually operated blinds
Pipework through panel

Fixed shut and painted over shutter boxes in squared reveals and distinct from those to no. 34. LHS in a poor condition and repairs indicate previous opening. RHS in need of repair. Highest significance.
Windows have no horns and appear to be historically detailed although the glazing is later and sources record that the windows of the first floor were blown out (including glazing bars) during WWII. Given the importance of the first floor windows and appropriate detailing these are considered to be of the highest significance.

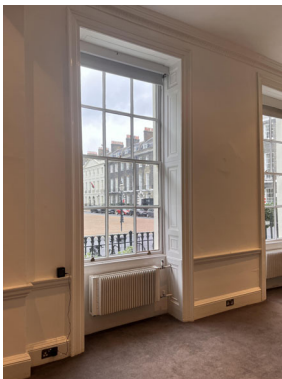
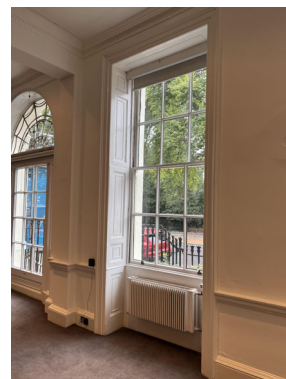
W.00.04

Weighted sash
6 panel sashes
OK condition
Pipework through panelling
Electric operated blinds

Square reveals to former no. 35 with shutters painted shut. Reasonable condition. Highest significance.
Windows have horns and glazing bars that lack the finesse of original windows suggesting post late Victorian date. Glazing bar pattern matches the 1919 front door suggesting all of the windows at ground floor were altered to match.

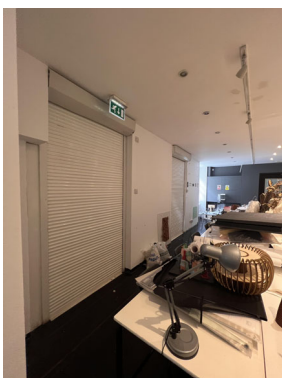
D.B1.11

1920s door with roller shutter.
Medium significance.
