Existing Internal Elevations Window Stack 08

Drawing Number Revision
BW125 - BW - ## - XX - DR - E3008

ARCHITECTURAL ASSOCIATION
 3-5 BLEEDING HEART YARD, LONDON, EC1N 8SJ
 TEL: 020 86385945
 WWW.BUILT.WORKS

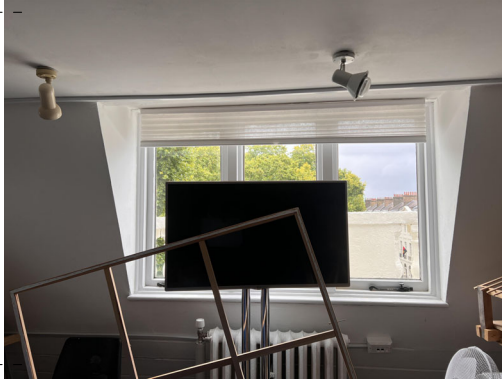
W.03.02

Modern casement
Post condition

Modern casement window.
Lowest significance.
No related detail of historic interest.
No related detail of interest.
Non original dormer (widened pre-existing).

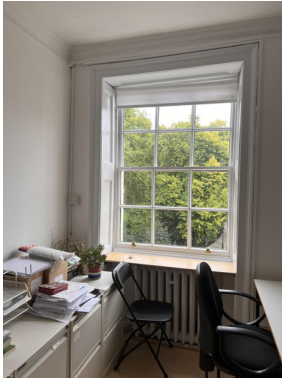
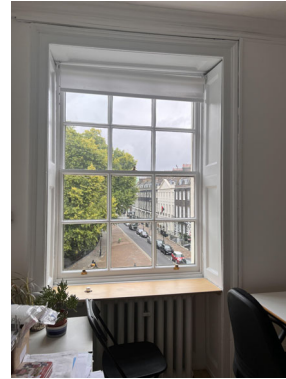
W.02.02

Weighted sash
6 panel sashes
Shutter box non functioning
OK condition
Manually operated blinds

Original shutters and architrave with simple panelled linings beneath window. Openable shutters in good condition. Highest significance.
Early 20th century window with horns and flatter glazing bars. Medium significance.

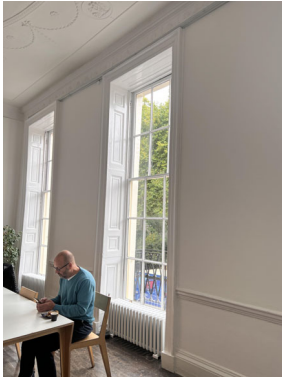
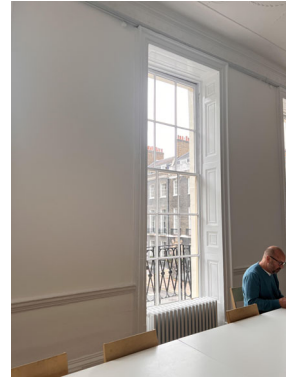
W.01.02

Weighted sash
6 over 9 panel sashes
Painted sashes
Pipework through panels

Shutters in square reveals with mouldings similar to no. 35. Appear to be original. Both sides fixed shut and painted over with signs of repair and much overpainted. Historic plans show RHS opened up for pipework in 1926. Highest significance.
Six over nine sash window with rounded glazing bars.
No horns. Highest significance.

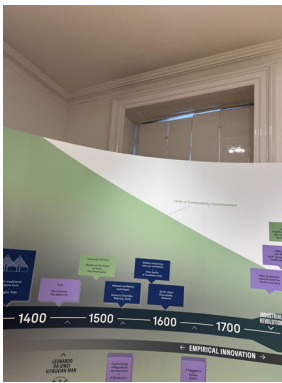
W.00.02

Square reveals to former no. 35 with shutters painted shut. Reasonable condition. Highest significance.
Windows have horns and glazing bars that lack the finesse of original windows suggesting post late Victorian date. Glazing bar pattern matches the 1919 front door suggesting all of the windows at ground floor were altered to match.

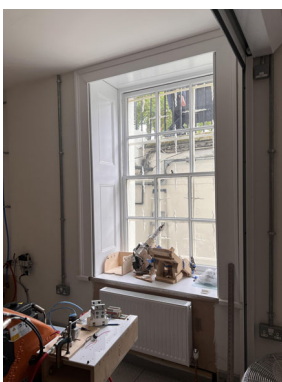
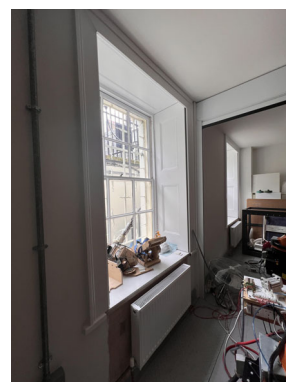
W.B1.02

New radiator

Historic window possibly 20th century but without horns. Very modest detailing.
Medium significance.
