Existing Internal Elevations
 Window Stack 14

BW125 - BW - ## - XX - DR - E3014

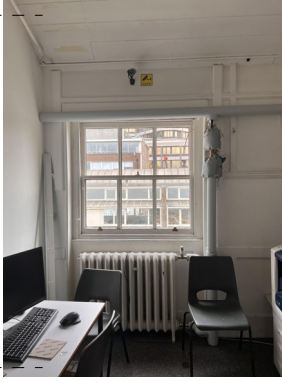
W.03.11

Modern casement
 Post condition
 Studwall cuts across

1920s sash with horns. Historic
 modest panel behind radiator
 reflecting floor hierarchy.
 Medium to high significance.

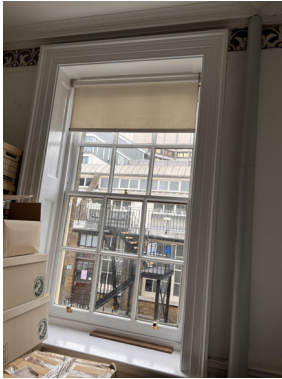
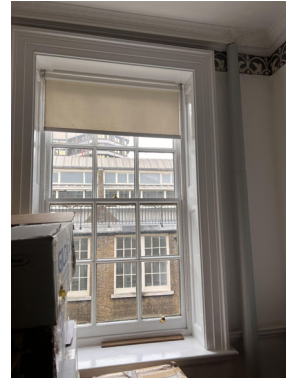
W.02.14

Weighted sash
 6 panel sashes
 Shutter box non functioning
 OK condition

1920s sash windows with horns
 in former stairwell to no. 35.
 Linings to window but no
 shutter boxes.

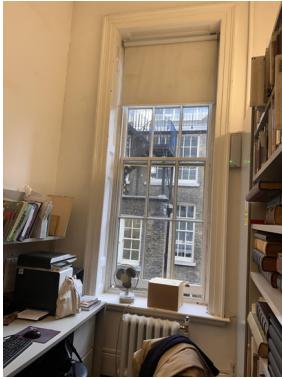
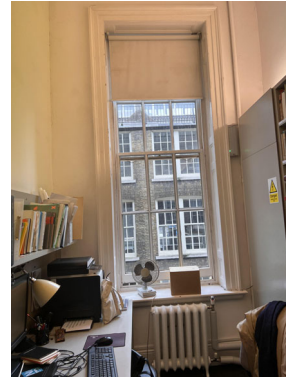
W.01.13

Weighted sash
 6 over 9 panel sashes
 Painted shutters
 Manually operated blinds shut
 Pipework through panels

Former location of principal stair to no. 35
 Bedford Square. Historic plans indicate
 that the windows to the rear elevation
 were reconfigured and made narrower
 when the staircase was removed. The
 window are surround therefore relate to
 works undertaken in the early 20th
 century and are tied to the removal of the
 staircase and the reworking of levels.

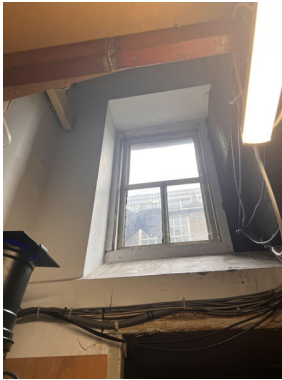
W.00.10

Modern window of lowest
 significance.

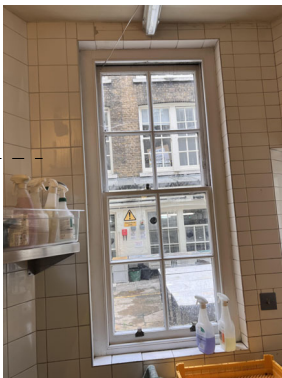
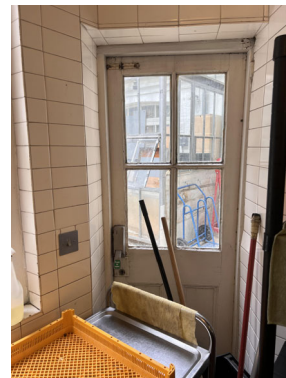
D.B1.38 W.B1.09

Window / door not visible from section cut
