Drawing Name
Existing Internal Elevations Window Stack 16

Drawing Number Revision
BW125 - BW - ## - XX - DR - E3016

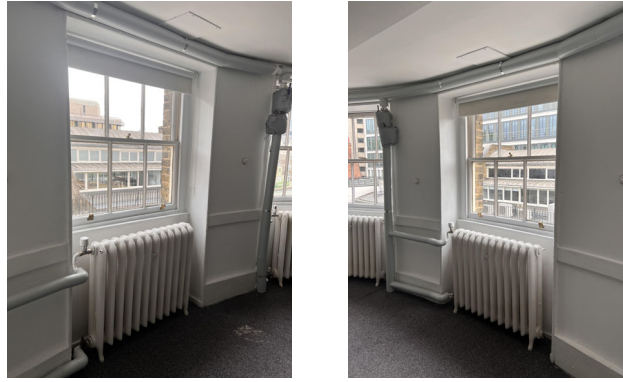
W.03.13

Modern casement
Post condition
Studwall cuts across

1920s sash with horns. Historic modest panel behind radiator reflecting floor hierarchy. Medium to high significance.

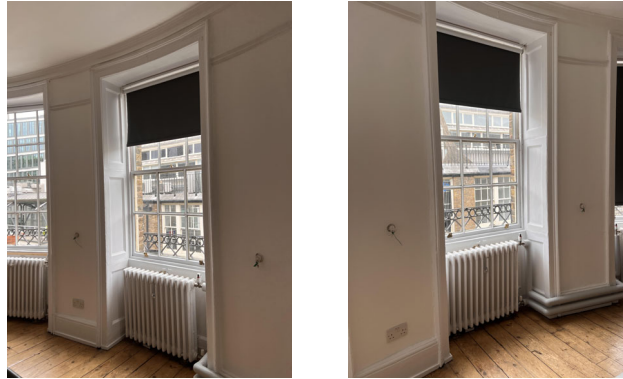
W.02.16

Weighted sash
6 panel sashes
Shutter box non functioning
Concealed radiator below
OK condition
Manually operated blinds

Original window much painted over and repaired shutter boxes. No horns. Panelling below good architrave. Reasonable condition but much repair on LHS and RHS with definition lost. Highest Significance.

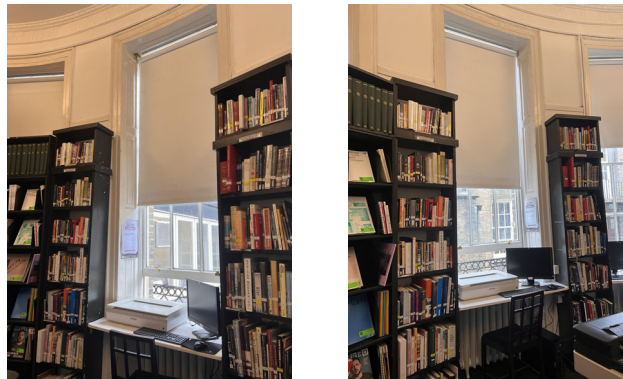
W.01.15

Weighted sash
6 over 9 panel sashes
Painted shutters
Manually operated blinds
Pipework through panels

FURTHER INSPECTION REQUIRED
Painted over shutters LH and RH sides that have lost definition through repair and overpainting. Highest significance.

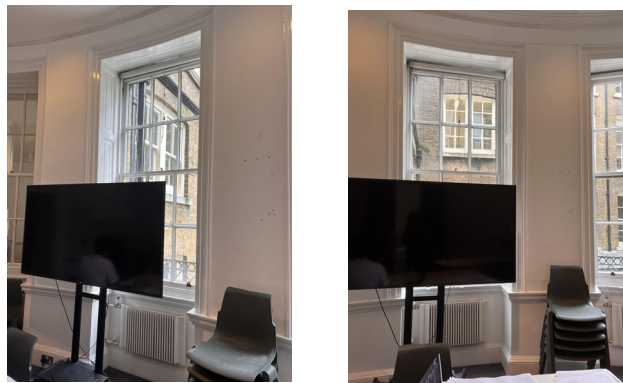
W.00.12

Weighted sash
6 panel sashes
OK condition
Manually operated blinds

Good quality historic window shutters painted shut with no lining below. New panel to side below cill with pipe fitting. High significance despite later alteration. Good glazing bars and probably original sashes. Highest significance.
