**Existing Internal Elevations
Window Stack 20**

Drawing Number Revision
BW125 - BW - ## - XX - DR - E3020

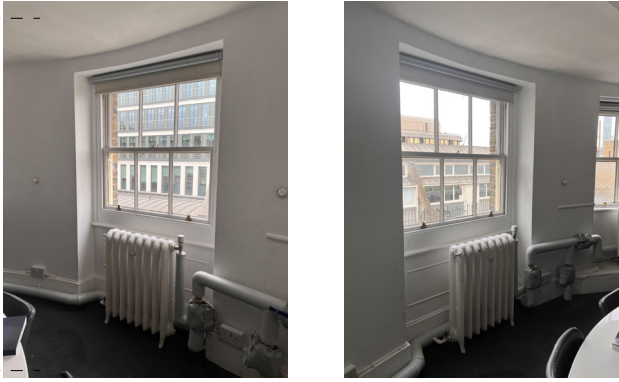
W.03.17

Modern casement
Post condition
Studwall cuts across
3 panel sashes

1920s sash with horns. Historic
modest panel behind radiator
reflecting floor hierarchy.
Medium to high significance.
Bay rebuilt 1926.

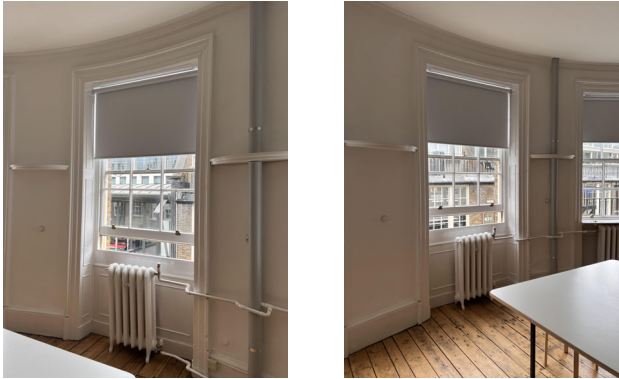
W.02.19

Weighted sash
6 panel sashes
Shutter box non functioning
Concealed radiator below
OK condition

Rear bay rebuilt 1926 - 1926
windows and shutter boxes
matching rear bay on other
levels.
Low to medium significance.

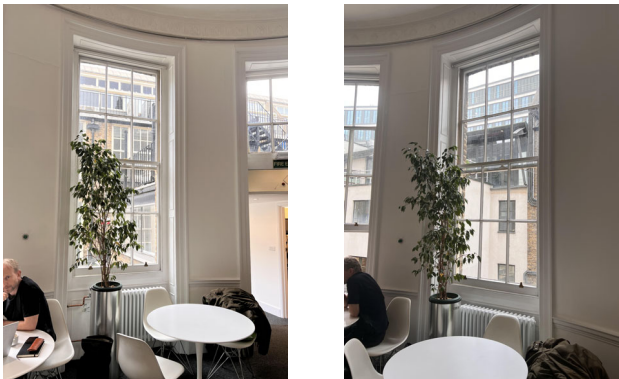
W.01.18

Weighted sash
6 over 9 panel sashes
Painted shutters
Pipework through panels

No shutters present only single panels
with modest details.
Likely to be 1920s fabric introduced after
rear bay reconstructed. Windows with
horns in a 1920s style.
Medium significance.

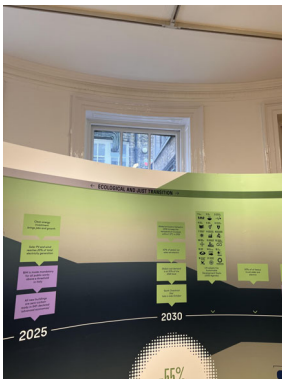
W.00.15

No shutters present only single
panels with modest details.
Likely to be 1920s fabric
introduced after rear bay
reconstructed. Windows with
horns in a 1920s style.
Medium significance.

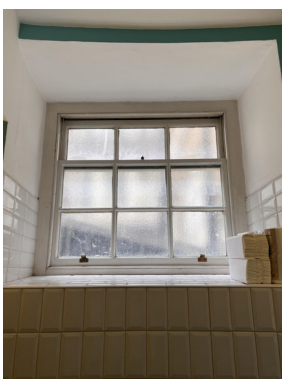
W.B1.12

1920s window in rebuilt bay
(1926).
Low to medium significance.
