Drawing Name  
**Existing Internal Elevations  
Window Stack 21**

Drawing Number Revision  
**BW125 - BW - ## - XX - DR - E3021**

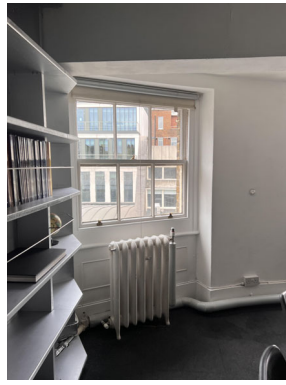
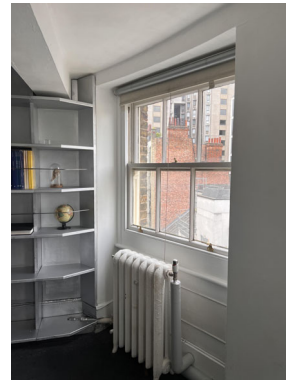
**W.03.18**

Modern casement  
Post condition  
Manually operated blinds  
3 panel sashes

1920s sash with horns. Historic  
modest panel behind radiator  
reflecting floor hierarchy.  
Medium to high significance.  
Bay rebuilt 1926.

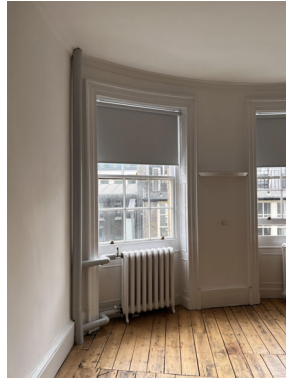
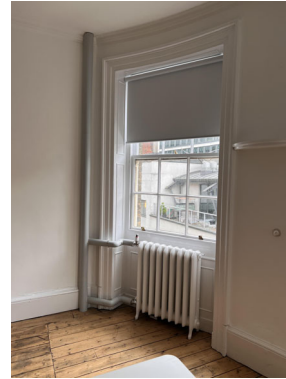
**W.02.20**

Weighted sash  
6 panel sashes  
Shutter box non functioning  
OK condition  
Manually operated blinds

Rear bay rebuilt 1926 - 1926  
windows and shutter boxes  
matching rear bay on other  
levels.  
Low to medium significance.

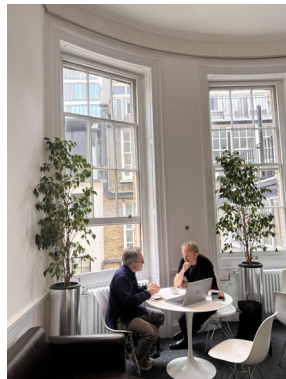
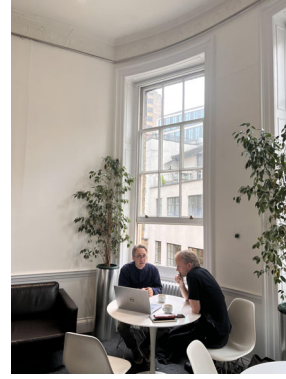
**W.01.19**

Weighted sash  
6 over 9 panel sashes  
Painted shutters  
Manually operated blinds shut  
Pipework through panels

No shutters present only single panels  
with modest details.  
Likely to be 1920s fabric introduced after  
rear bay reconstructed. Windows with  
horns in a 1920s style.  
Medium significance.

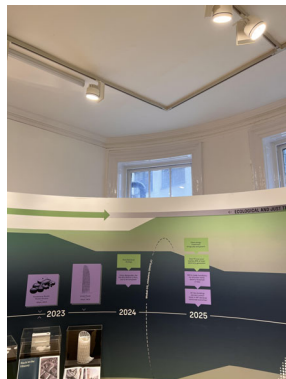
**W.00.16**

No shutters present only single  
panels with modest details.  
Likely to be 1920s fabric  
introduced after rear bay  
reconstructed. Windows with  
horns in a 1920s style.  
Medium significance.
