The Cottage, Hilltop Road Structural Survey Report For Planning

PROJECT NO.	2150		
PROJECT NAME	The Cottage, Hilltop Road		
CLIENT	John Weidner		
PROJECT ADDRESS	The Cottage, Hilltop Road, NW6 2QA		
DOCUMENT TITLE	Structural Survey Report		
DOCUMENT REV.	D		
DATE	03.07.21		
PREPARED BY	Adam Harrison MEng CEng FICE	TITLE	Director
CHECKED BY	Alex Clifton BEng	TITLE	Senior Engineer
<p>This report has been prepared by Constructure Limited with reasonable skill, care and diligence (taking account of the resources devoted to it by agreement with the Client); under the terms and conditions agreed with the Client (incorporating Constructure Limited's General Terms and Conditions of Business); for the sole use and benefit of the Client and for the sole purpose agreed with the Client.</p> <p>The benefit of this report shall not be assigned by the Client to any third party, without the express prior written consent of Constructure Limited.</p> <p>This report shall not be relied upon by any third party without the express prior written consent of Constructure Limited and Constructure Limited accepts no liability to any third party to whom this report (or any part thereof) is disclosed without

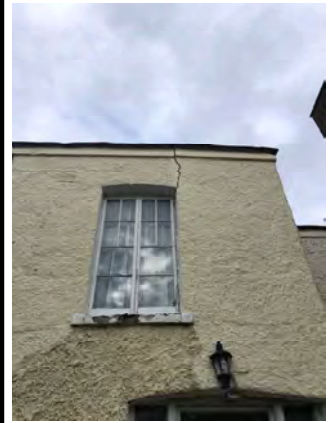
[3] Front facade wall

From the front of the property it could be seen that the building has suffered some historical movement, possibly as a result of shallow footings in combination with now pollarded plane trees along the street, roughly 5-6m from the facade line. A large crack was visible to the side of the first floor window [3], which was seen to reflect internally also, suggesting that the masonry here has completely lost tie action across the window head. The painted pebble dash finish to the masonry was extremely rough and patchy, suggesting there have been numerous historical repairs carried out (most likely to patch over areas of cracking to the masonry behind), and there was seen to be significant moss growth out of the render and window cill at ground floor level [17].

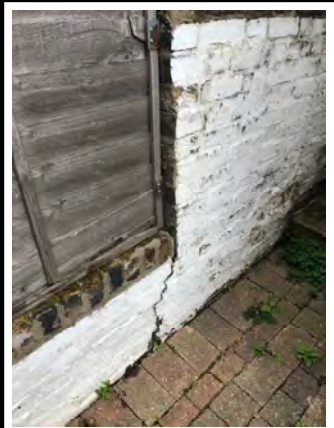
[6] West boundary wall

The boundary wall to the west is seen to be in poor condition, with cracking visible through the painted brickwork [6]. To the south facade wall, cracking was visible to a number of locations, with render flaking/crumbling away from the masonry. This is reflected by internal damp, suggesting that the render is both letting water in, and holding this against the masonry creating damp internally [11].

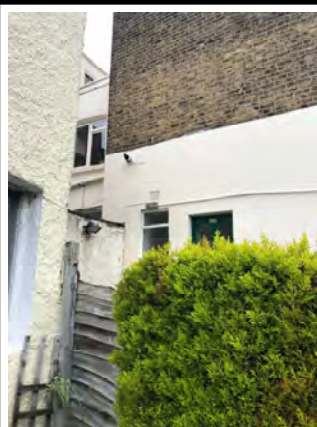
[7] Enclosed wall to north

The kitchen area encloses onto the neighbours wall between ground and first floor level [7], and this wall appears to be potentially defective at the interface between the two in-so-much as this represent a likely water ingress position if not fully toothed. There is a lack of coping or flashing to the top of both sections of wall forming the sides of the existing kitchen, again suggesting these could be weak points for water ingress & damp issues.

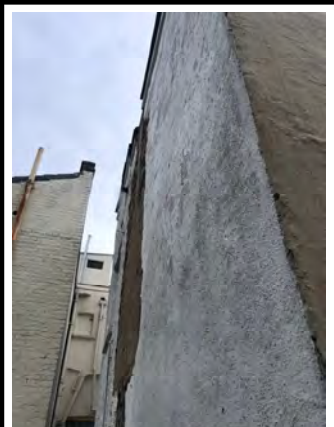
[9] West flank wall

To the west side of the property, the flank wall is seen to be in reasonable condition, albeit a chimney breast has been removed previously [16] and replaced with a rough finished block wall (un-rendered). As such we consider that this will be a possible line of water ingress, unless remediated [9].

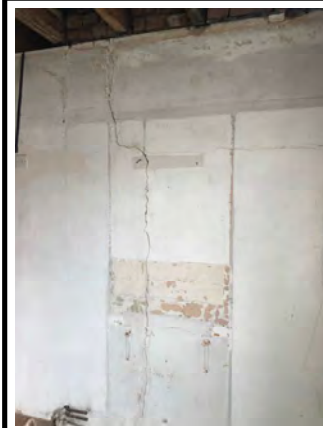
[10] Bedroom wall - 1st floor

At first floor level, the cracking to the front facade is reflected internally [14], with additional cracking visible to the side (north) wall [10]. This is consistent with a subsidence movement to the front facade, likely initiated by footings being insufficient depth, in combination with large trees to the pavement along Hilltop Road.

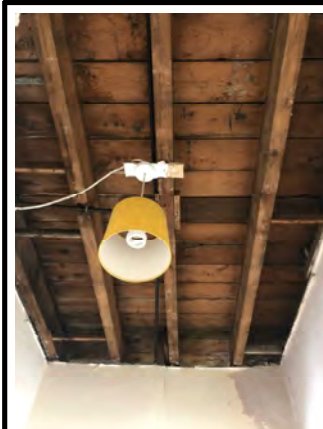
[13] Ceiling over first floor hallway

The rafters forming the flat roof were visible above the hallway [13], with these also appearing in reasonable condition.

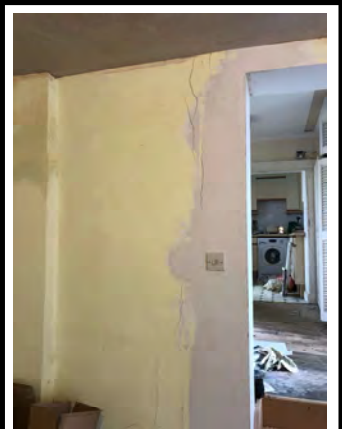
[15] Living room dividing wall

Within the living room, it was noted that several of the external walls were damp/showed signs of previous damp ingress, and there was a crack visible to the dividing wall between living room and entrance hallway [15]. From a detailed inspection of this crack, it was noted that a rotation of the wall appears to have occurred, possibly as a result of some movement to the front facade, with the crack being more pronounced at the top of the wall (near to the assumed lintel bearing position).

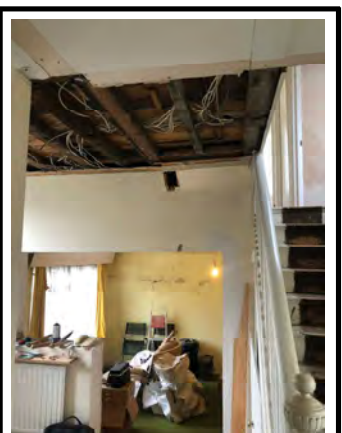
[18] View into living room from hallway

The ceiling was missing to the hallway [18] revealing floor joists over, roughly 100x50 at 400 centres. Some notching was visible to these.
