Design and Access Statement

In support of Planning and Listed Building Application Reference:
PP-11211183, submitted to Camden Council on 22nd April 2022

Address: 2/3, Charrington Street, London NW1 1RS

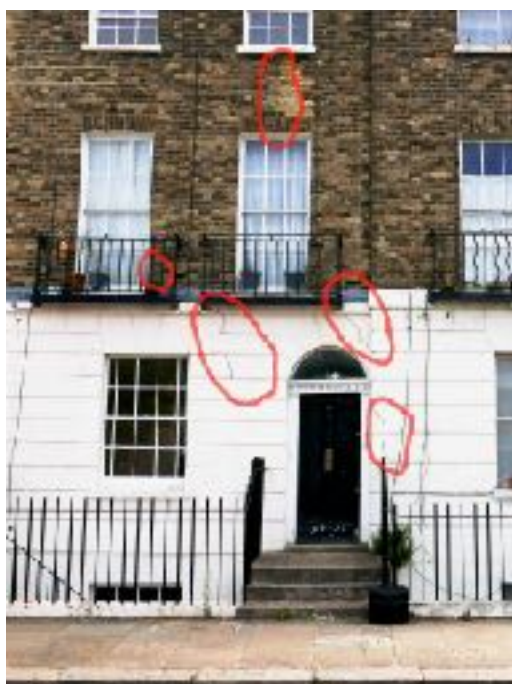
Photo1: Typical cracks in the street front elevation.
Refer dwg. Nos.
JGPS/CHAR/2/3/100RevA
JGPS/CHAR/2/3/101RevA
5015544/RDG/XX/XX/DT/S/0200/T3
5015544/RDG/XX/XX/DT/S/0300/T3

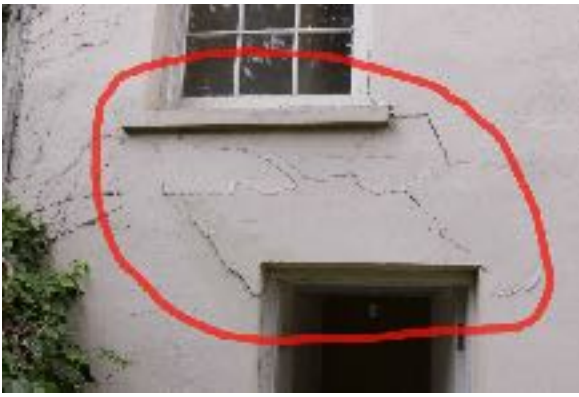
Photo 2: Typical cracks above rear garden

door

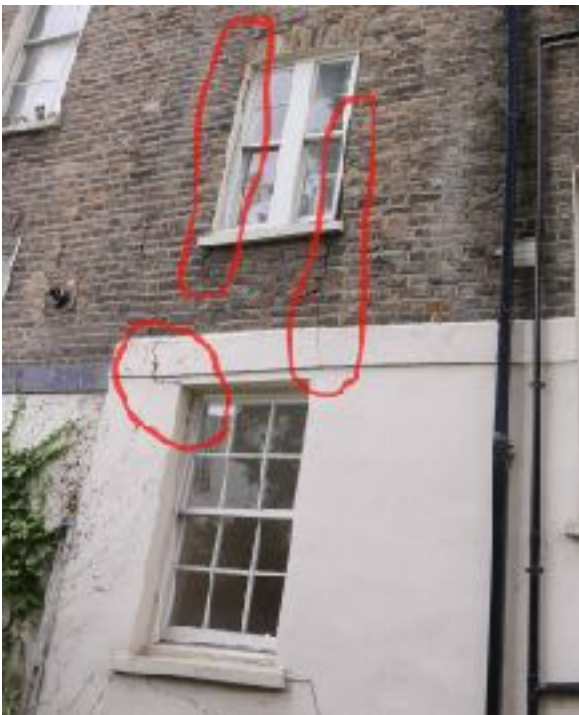
Photo 3: Typical cracks rear elevation

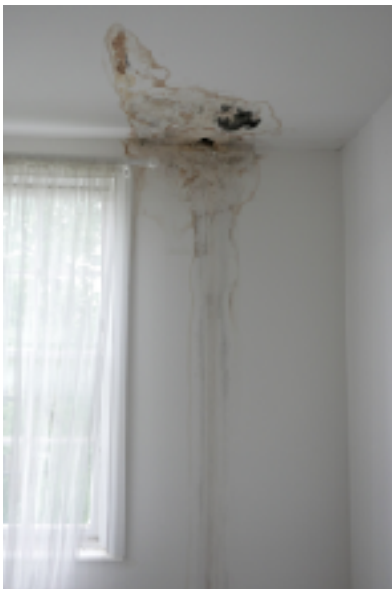
Photo 13: Second Floor Leak from Attic in
bedroom
Refer dwg. Nos.
JGPS/CHAR/2/3/103RevA

The roof to be repaired to prevent leaks, and the ceilings below to be made good and repaired.
