Design and Access Statement

In support of Planning and Listed Building Application Reference:
PP-11210537, submitted to Camden Council on 22nd April 2022

Address: 1, Charrington Street, London NW1 1RS

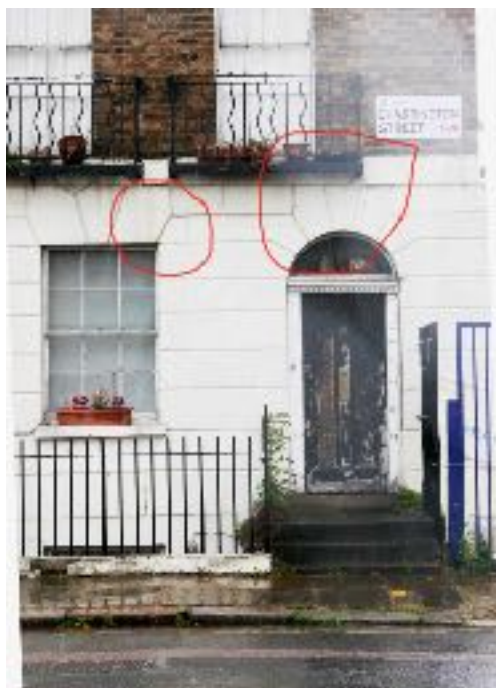
Photo1: Typical cracks in the street front elevation.

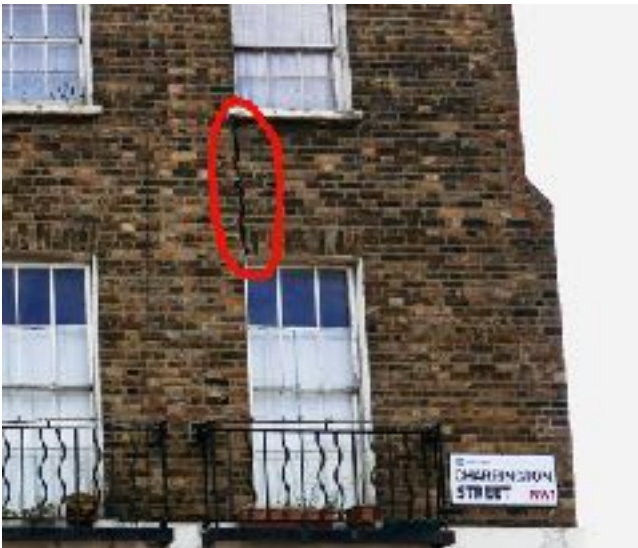
Photo 2: Typical cracks in the street front elevation.

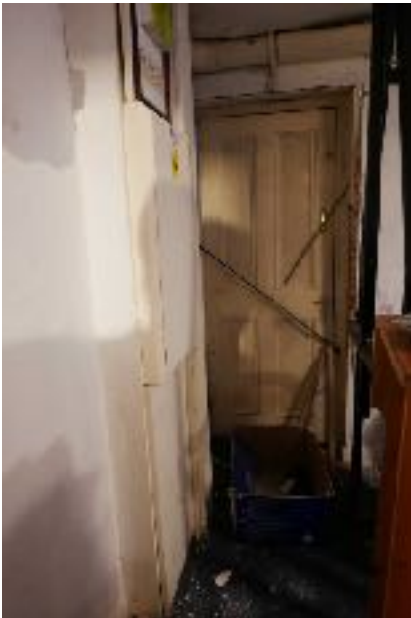
Photo 3: Typical cracks Basement level.

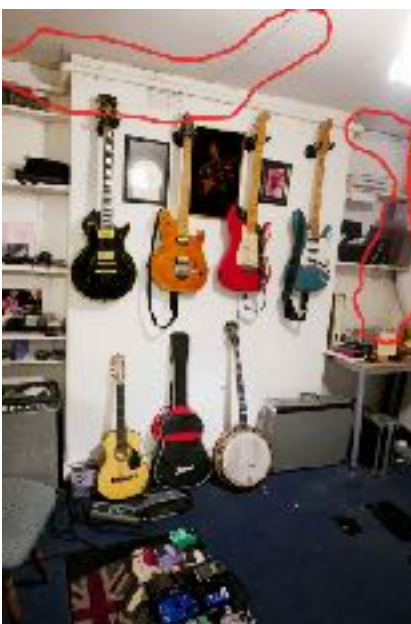
Photo 4: Typical cracks and damp through ceiling

From pipework

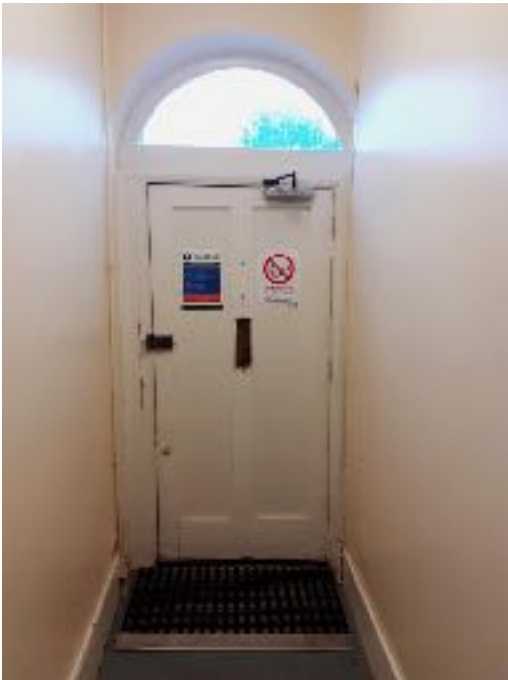
Photo 5: Typical cracks around front door and frame.

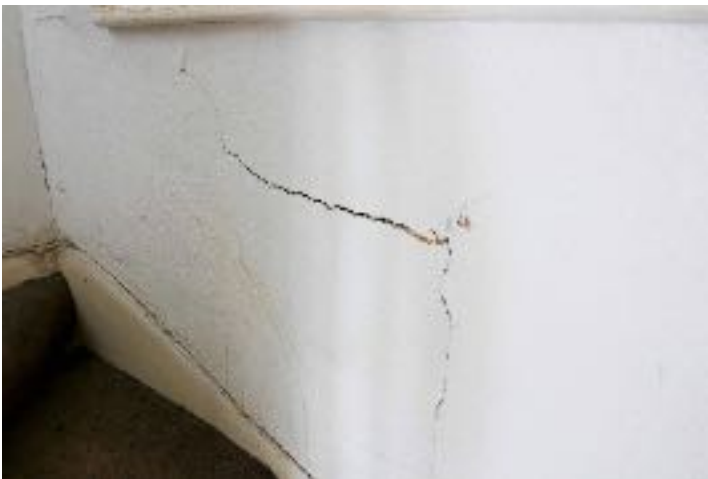
Photo 6: Typical cracks in the rear wall on stair landing between first and second floors.

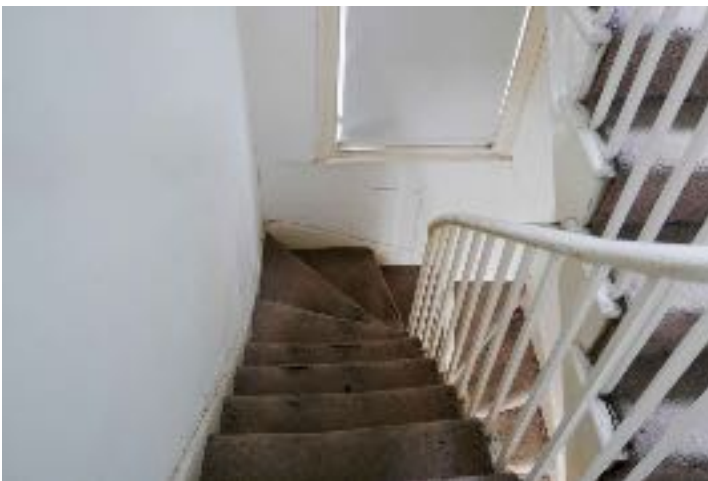
Photo 7: Typical cracks in rear wall on stair landing between first and second floors.

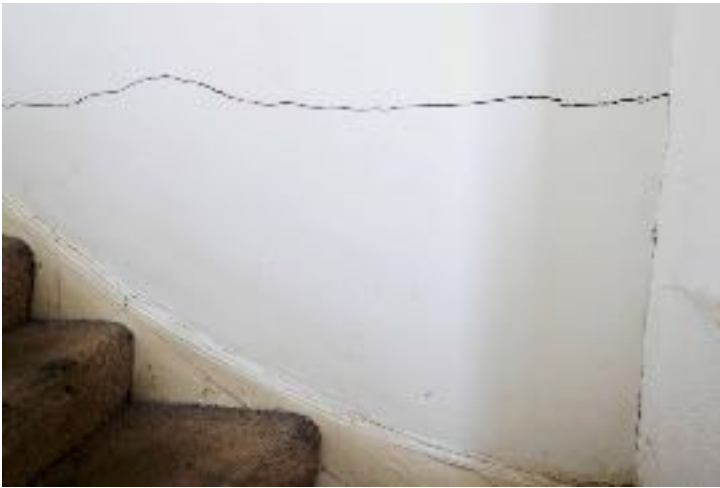
Photo 8: Typical cracks in rear wall on stair landing between first and second floors.

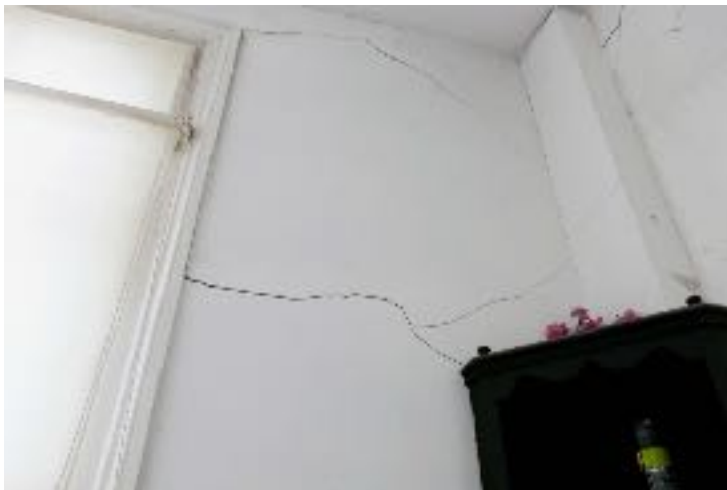
Photo 9: Typical cracks in First Floor rear wall to bathroom.

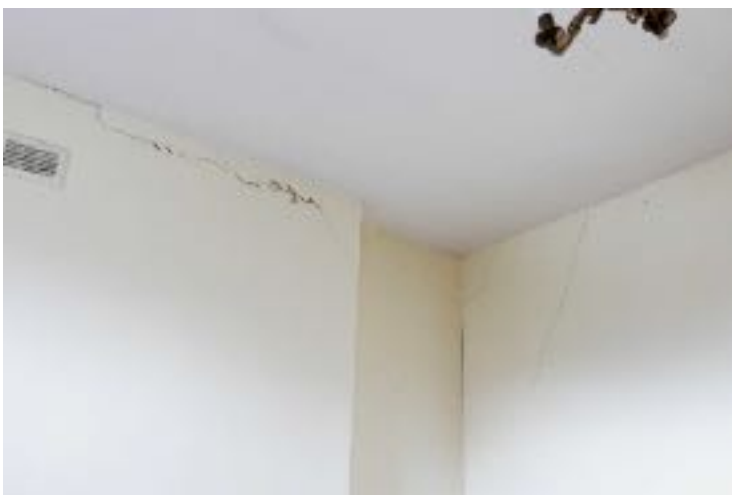
Photo 11: Typical cracks in First Floor rear wall to bathroom.

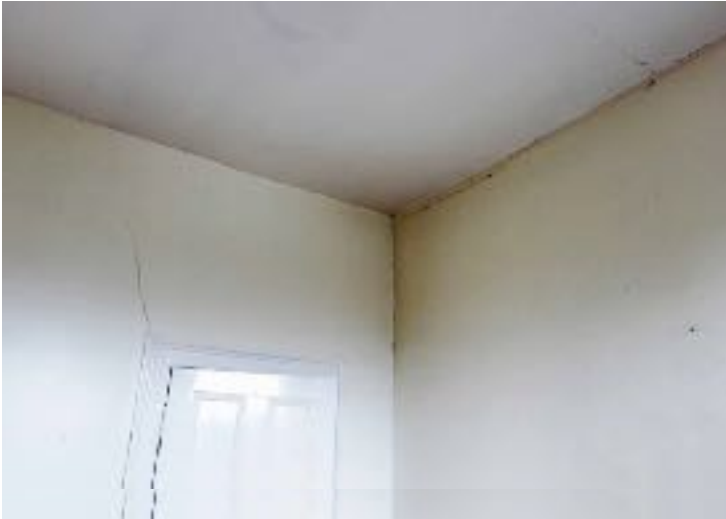
Photo 12: Typical cracks in First Floor party wall and door.

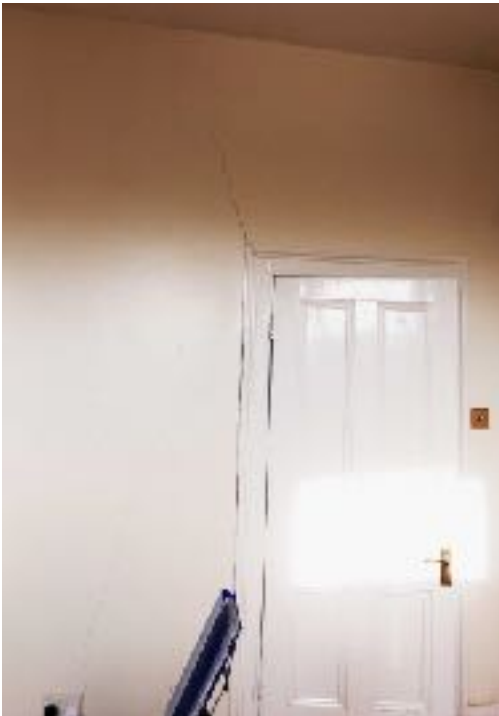
Photo 14: Typical cracks in First Floor party wall and door.

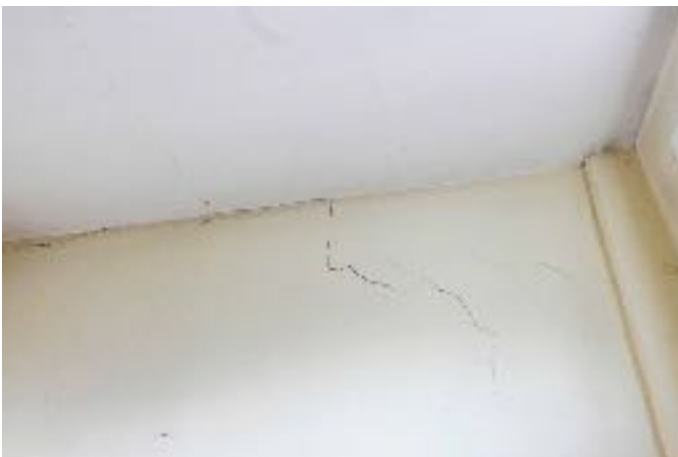
Photo 15: Typical cracks in First Floor party wall.

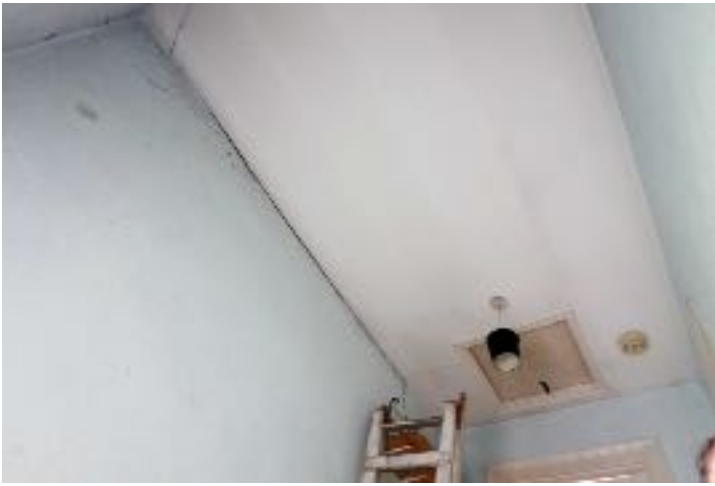
Photo 16: Typical cracks in Second Floor party wall, ceiling and door.
Refer dwg. Nos.

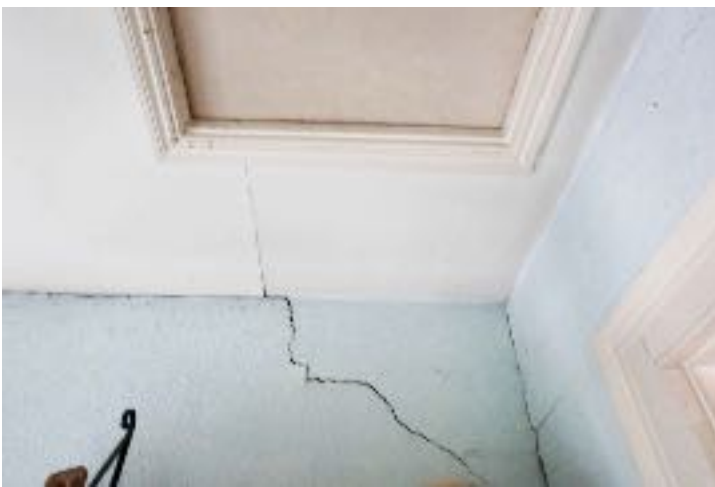
Photo 17: Typical cracks in Second Floor party wall and door.
Refer dwg. Nos.

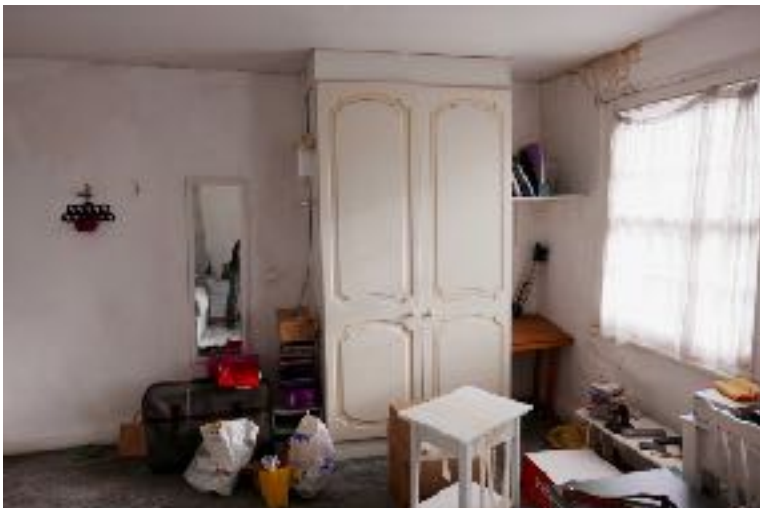
Photo 18: Typical cracks in Second Floor party wall and ceiling, leakage from attic.
Refer dwg. Nos.

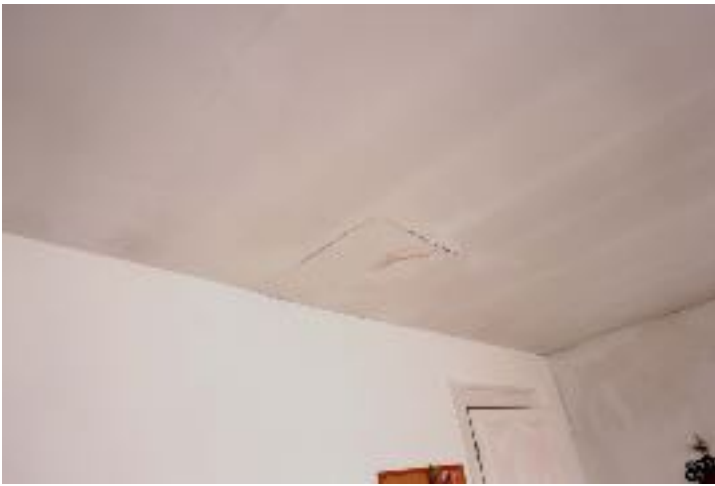
Photo 19: Typical cracks in Second Floor party wall and ceiling.

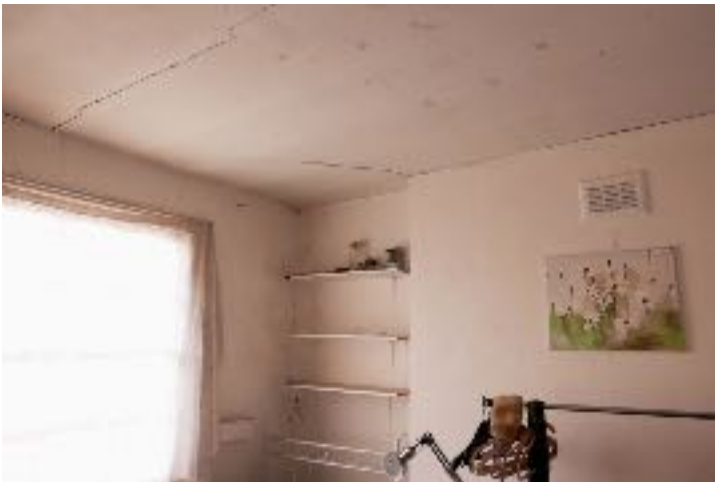
Photo 20: Typical cracks in Second Floor party wall and ceiling.
