## Design note

| Ambassadors Theatre, London | 2 Mar 2023 | RR | 5208_DN_001 |

**Title**  
Structural design philosophy, remedial works overhead pavement support

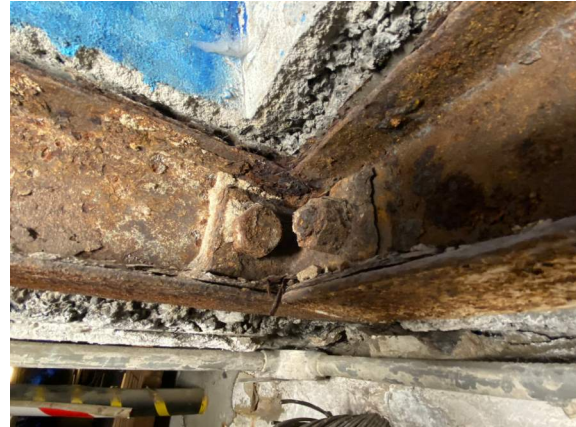
With regards to the steel trimmer beams around the skylights, similar deterioration was found: the concrete originally encasing the steel had spalled nearly completely, due to the corrosion expansion, and had exposed the soffit and sides of the beams. The steel was in an equally poor condition: serious delamination was visible at the top and bottom flanges and the web had been affected too. As a consequence, the steel trimmer beams need remedial works as well.

*Left photo: the concrete encasing around the trimming steel beams had spalled, due to corrosion expansion.  
Right photo: delamination was severe in certain locations, in particular on the top and bottom flange.*

The structural design philosophy for the remedial works sets out to make the structure safe again whilst balancing this with practical restraints. Removing the existing steel beams would result in digging up the pavement and extensive temporary works as the slabs also prop the external retaining walls. As a consequence, new steel beams are proposed which sit below the existing ones, taking over their support function. Putting these beams in place with a significant level of corrosion protection (by galvanising) will ensure the correct level of support is achieved again. Also, the insertion of the steel beams could be reversed at a later date if it is ever decided to replace the full slab overhead.

The new steel beams will be as shallow as possible, not to affect the headroom too much. Depending on the extent of the spalled concrete, steel top plates will be introduced to provide sufficient support width. The area where the concrete is lost will be infilled with grout.

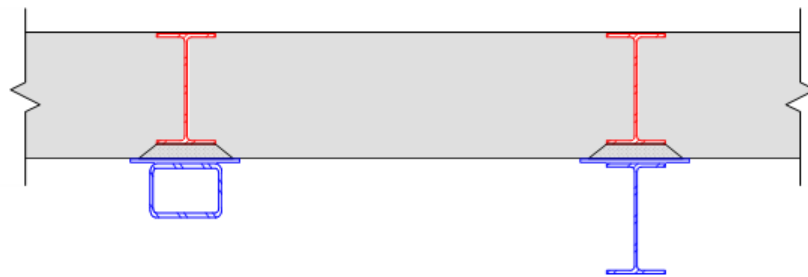
*Principle of remedial works: providing new steel beams below the existing ones to take over the support function: new steel sections can be UB-sections (shown right) or reduced depth sections (shown left) where headroom is an issue.*
