Design note

Project	Date	By	Reference
Ambassadors Theatre, London	2 Mar 2023	RR	5208_DN_001

Title
Structural design philosophy, remedial works overhead pavement support

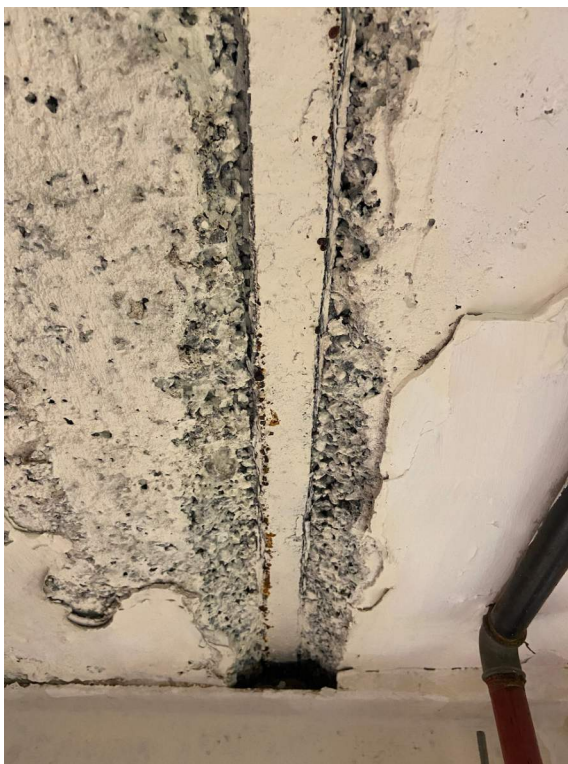
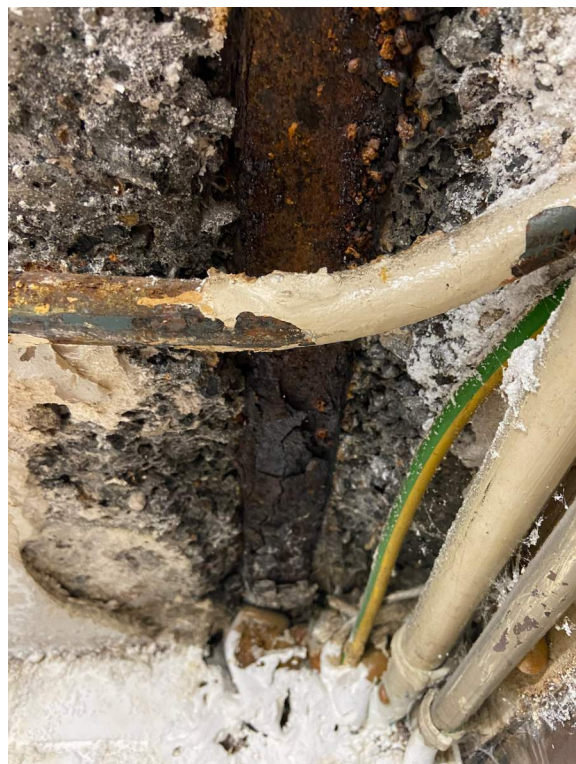
The existing structure has been inspected from below - the top is covered by the pavement and its build-up and this was not dug up - to understand it's current condition. What became apparent was that the concrete cover on the bottom flange had completely spalled, which was due to the corrosion expansion of the steel beams: when steel corrodes its volume increases up to a factor of ten. The steel beams had suffered from various levels of corrosion: certain areas only had surface corrosion, whereas other areas (typically near the supports) had completely delaminated and could be removed by hand. Hence, the structural integrity of the steel beams - and thereby the floor as a whole - had been compromised and can't be relied on anymore.

*Left photo: the concrete encasing around the bottom flange had spalled, due to corrosion expansion.
Right photo: the corrosion was quite severe in certain locations, with delamination of the steel.*

The cause of the corrosion is water ingress, in combination with the lack of ventilation (as the steel is encased in concrete). This might have been further exacerbated by the the clinker concrete typically used in those days: when the clinker concrete gets wet it creates a strong acidity which affects the steel.

The structural design philosophy for the remedial works sets out to make the structure safe again whilst balancing this with practical restraints. Removing the existing steel beams would result in digging up the pavement and extensive temporary works as the slabs also prop the external retaining walls. As a consequence, new steel beams are proposed which sit below the existing ones, taking over their support function. Putting these beams in place with a significant level of corrosion protection (by galvanising) will ensure the correct level of support is achieved again. Also, the insertion of the steel beams could be reversed at a later date if it is ever decided to replace the full slab overhead.

The new steel beams will be as shallow as possible, not to affect the headroom too much. Depending on the extent of the spalled concrete, steel top plates will be introduced to provide sufficient support width. The area where the concrete is lost will be infilled with grout.

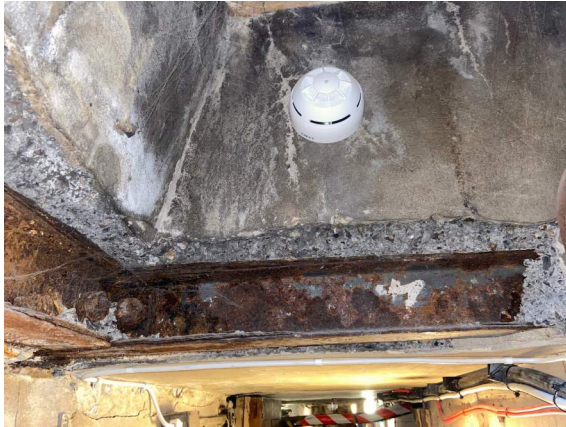
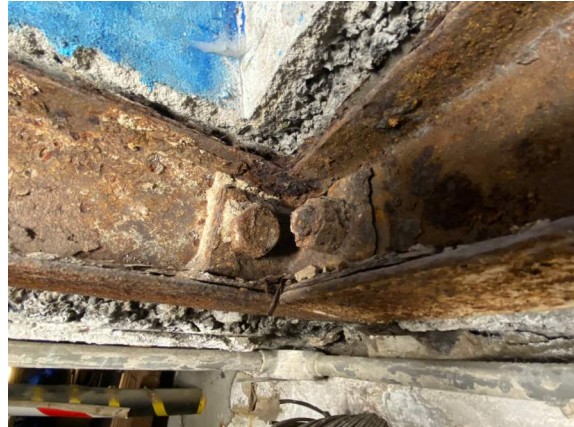
With regards to the steel trimmer beams around the skylights, similar deterioration was found: the concrete originally encasing the steel had spalled nearly completely, due to the corrosion expansion, and had exposed the soffit and sides of the beams. The steel was in an equally poor condition: serious delamination was visible at the top and bottom flanges and the web had been affected too. As a consequence, the steel trimmer beams need remedial works as well.

*Left photo: the concrete encasing around the trimming steel beams had spalled, due to corrosion expansion.
Right photo: delamination was severe in certain locations, in particular on the top and bottom flange.*

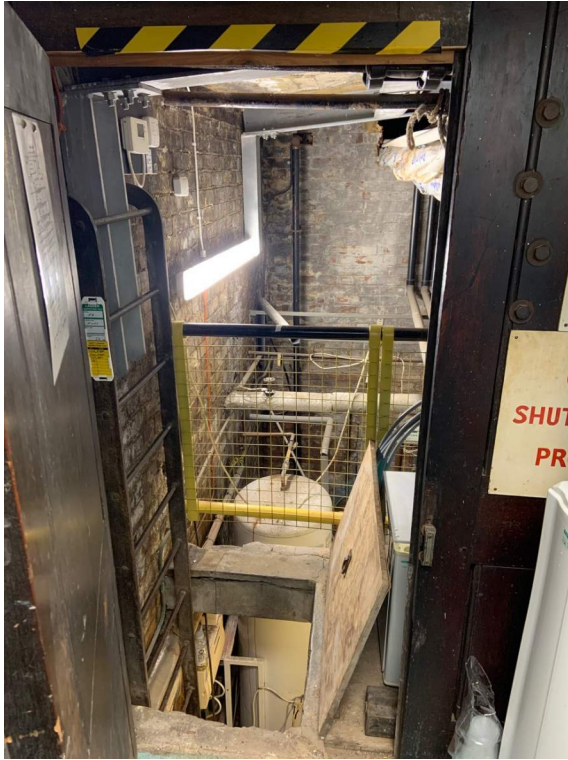
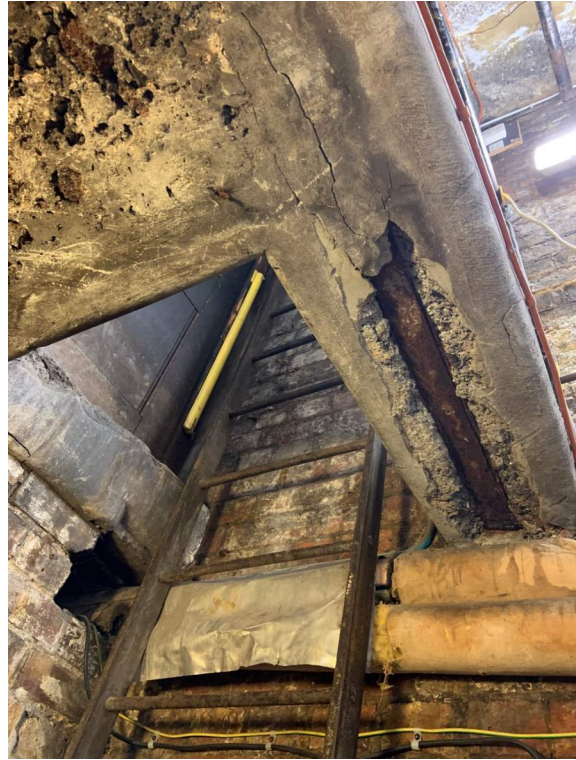
With regards to the boiler room, a small portion of the existing filler-joist floor is removed completely: the structure for this is also in a really poor condition - both the steel and the concrete - and its removal is simplified as this is a suspended floor without anything above. Adding remedial works would lead to a reduced headroom in an already confined space and it would be difficult to deal with the safety risk of the spalling concrete (falling on people working below).

Left photo: small portion of the boiler room floor seen from stalls level. Right photo: existing structure seen from below, showing the significant corrosion and subsequent spalling of the concrete.
