Prop Room - Corrosion of existing steels and proposed remedial works required, Stage level / Lower Ground Floor

Prop Room - Proposed remedial works, Stage level / Lower Ground Floor

West Street Passage (front of the Theatre) - Corrosion of existing steels and proposed remedial works required, Stage level / LGF

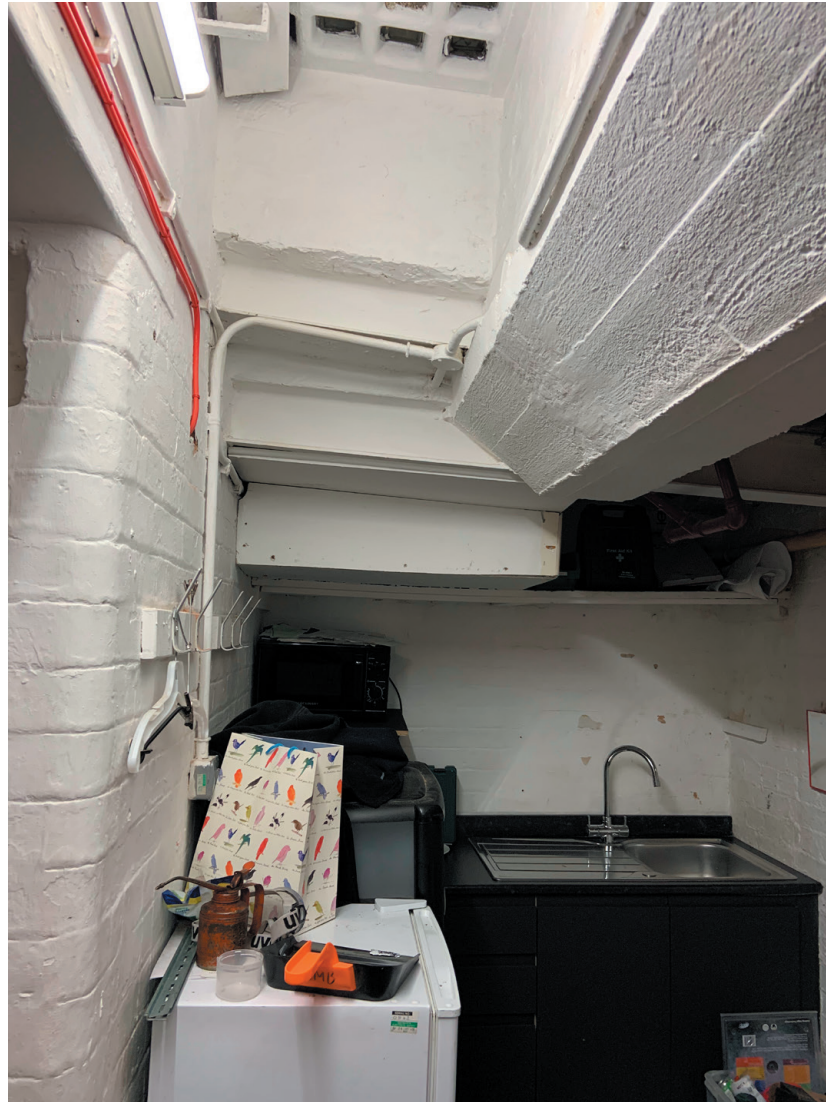
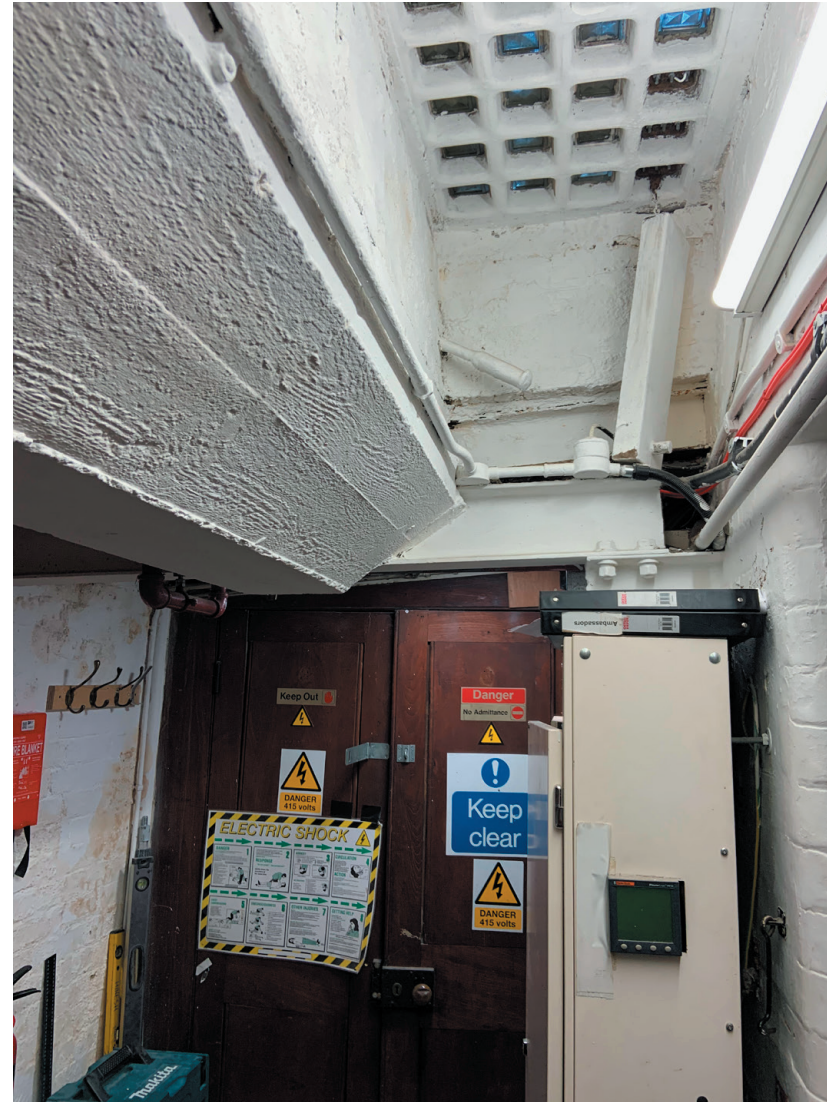
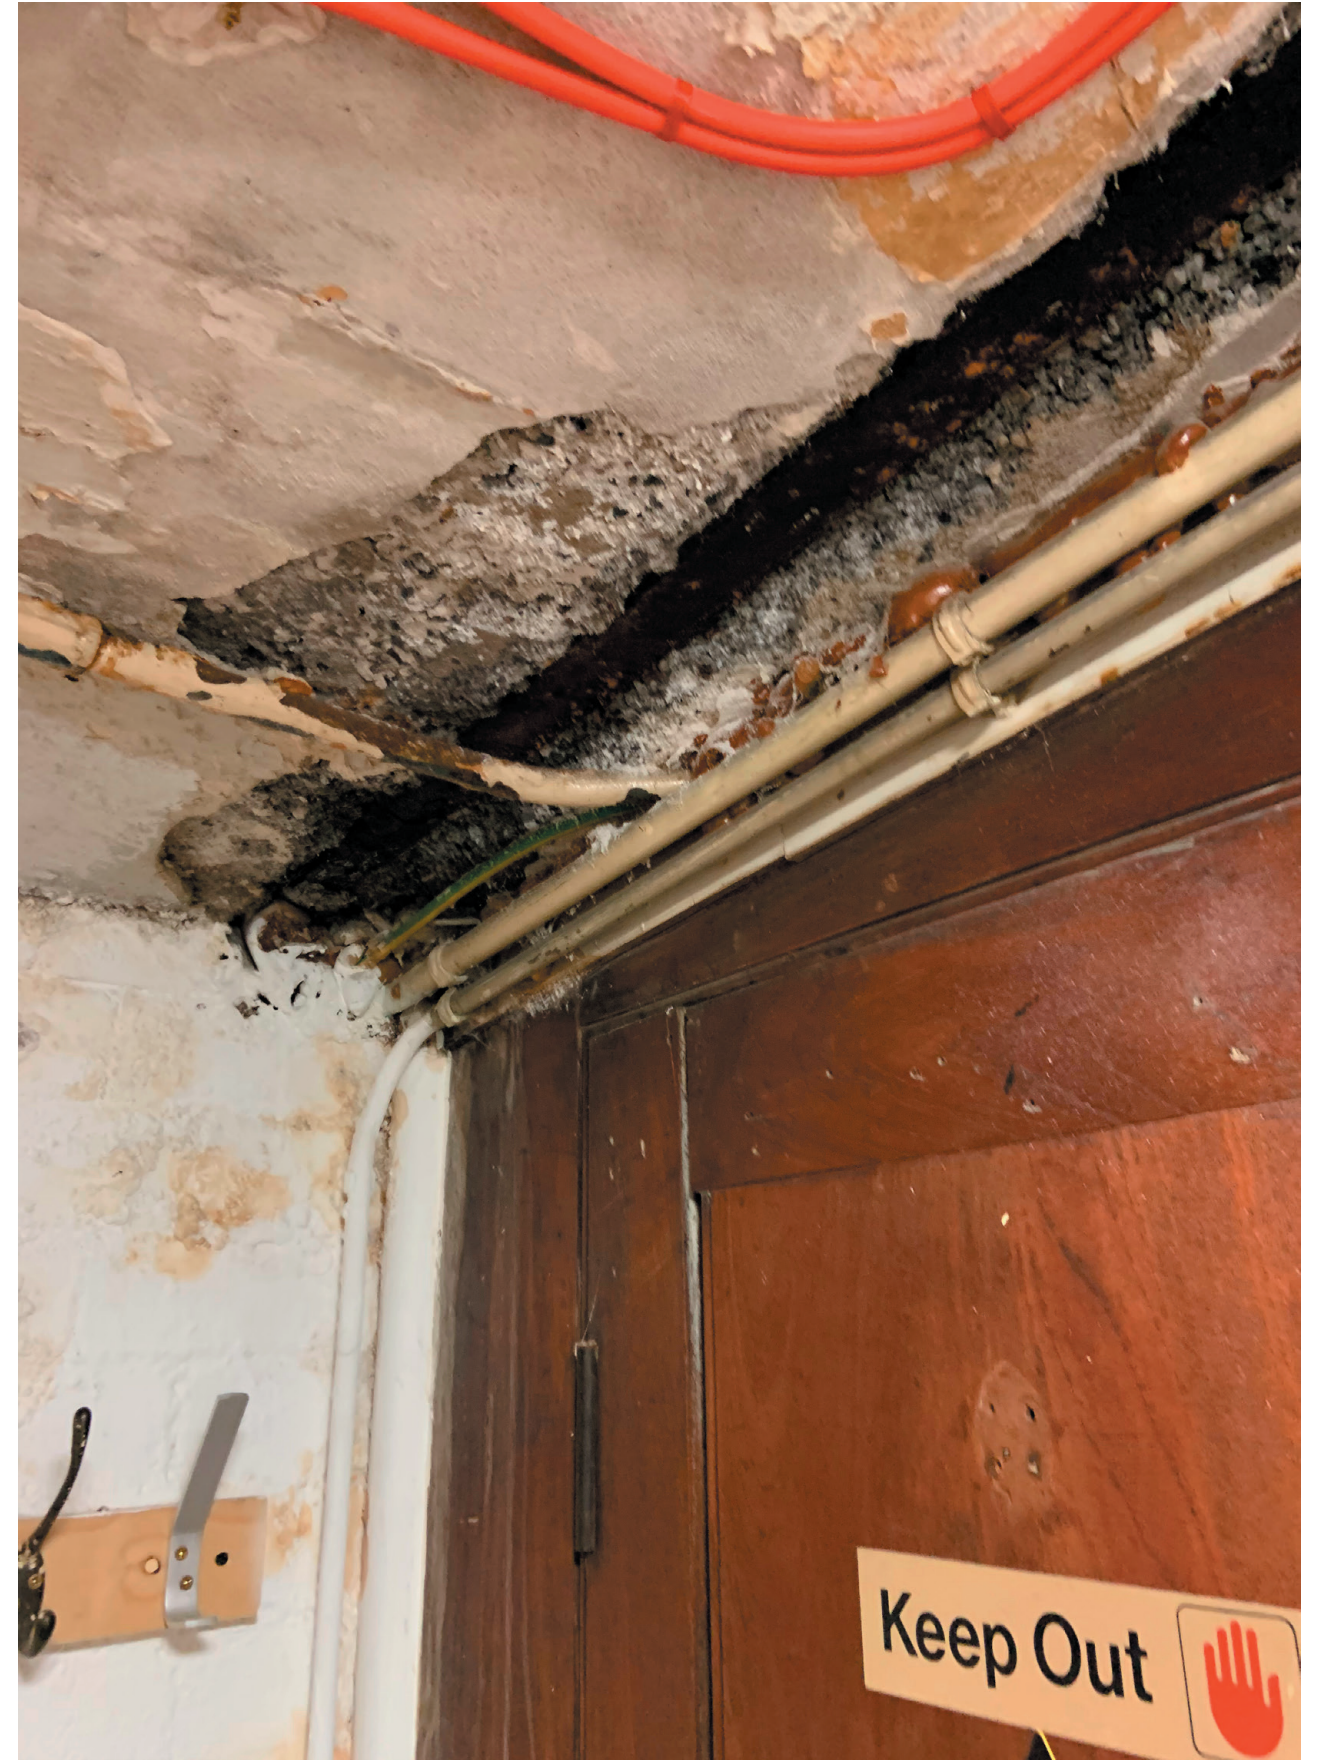
The existing structure within the Prop. Room at Stage level has been carefully inspected from below - the top is covered by the pavement and its build-up - to understand its current condition. In many locations the concrete cover on the bottom flange had completely spalled, which was due to the corrosion expansion of the steel beams: when steel corrodes its volume increases up to a factor of ten. The steel beams had suffered from various levels of corrosion: certain areas only had surface corrosion, whereas other areas (typically near the supports) had completely delaminated and could be removed by hand. Hence, the structural integrity of the steel beams - and thereby the Prop Room ceiling as a whole - had been compromised and can't be relied on anymore. The cause of the corrosion is water ingress, in combination with the lack of ventilation (as the steel is encased in concrete). This might have been further exacerbated by the the clinker concrete typically used in those days: when the clinker concrete gets wet it creates a strong acidity which affects the steel.

Photo of one of the existing Prop. Room steels where the corrosion of the steels was quite severe in certain locations, with delamination of the steels themselves.

The structural design philosophy for the remedial works sets out to make the structure safe again whilst balancing this with practical restraints. Removing the existing steel beams would result in digging up the pavement and extensive temporary works as the slabs also prop the external retaining walls. As a consequence, new steel beams are proposed which sit below the existing ones, taking over their support function. Putting these beams in place with a significant level of corrosion protection (by galvanising) will ensure the correct level of support is achieved again. Also, the insertion of the steel beams could be reversed at a later date if it is ever decided to replace the full slab overhead. The new steel beams will be as shallow as possible, not to affect the headroom too much. Depending on the extent of the spalled concrete, steel top plates will be introduced to provide sufficient support width. The area where the concrete is lost will be infilled with grout repair. See drawing 2201-3-330, 335 and 336 for details.

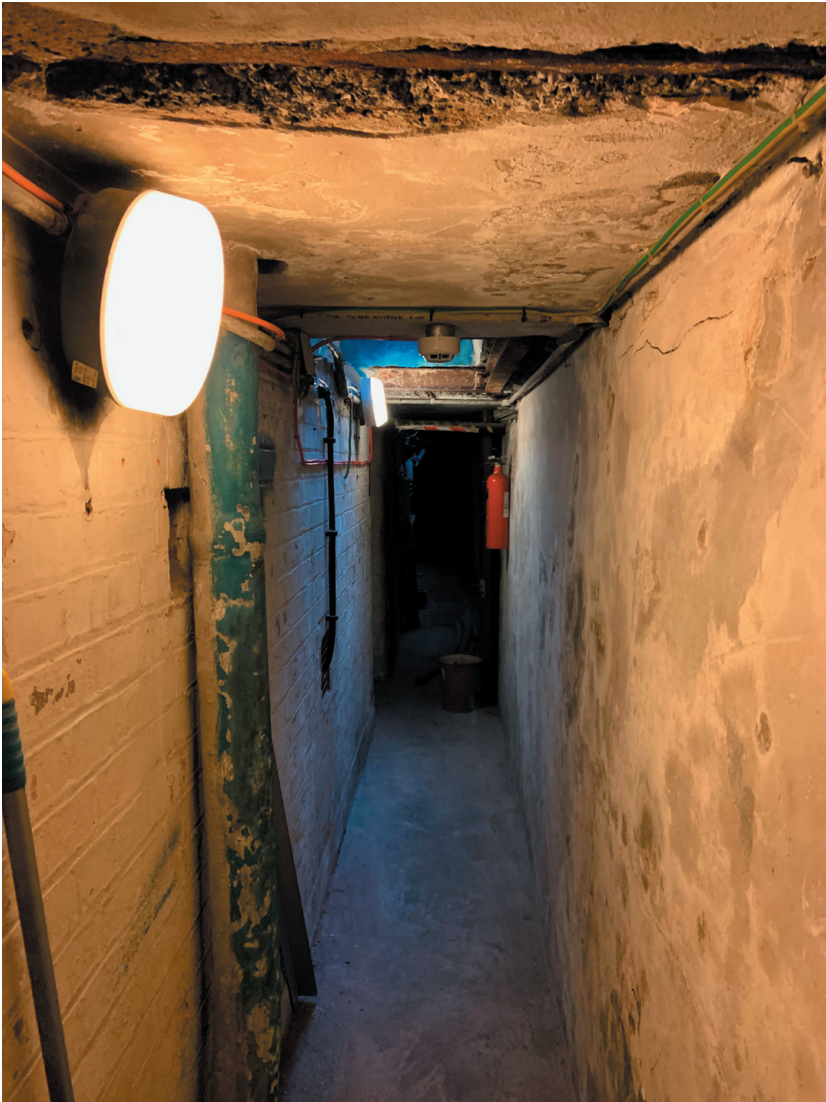
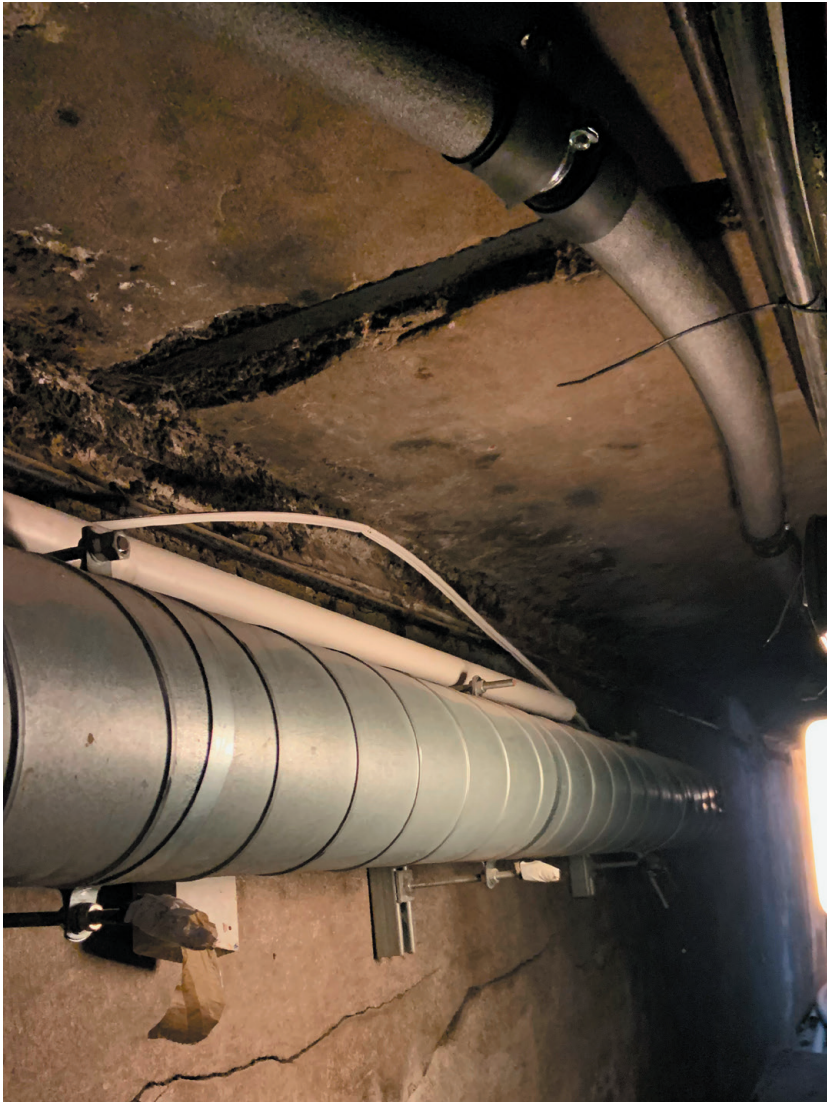
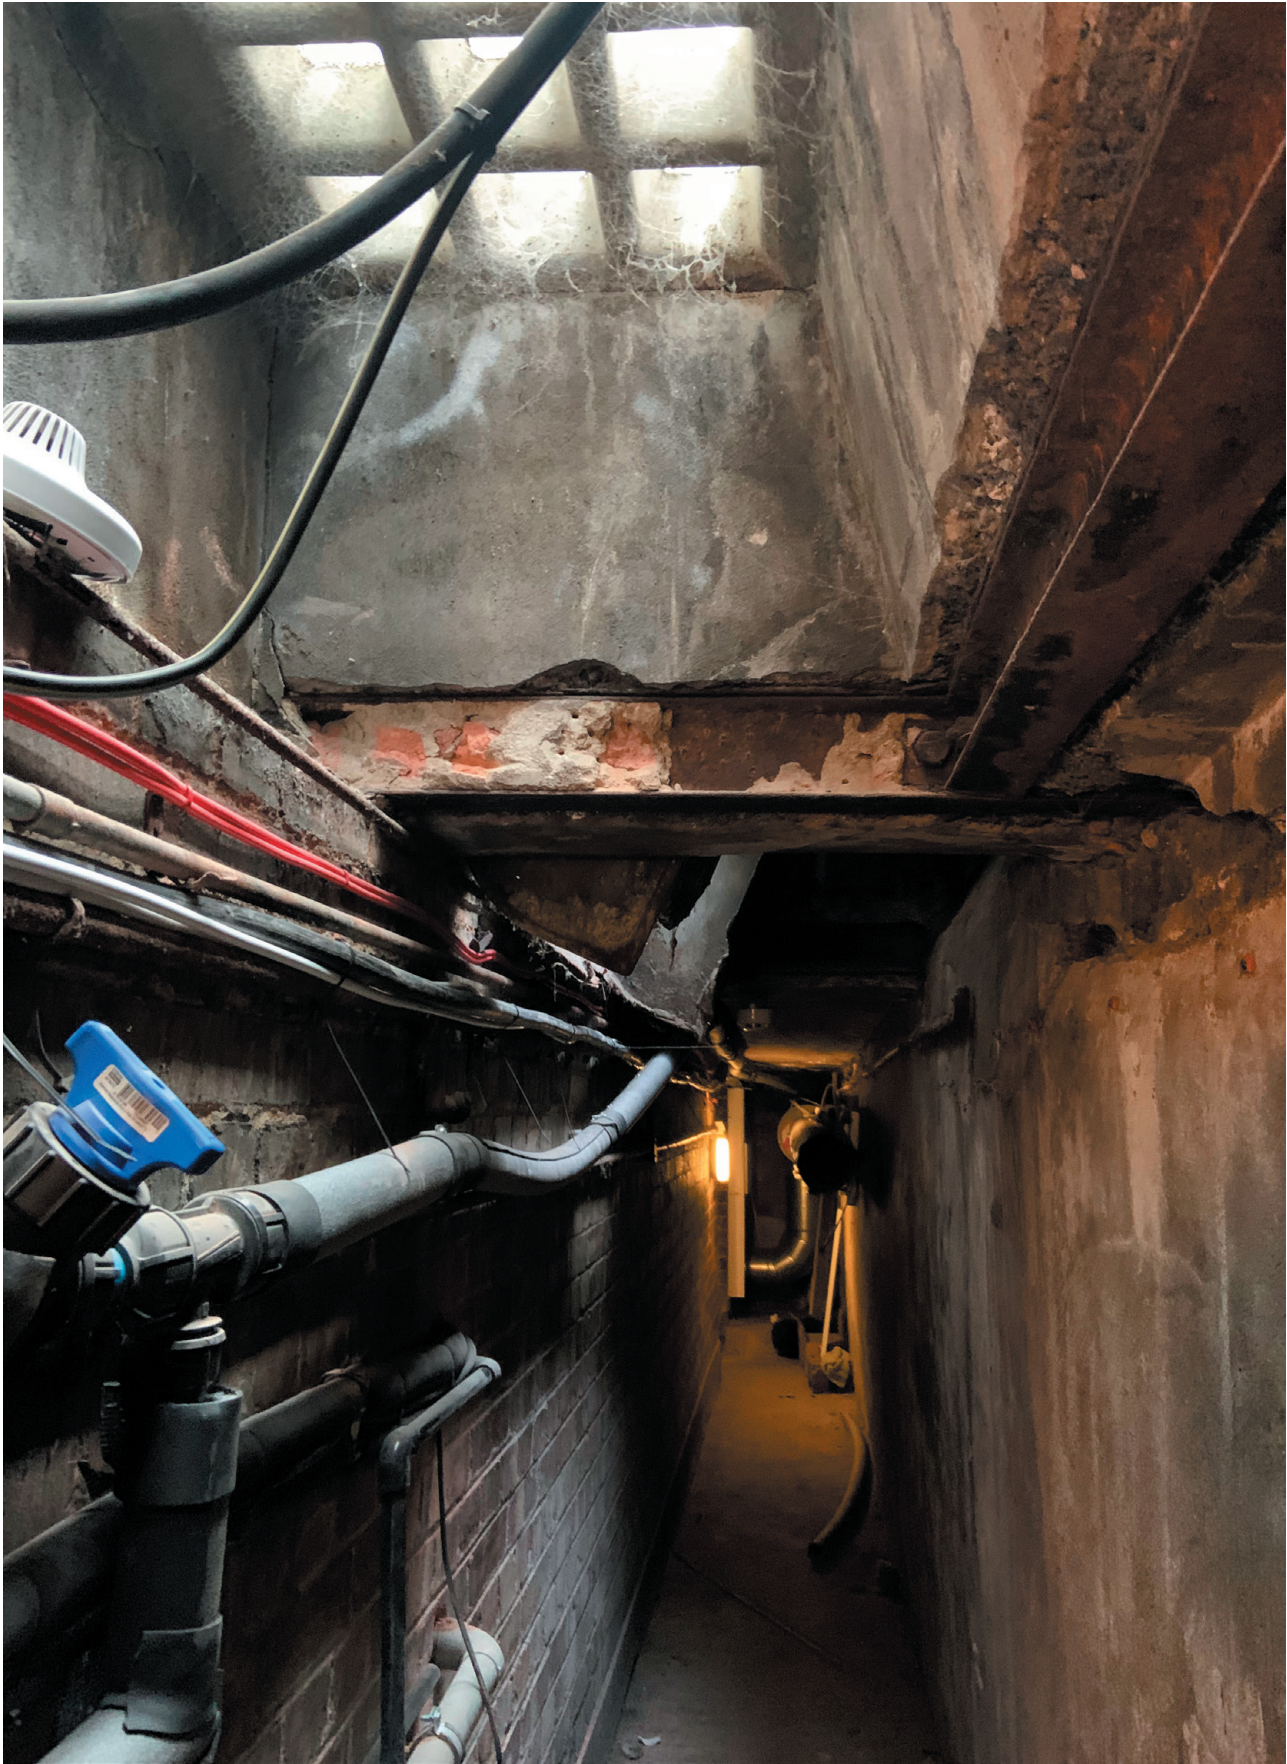
The West Street passage runs along the front theatre elevation and under the public pavement at the front.
As for the Prop. Room existing structure, the West Street passage has also been carefully inspected and presents the same problems: in many locations the concrete cover on the bottom flange had completely spalled and the existing steel beams had suffered from various levels of corrosion compromising the structural integrity of the concrete slab forming the structural sub-layer of the public pavement above. This represents a serious concern in relation to the public health and safety.

Photo of one of the existing West Street passage where the existing steels show visible signs of corrosion and delamination.

As for the Prop. Room it is proposed to install new shallow steel beams below the existing ones, taking over their support function as a reversible remedial work approach. See drawing 2201-3-340_G and 341 for details.
