11 Chester Terrace
NW1 4ND

Ref: 2023/0282/P & 2023/0650/L

**Review of various reports regarding
balustrade and retaining wall at
Chester Terrace**

Contract: 7613

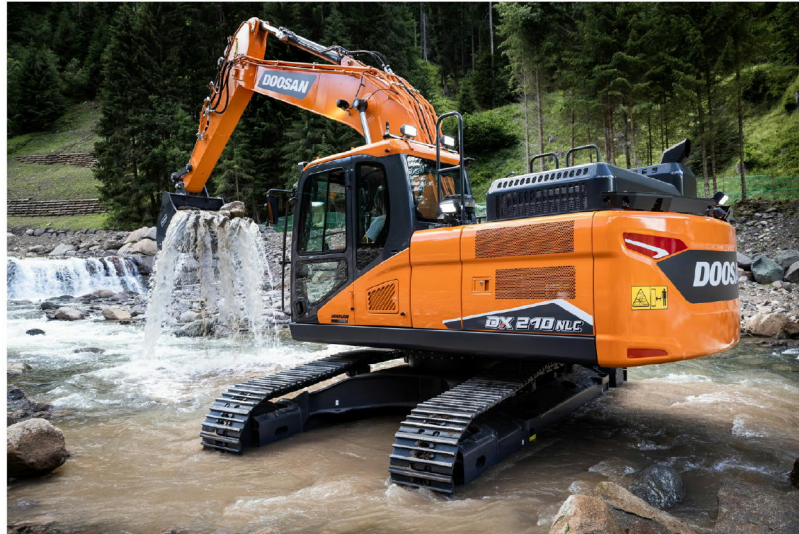
Fig 1 – Top (21 Tonne Excavator)

HPM's Method Statement shows a 21 Tonne Excavator being required to install the piles. For reference (see Image 1) which shows a typical 21 Tonne Excavator. I do not consider such a machine is necessary to install piles or excavate the foundation. Piles may be installed using much smaller machinery – some proprietary piling systems can be installed by hand (see Image 2). Using much smaller hand-installed systems would enable the piles to be installed around trees and their roots.
