26 Rosslyn Hill. London. NW3 1PA

21040. Tree survey and arboricultural method statement. V5. <u>December 2022.</u>

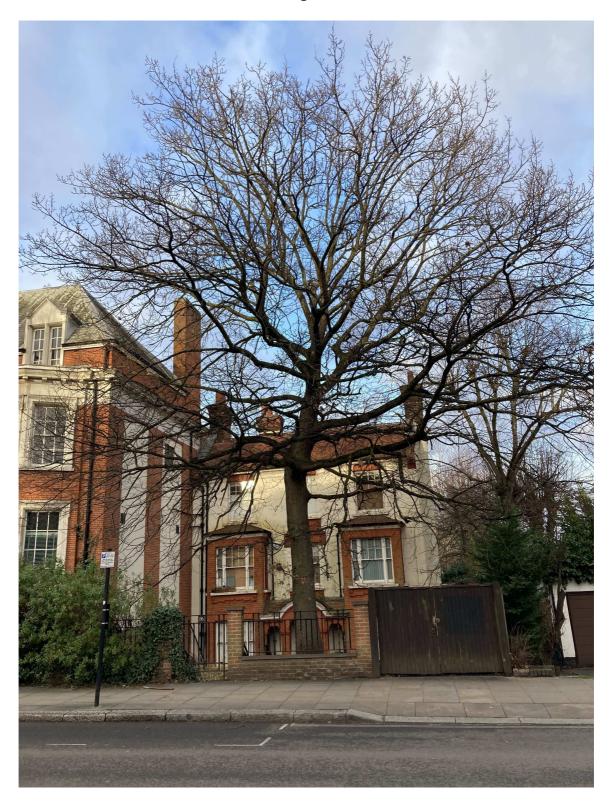
T1 native Oak. Despite the kink in its stem this Oak has got to be a category A. The TPP shows that the normative RPA of T1 covers much of the front garden.

1. Hand rake out and remove all front garden debris and litter. Assemble the tree protection fence in the position shown on the TPP. The fence follows clearly identifiable features. The fence will stay in place until all building works are complete.

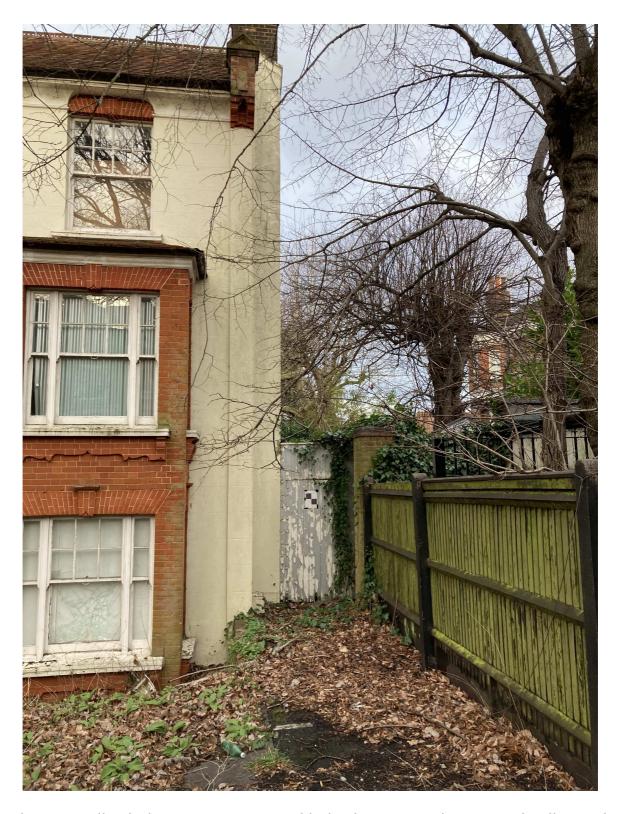
Ts2 and 3 are pollarded Limes. Limes are likely the most robust city dwellers. The overhang of T2 has been pruned back from the building in the past. Some similar pruning will be required as part of the proposal to facilitate scaffolding of the front and side elevations.

- 2) By consent from the LPA and correspondence with the owner of number 24 the Lime, T2 will be pruned back to facilitate scaffolding.

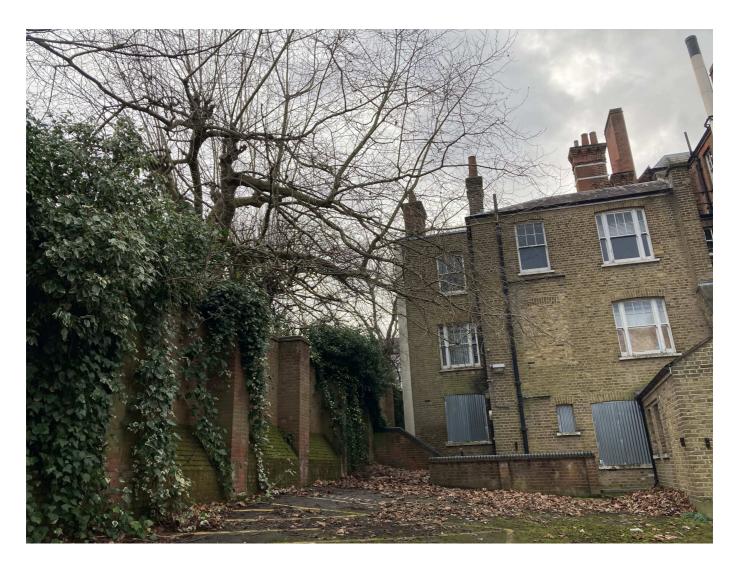
T4 London Plane is overhanging the area where there are proposals to extend the dwelling footprint. T4 has been reduced and reshaped on the neighbours side and to a far lesser extent over the boundary of number 26. It can be target pruned back close to the boundary as part of the proposal. More than likely professional pruning will increase the longevity of this Plane and make it more of a visual amenity.

The buttressing at the base points to the boundary wall retaining a significant amount of soil which again is supporting heavy trees. (Please refer to levels on the TPP). Aerial images show a reasonable area of permeable ground over the boundary. The TPP shows a distance of 10 metres from the boundary wall to the western elevation of number 24.

- 1. By consent from the LPA and correspondence with the owner of number 24 the London Plane T4 will be target pruned back close to the boundary. Arborists will be guided by the normative reference BS 3998 2010 "Tree work recommendations".
- 2. There is no visible reason today to believe that the garden of number 24 will need to be accessed. Care will be taken with piling rig booms that could come close to the crowns of Ts 2, 3, 4 & 5.
- 3. Party wall surveyors and structural engineers will report if there has been a breach of the boundary retaining wall with tree roots. Advice will be sought from the site arboriculturalist as to the significance of proposed remedial works.
