# STATE OF CONDITION REPORT

#### **STEEL WINDOWS**

#### **179 TOTTENHAM COURT ROAD**

Date of Report: 26/01/2023

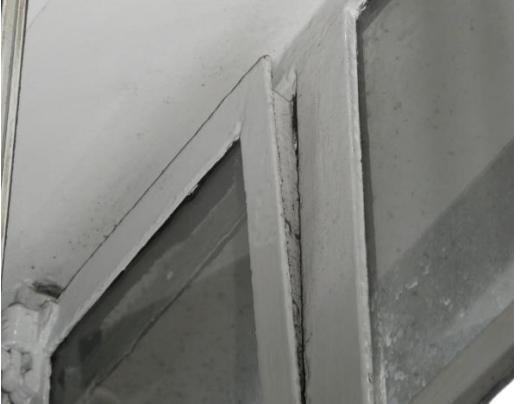
The upper spring fanlight catches the lock that these windows are closed by and are generally inoperable, as are the pulleys where they have been heavily overpainted and are now seized. Missing operating cords are also evident.

Photograph 4: Example of a horizontal pivot casement window and spring catch which are inoperable due to the thick layer of paint.

Replace all the window furniture with new i.e. cockspur handles, peg stays, fanlight catches, pulleys and operating cords.

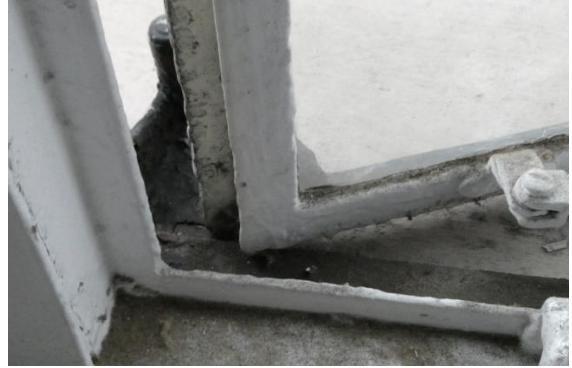
The opening casements have no perimeter weatherstripping around the frames and as a result the build-up of paint prevents the outwardly opening vent closing against the outer frame. Consequently, the opening windows allow uncontrolled air and noise penetration to the interior and most probably allows wind driven rain to pass to the inside in wet weather conditions.

Photograph 5: The build-up of paint prevents the window from closing correctly against the outer frame.

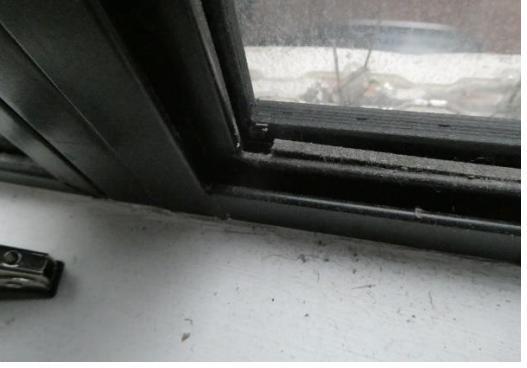
Photograph 6: Gapped internal foam seal.

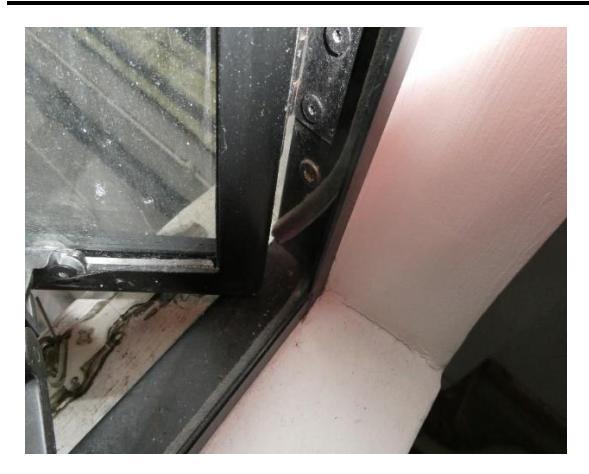
Photograph 7: The foam gasket in this example has partly de-bonded and affecting its ability to seal and the operation of the window.

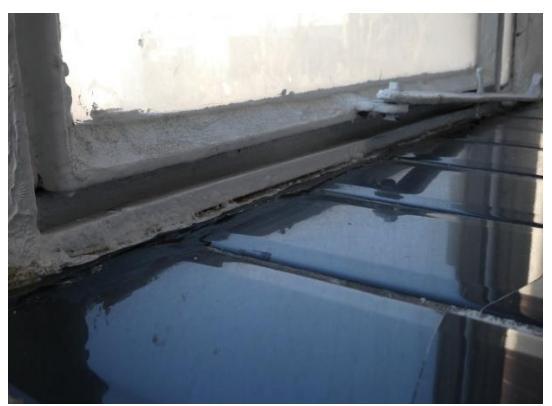
There is evidence of corrosion at the cill and upper window frame sections. Photographs 9 and 10 refer.

Photograph 9: Corrosion and distortion evident at the cill of a window.

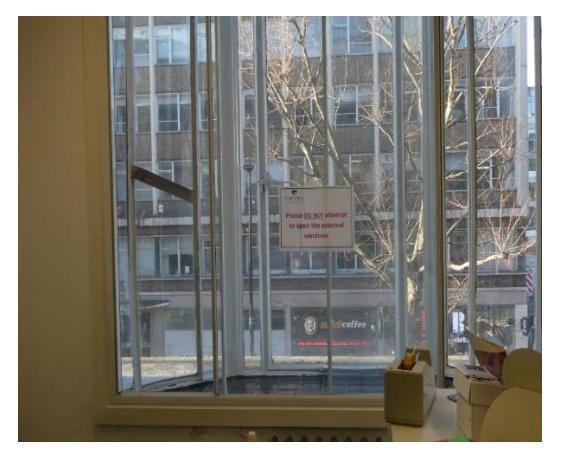
All the opening windows to each bay have a notice on them stating "do not open" or "faulty window under repair". Photograph 8 refers.

Photograph 8: Example of a window fitted with a "Do not open" sign.

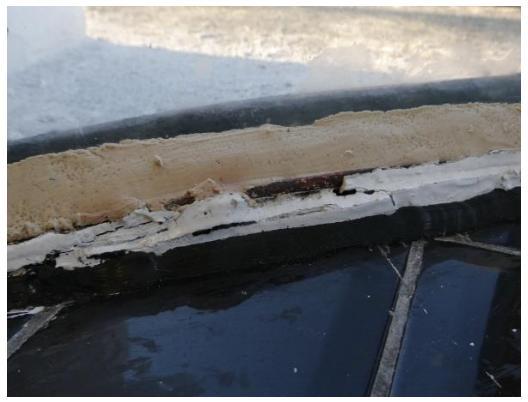
Photograph 10: Corrosion evident at a window cill. The pane of glass has recently been replaced where the distortion in the steel frame had cracked the original pane.

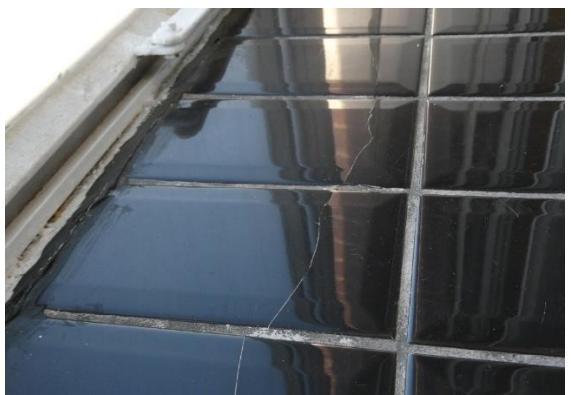
On one bay the corroding window cill section and probably the frame fixing brackets has resulted in the internal tiles to the cill cracking. Please refer to photograph 11 which shows this issue.

Photograph 11: Tiles adjacent to the corroding steel frame which have cracked.

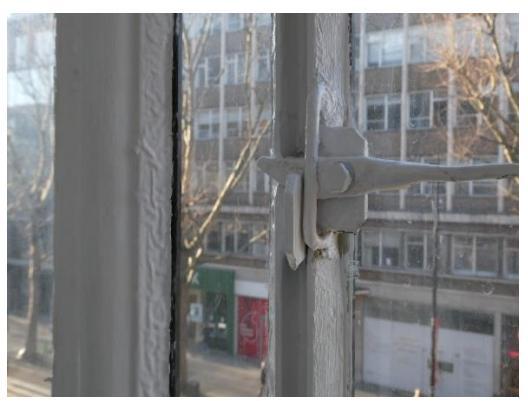
Photograph 12: Example of a window frame and cockspur handle which have been extensively overpainted.

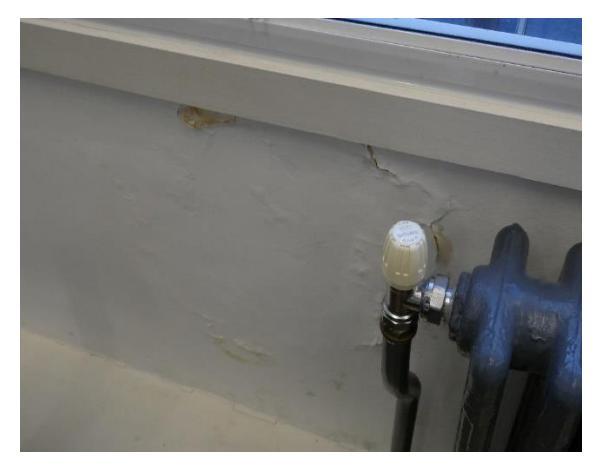
Below all three window bays there is evidence of staining from water ingress and peeling, bubbling paint at the corners of the bays. Please refer to photographs 13 and 14 which show this issue.

As the windows could not be opened, I was unable to inspect the external seals between the window frames and the external stone/concrete cill, but given the extent of the water and damp penetration, failed external sealants and water passing under the corroded sections of frame are the most probable cause.

Photograph 13: Peeling paint and water staining below a window.

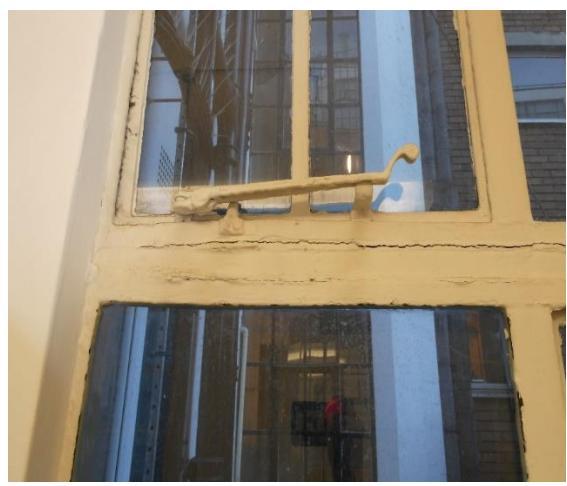
The steel windows to the rear elevation are generally in a (albeit slightly) better condition, but there is still evidence of corrosion. The windows located in the kitchen area has corrosion which is much more severe. Please refer to photographs 15 and 16 at the end of this report.

Photograph 15: Corrosion at a joint between profiles.

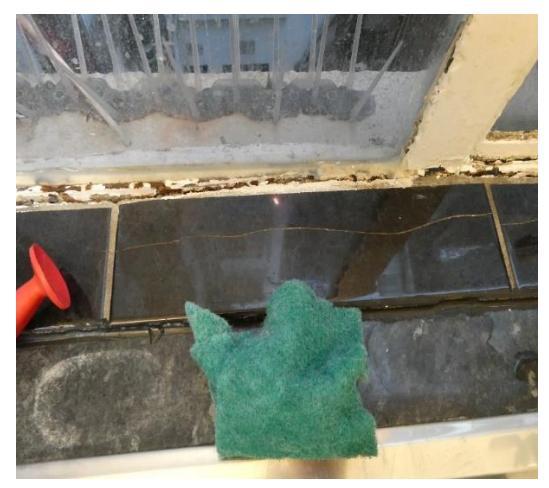
Photograph 16: Severe corrosion along a window cill.

Generally, the windows to these elevations are in a reasonable condition, except for the kitchen window, which is badly corroded and should be replaced.

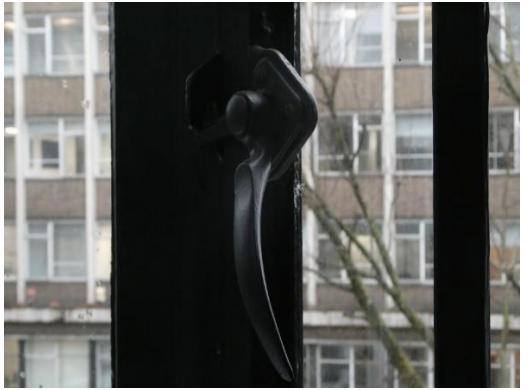
I found no evidence of any corrosion to these windows, so presumably specialist remedial works have been undertaken to these windows to rectify any corrosion prior to the windows being repainted. The remedial works have included fitting new "cockspur" handles. Please refer to photograph 18.

Photograph 18: New Cockspur handle to a repainted window.

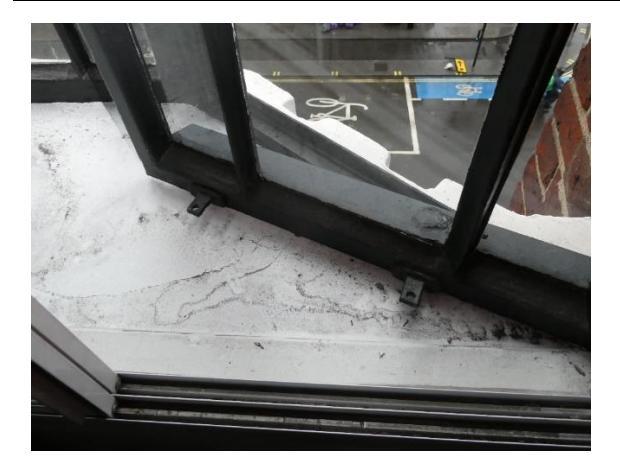
Photograph 19: Water stains on cill from the opening window.

The opening windows need to be adjusted so that they close tightly, which may require removal of some of the recent over painting. In addition, new sliding 'peg' stays must be fitted to these windows to ensure the windows will be restrained when in their chosen open position during windy conditions.

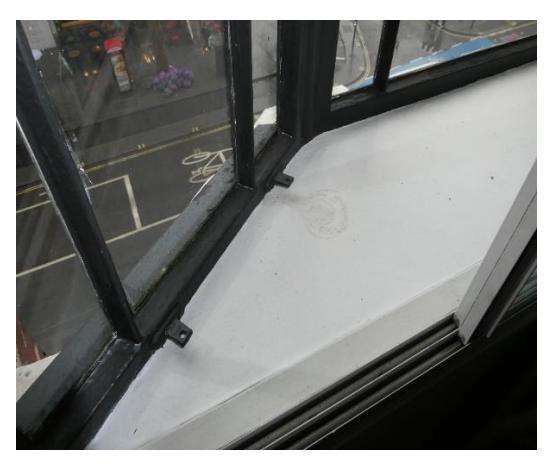
I noted that the peg stays have not been provided at the cill, although their brackets remain in place, so the windows cannot be restrained when opened.

Photograph 20: Peg stays missing but brackets in place.

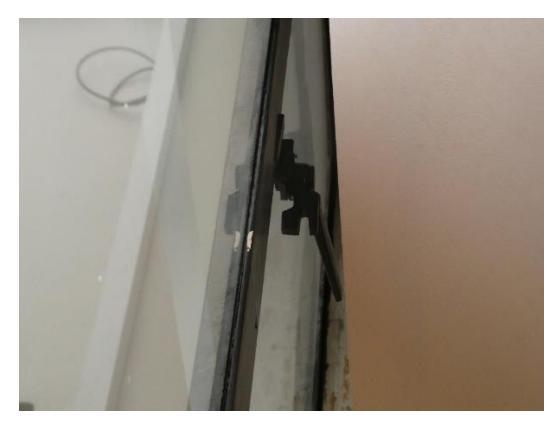
The horizontal pivot ventilators are stuck open, where the operating cord, required to open and close the window, is missing. The top fanlight spring catches have been overpainted to the extent that they have seized and cannot lock the window closed.

Photograph 22: The upper casement windows cannot be fully opened.

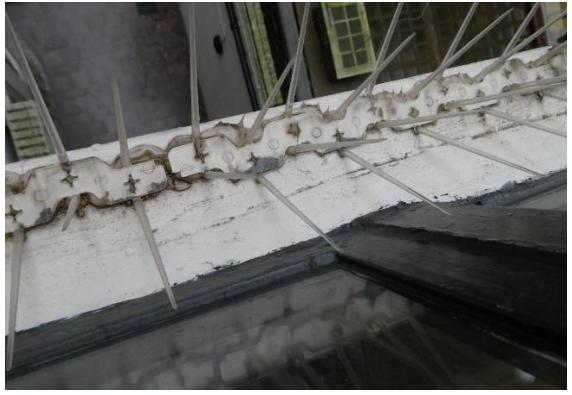
The internal and external glazing compounds have all been overpainted and the external sealants at cill level between the window frames and structure are in a good condition. Please refer to photograph 23.

Photograph 23: External sealants are in a good condition.

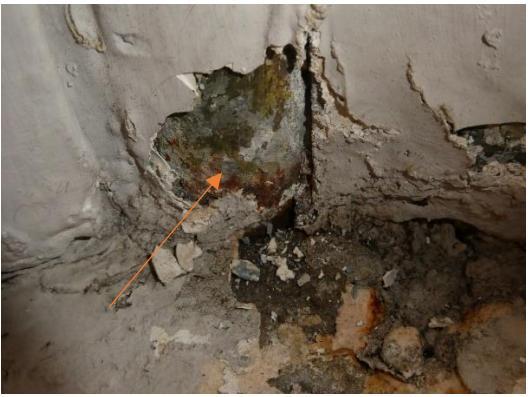
On closely examining these windows it is evident that they were originally galvanised prior to being painted on site but nonetheless some corrosion is occurring, particularly at the base of the tubular steel mullions between the facetted windows and there is also evidence of corrosion to adjacent window frame sections.

Photograph 24: Corroding steel evident at the base of a tubular mullion. Part of the remaining galvanised steel coating is arrowed.

Nonetheless, there is evidence of some light corrosion at the cill level of the windows and to the circular mullion profiles. The opening windows do not close tightly because of past overpainting, so I recommend the old paint is stripped off, local corrosion removed and surfaces locally repainted with cold galvanising paint and the frames then repainted.

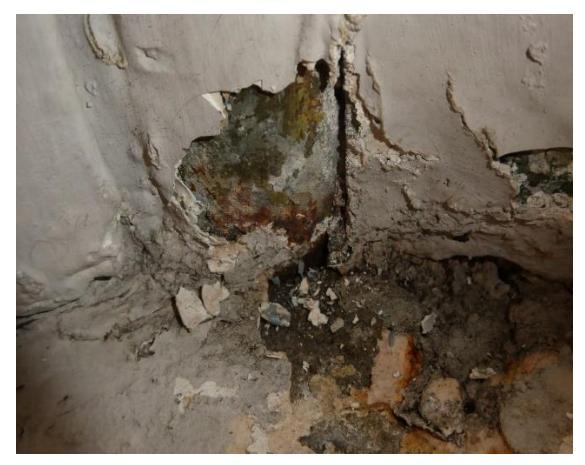
Photograph 25: Corroding cill section.

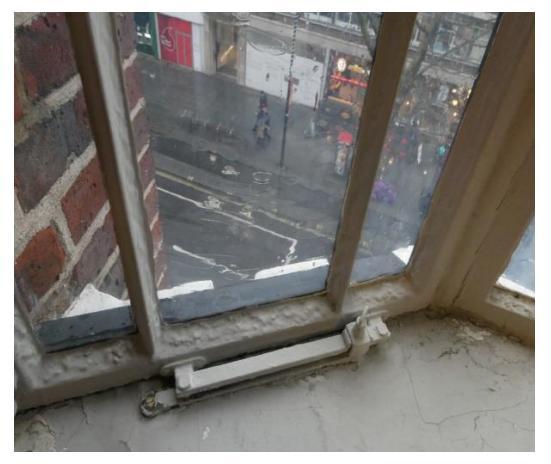
The window frame sections have been overpainted several times and corrosion is not widespread but, as on some of the other floors, the old paint has not been removed from the opening casements prior to being repainted. The opening joints between the fixed outer frame and inner moving frame are therefore not able to be fully closed tight, one section to another, with the result that wind driven rain has penetrated through the window joints and onto the internal cills. Please refer to the photographs 26 and 27 at the end of this report.

Photograph 26: Water stains below an inward opening window.

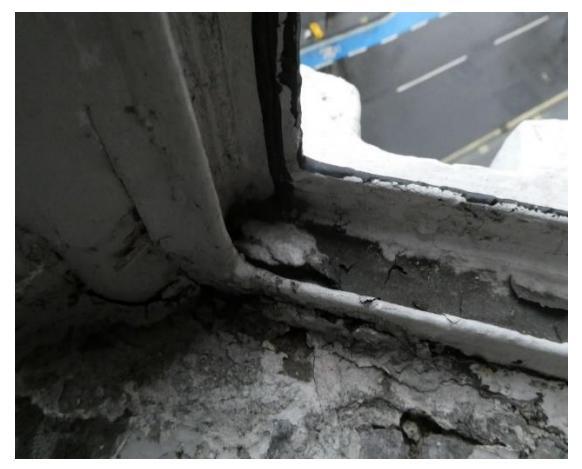
Photograph 27: Damage evident to window due to water ingress. Damaged paint on the internal cill evident.

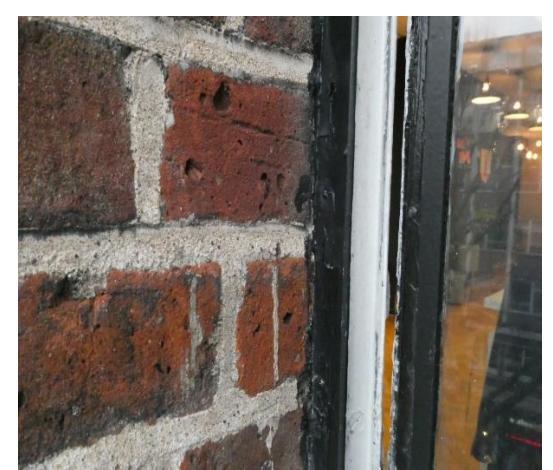
One window was openable, and this enabled the external seal between the brickwork and adjacent window frame to be inspected and I found it to be in a poor condition with evidence of local sealant failure.

Photograph 28: Localised failure of the sealant applied between frame and brickwork.

Opening windows require adjustment to ensure they are operational and fully close, and new window furniture, i.e. cockspur handles, and peg stays fitted. The external glazing compounds should be replaced prior to being painted and the external peripheral sealants also cut out and replaced.

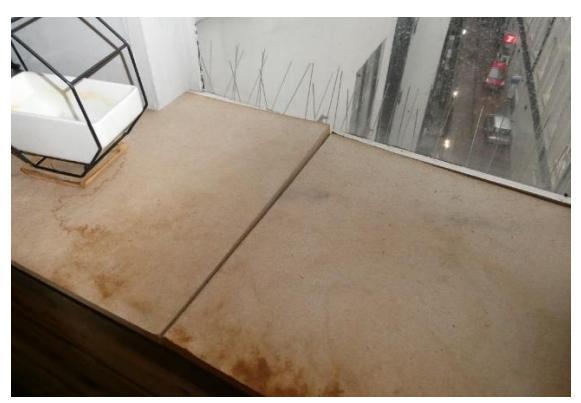
Internally, there is a timber cill with evidence of extensive water staining on the cill at locations below each of the opening windows. Please refer to photograph 29.

Photograph 29: Evidence of water penetration on an internal cill.

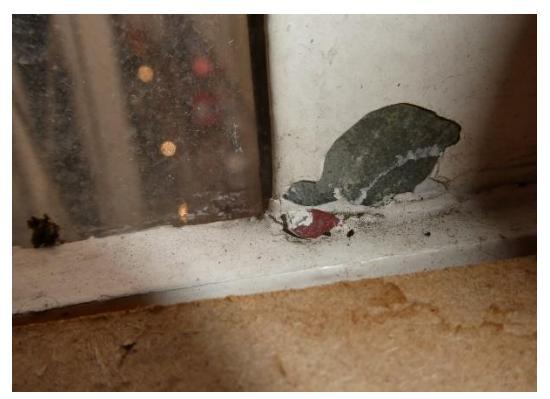
In a couple of locations, the internal paint finish has been damaged exposing a galvanised finish to the window frames. Please refer to photograph 30 at the end of this report.

Photograph 30: The steel frame sections have been galvanised prior to being painted.

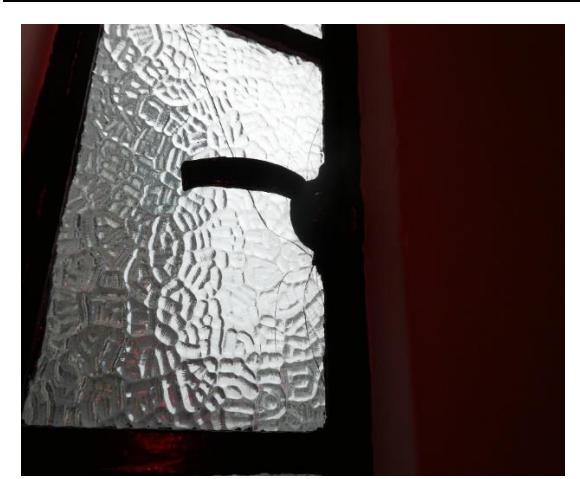
The window frames to the rear elevation windows are generally all in a reasonable condition, except for one of the windows on the north elevation, where the glass is fractured adjacent to the cockspur handle and where the cill frame section is corroding. Please refer to the photographs 31 and 32.

Photograph 31: Glass fractured in toilet window.

Two fractured panes of glass on a south facing window and one fractured pane to the toilet window requires replacement. There is some light surface corrosion to the toilet window that needs to be removed and the window repainted.

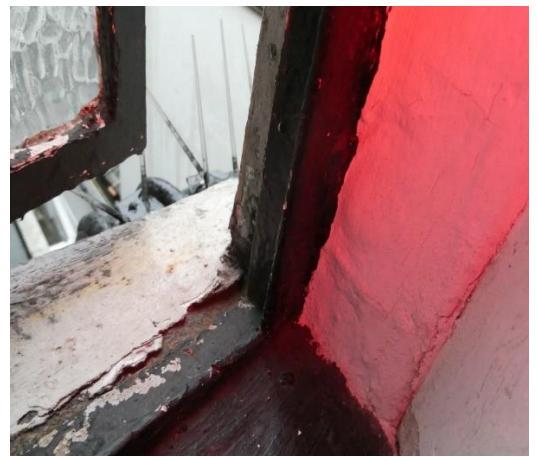
Photograph 32: Corroded window in toilet.

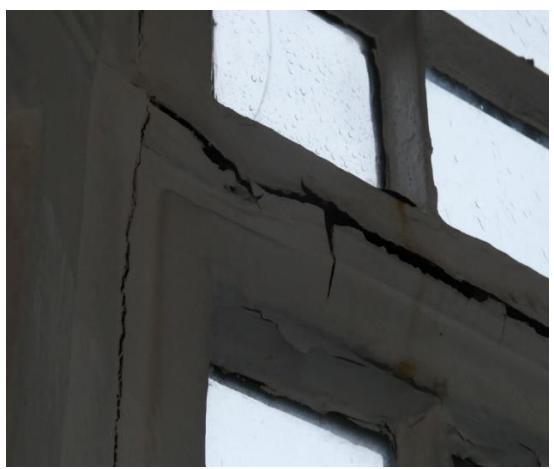
The extensive corrosion has resulted in several panes of glass to fracture in each of the three bays. Please refer to photographs 33 to 40.

Photograph 33: Extensive damage along a coupling transom.

In my opinion, all these windows should be replaced with new steel windows that would be double glazed and finished in a polyester powder coat paint.

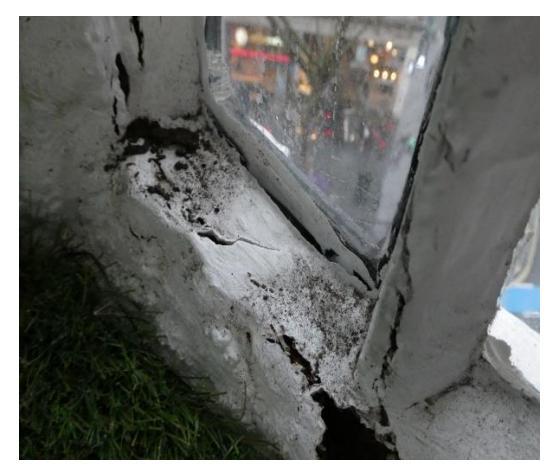
Photograph 34: Powdered rust originating from between the paint and frame setting on cill section.

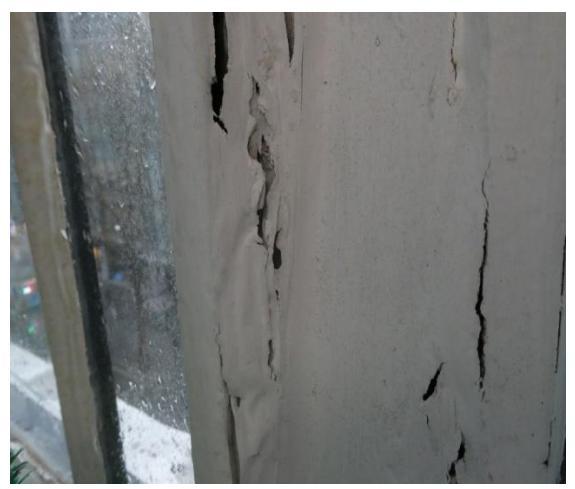
Photograph 35: The corroding steel frame sections are distorting and are splitting the paint.

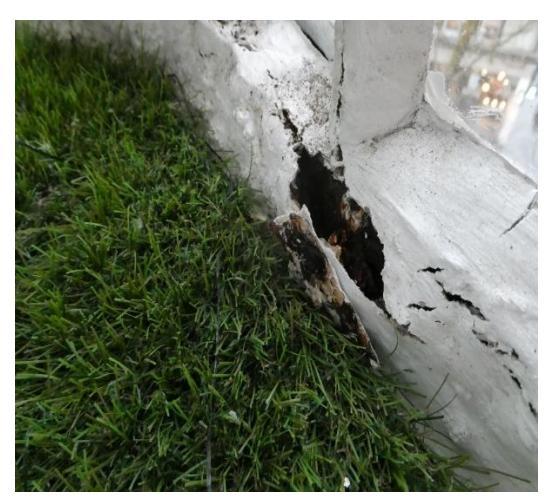
Photograph 36: Extensive rusting at a sill section.

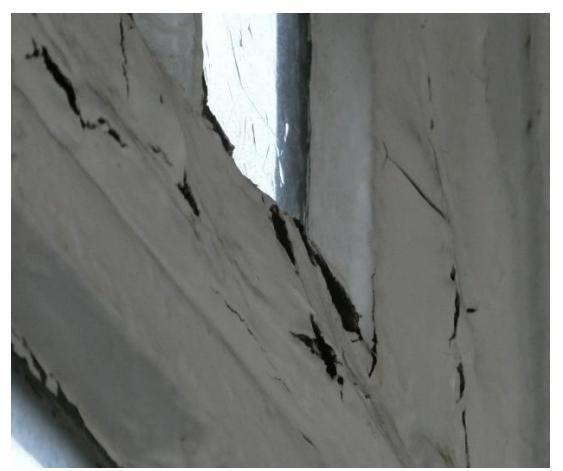
Photograph 37: Corroded transom and frae. The glass pane in this example has cracked.

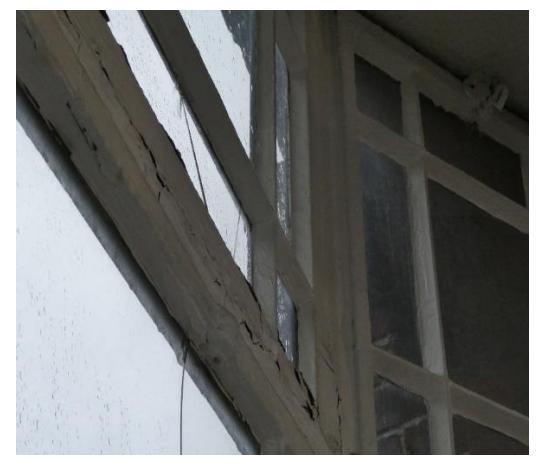
Photograph 38: Corroded frames and cracked glass.

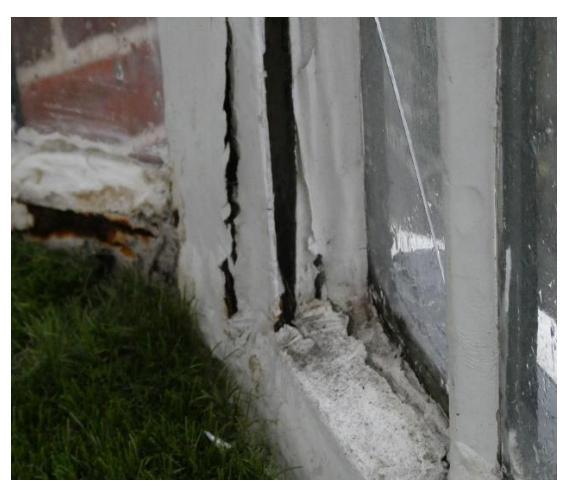
Photograph 39: Further example of extensive corrosion and glass which has cracked where the frame has distorted.

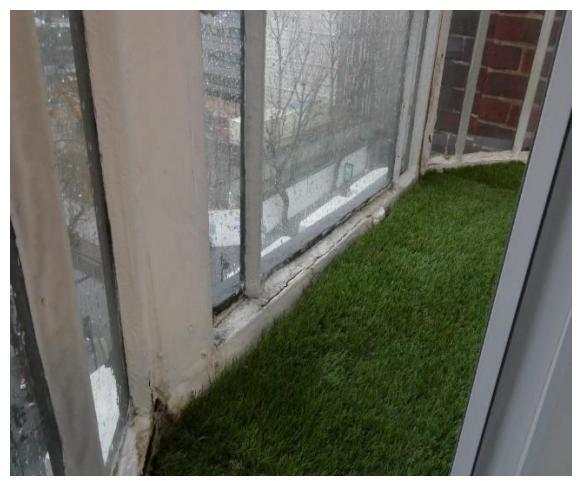
Photograph 41: Cill of a bay window which has been filled with putty and then overpainted.

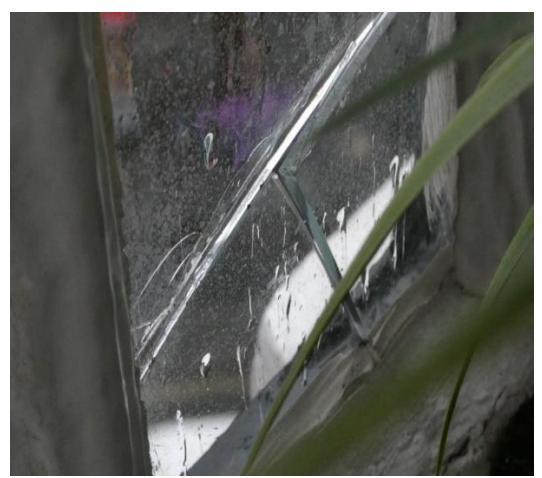
Photograph 40: Broken glass evident from the pressure exerted by the corroding and distorting steel framing.

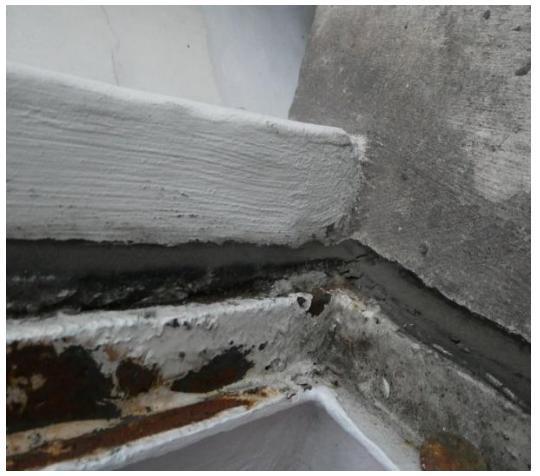
There is however corrosion evident to the window frames on the east and south elevations. Please refer to photographs 42-44.

In particular, the exposed surfaces of the opening side hung open out windows indicate that past repainting has been poorly applied with no attempt to remove rust from the frame surfaces before painting.

Photograph 42: The rust in this example had not been fully cleaned off prior to painting. This is also shown in photo 43.

In my opinion, it would not be economic undertake refurbishment of these windows. Instead, they should also all be replaced with new windows as described above.

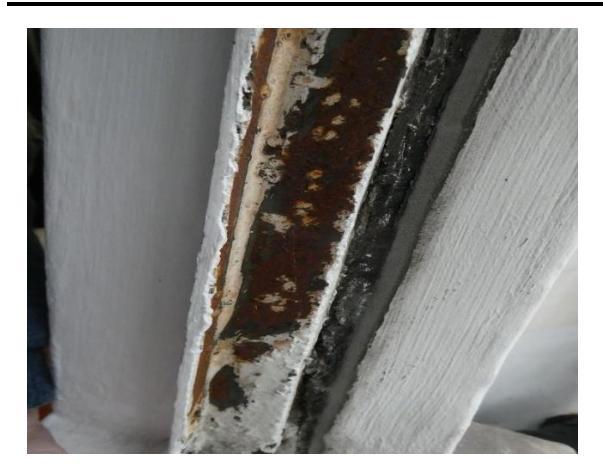
Photograph 43: Rust below paint where the surfaces were not prepared properly.

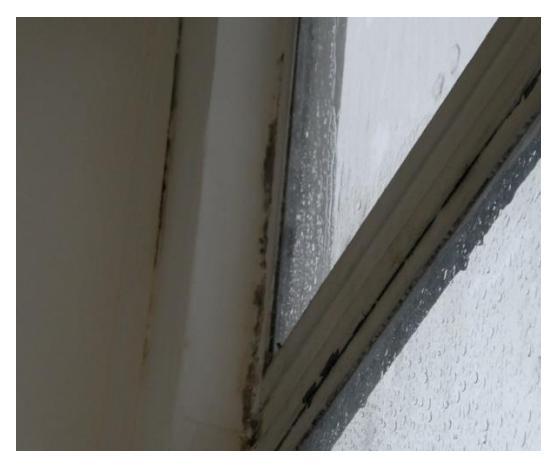
Photograph 44: Corroding window on south elevation.

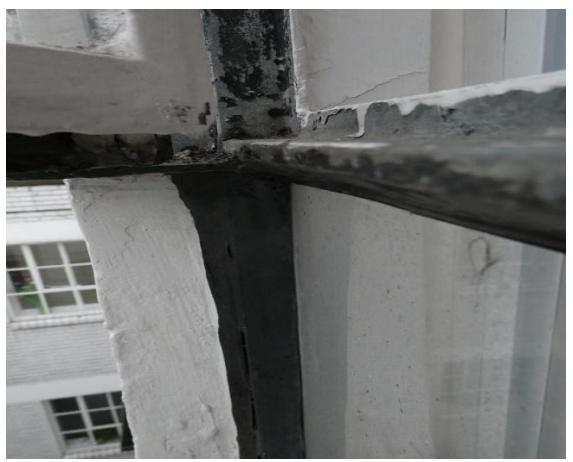
Photograph 45: Build-up of hardened paint affecting the closing operation of the window.

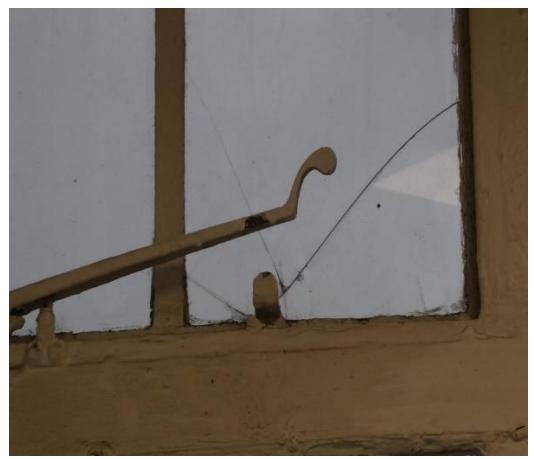
As with the west elevation, the corroding frame sections is resulting in some glass fractures. Please refer to photographs 46 and 47 at the end of this report.

Photograph 46: Fractured glass pane due to distortion in the steel framing.

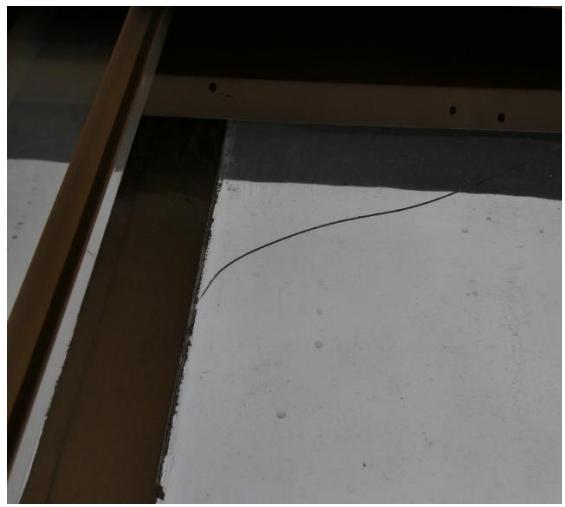
Photograph 47: Fractured glass pane.

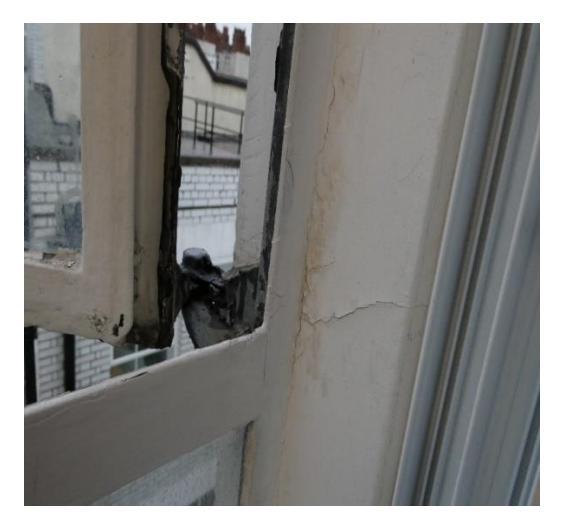
There is evidence of water stains to internal reveals and cills, which is an indication of local sealant failures at window to structure interfaces at the jamb and cill. Please refer to photographs 48 and 49.

Photograph 48: Water stains to a plaster reveal.

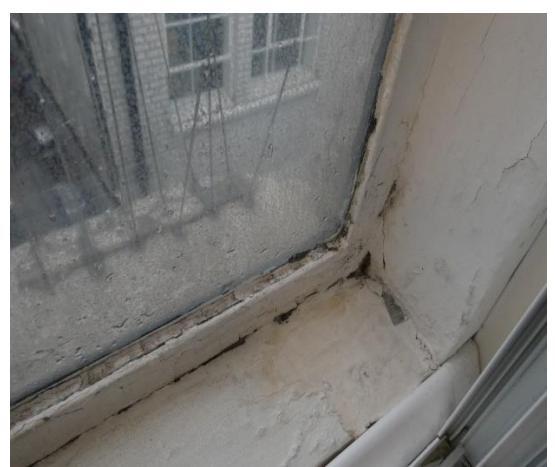
Photograph 49: Water stains below a fixed light panel.

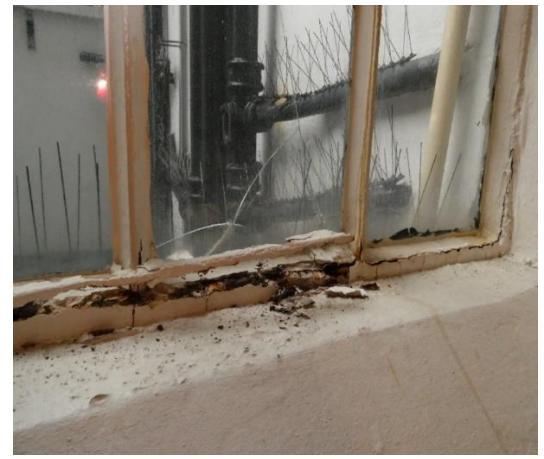
The windows to the upper areas of the rear staircase are generally in a very poor condition with extensive corroded frame sections and multiple panes of glass that have fractured because of the corroding steel frames.

In some instances, the corrosion is so advanced that part of the window frame is disintegrating. In other locations glass panes have fractured. Please refer to photographs 50 to 55 for examples.

Photograph 50: The cill section of this staircase window is disintegrating.

I, therefore, recommend that all the staircase windows are replaced with new steel windows that may not be required to be double glazed given their location, but they should be finished in a polyester powder coat paint finish.

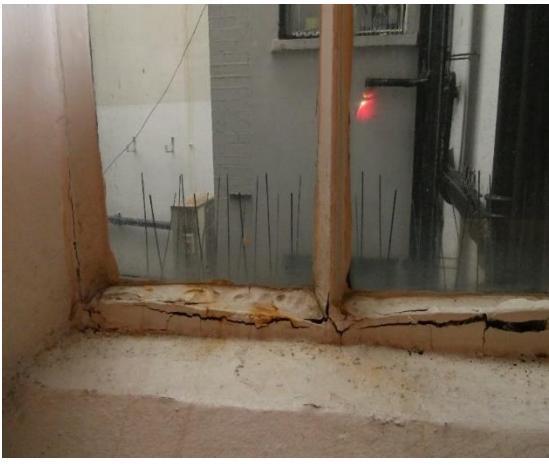
Photograph 51: Further example of extensive corrosion.

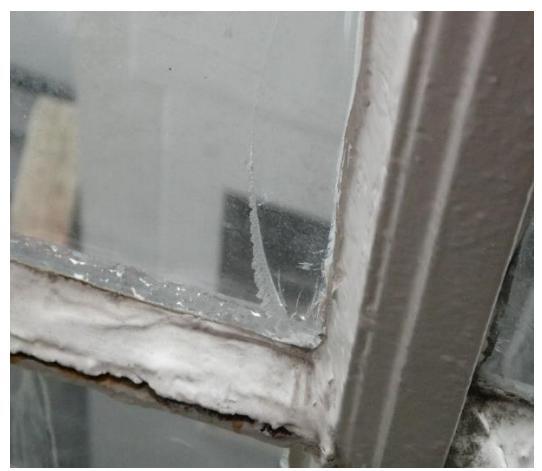
Photograph 52: Pressure fracture to a glass pane.

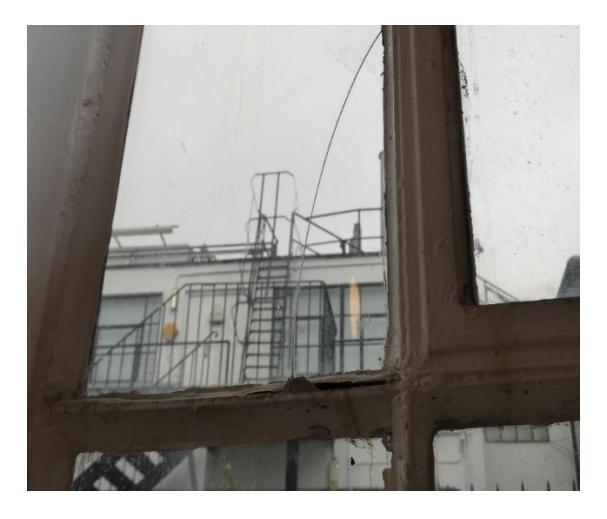
Photograph 53: Glass fracture from a corroded frame.

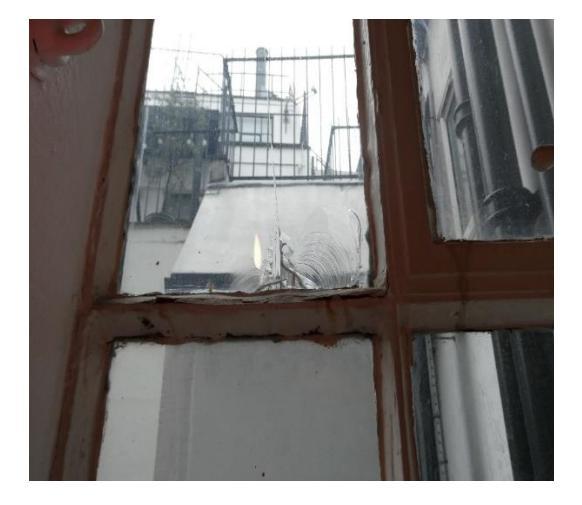
Photograph 54: Glass pane subject to pressure originating from a corroded section of frame which has spalled and fractured the glass.

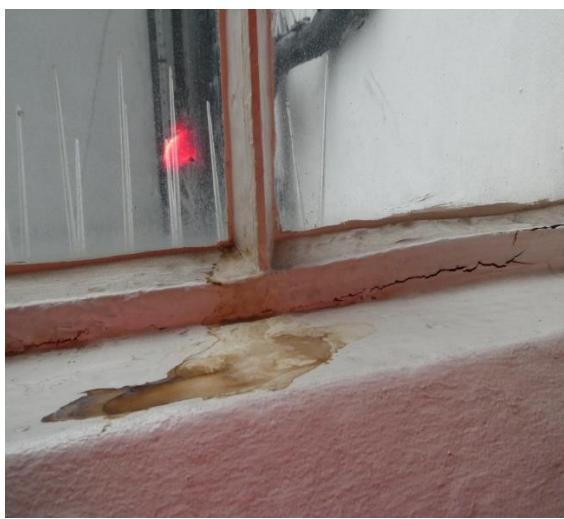
Photograph 55: Rust stained water that has penetrated though the failing external glazing putty.
