Arboricultural Implications Assessment

Proposed restoration and refurbishment works

4-6 Bedford Place

Date: March 2023

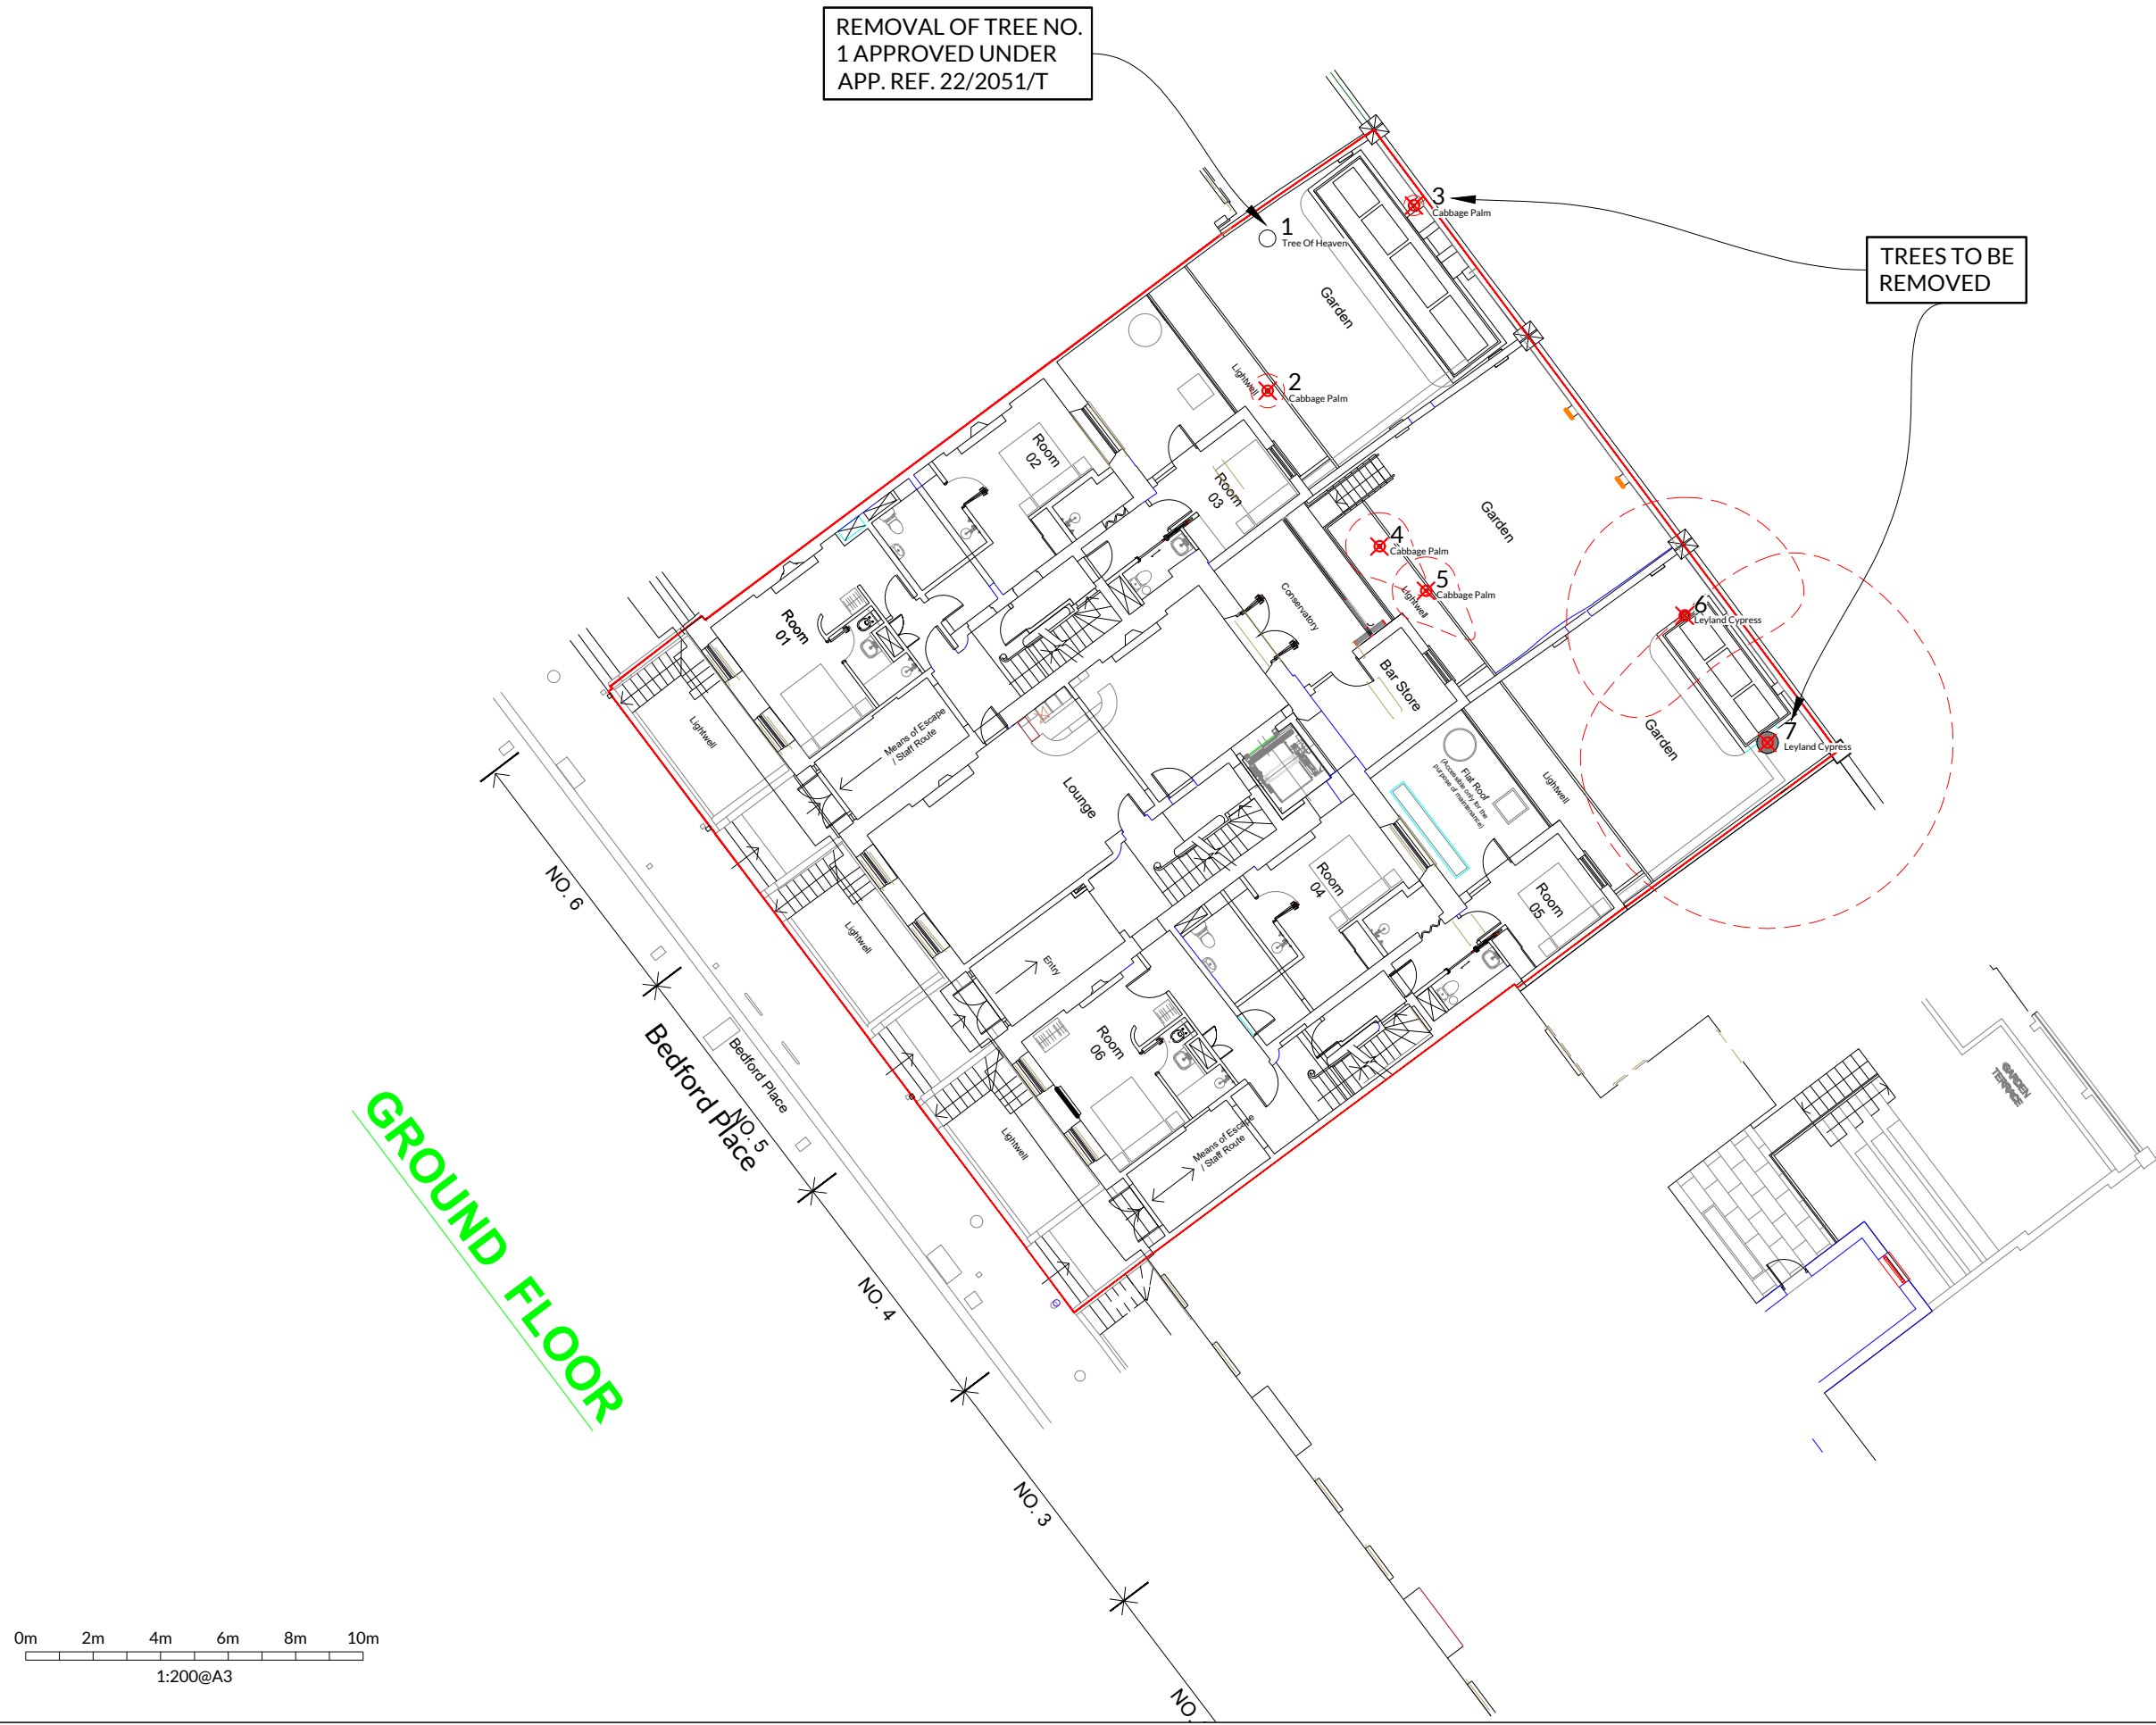
Drawing:
TREE REMOVALS PLAN

- 2.1.1 The tree removals plan ('TRP') at **Appendix 2** shows the ground floor plan of the finalized proposals overlaid onto the tree locations and constraints plan derived from the tree survey, and shows the implications of the scheme for the trees surveyed. The assessment below reflects this drawing.

- 2.2.1 The proposals will result in the removal of the remaining trees in the survey, as listed in *Table 1* below.

Tree no.	Species	Height	BS category	Work required	Reason for work
2	Cabbage Palm	6m	C	Remove	Provision of lightwell to lower ground/basement floor
3	Cabbage Palm	3m	C	Remove	Locations of air-source heat pumps
4-5	Cabbage Palm	3m-4m	C	Remove	Provision of lightwell to lower ground/basement floor
6-7	Leyland Cypress	11m & 16m	C	Remove	Locations of air-source heat pumps

- 2.3.1 The proposals are accompanied by a landscape master plan by Wright Landscape and Arboriculture Ltd., which envisages the planting of a total of ten replacement trees and tree-like larger shrubs, comprising 3no pleached Hornbeams in the rear garden of No. 6, 3no. Birches in the rear garden of No. 5, and a Judas Tree and 2no. Table Dogwood, together with a further Birch, in the rear garden of No. 4. To ensure adequate soil volumes for the planted trees, planting will be within a system of underground soil cells, thereby providing support to the proposed paved areas above.
