**The Hoo
17 Lyndhurst Gardens
Hampstead**

**Design & Access Statement
for Planning & Listed Building Consent
for the Southern Boundary Wall**

Revised March 2023

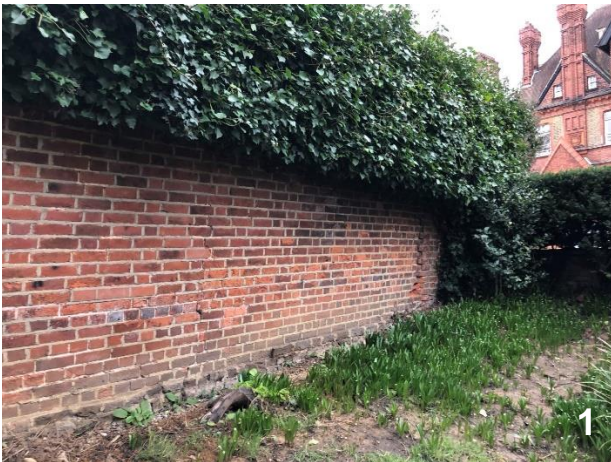
Investigations have shown that the boundary wall to the South of The Hoo is in a state of near collapse.

1. Image of existing dilapidated garden wall
2+3. Existing trees effectively supporting existing wall
4. Existing wall leaning towards neighbours garden

The proposals is to carefully remove the existing brick wall and replacing it with a new wall which will visually match the existing wall

Because the trees are not within the ownership of The Hoo, it will not be possible to carry out strip foundation excavations in the normal way. We propose to carefully insert 200mm diameter mini piles between the roots of the trees, linked by a concrete pile cap which will lie above the tree root depth zone. A reinforced concrete retaining wall built off this cap will be clad to the south in a single leaf skin of facing brickwork to match existing, up to The Hoo garden level, and above this, topped with the boundary wall in 13.5" brickwork. The visible south elevation of the wall will be rebuilt in a mixture of Flemish and English Garden Wall bond to match the existing wall. This upper part of the wall forms a guarding to The Hoo Annexe path way and will therefore be internally reinforced for structural integrity. A matching brick saddle coping will finish the wall.

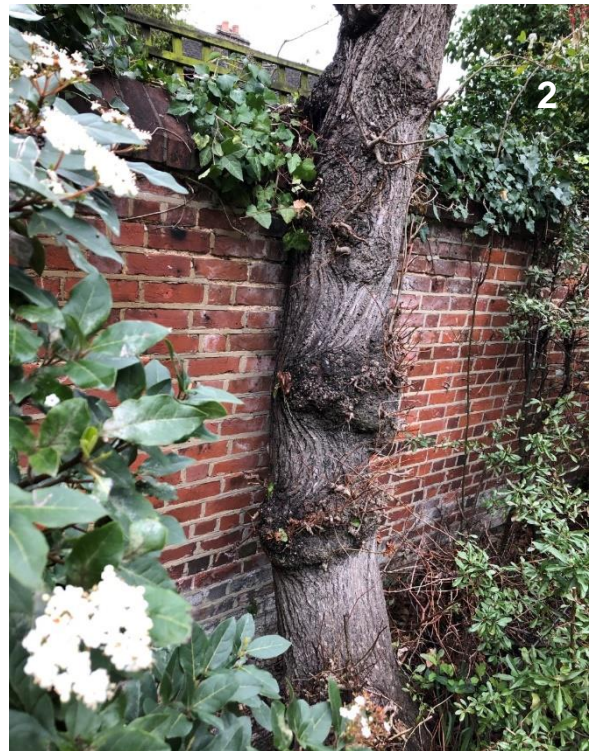
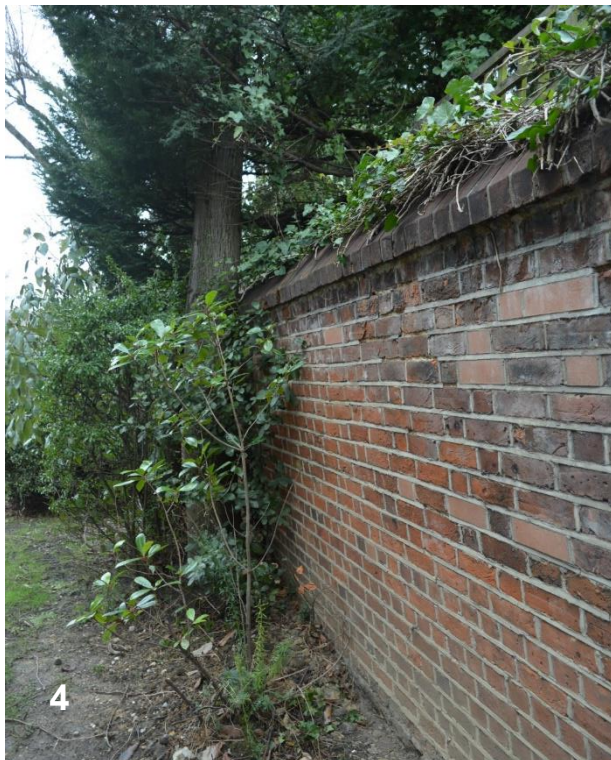
The wall, which is in the ownership of The Hoo, is a brick retaining wall holding up approximately 2 metres in level change rising to the North. The wall has been undermined by the profuse tree growth on both sides of the boundary. The wall is now effectively being held upright by the trees growing on the north side boundary of No.15 to the South. We have carried out careful trial excavations to determine the root zones and root locations of these trees in No.15's ownership.

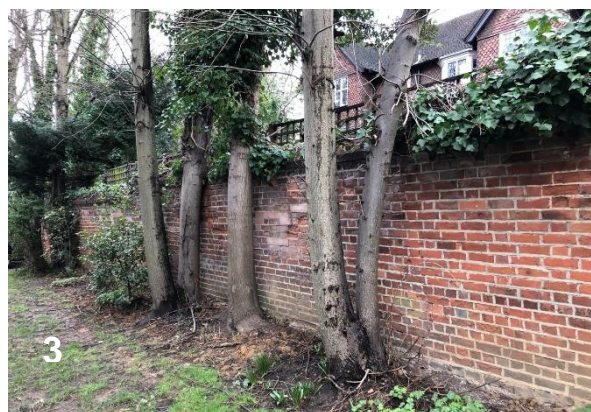
The existing wall is in a potential state of collapse and forms a danger to the adjacent residents
