**ARBORICULTURAL IMPACT ASSESSMENT REPORT FOR:**

83 Belsize Park Gardens  
London  
NW3 4NJ

**Ref:** SMR/83BPG/AIA/01a

**Date:** 5<sup>th</sup> April 2023

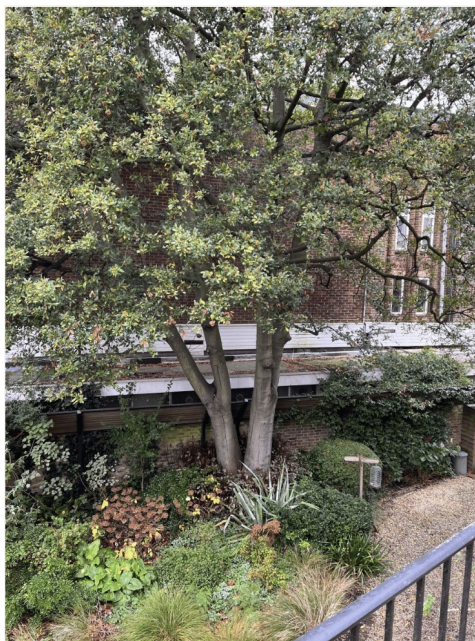
- 3.3.4 At the time of inspection, vertical cracks were evident on the stems of bay T1 and Ganoderma brackets were observed at its base. It is thus recommended that decay testing investigation be undertaken of this tree – the findings of which may affect the currently assessed B categorisation (moderate quality); i.e. it could conceivably be downgraded.

Photograph (i): Bay T1 taken from first floor rear balcony

- 3.3.5 Full details of the surveyed trees can be found in Appendix 1 of this report.
- 3.3.6 In addition to the further investigation of the bay T1 referred to above, there are recommended general husbandry works for the two hawthorn trees (T2 & T3) on the site frontage. These are listed in Appendix 2.

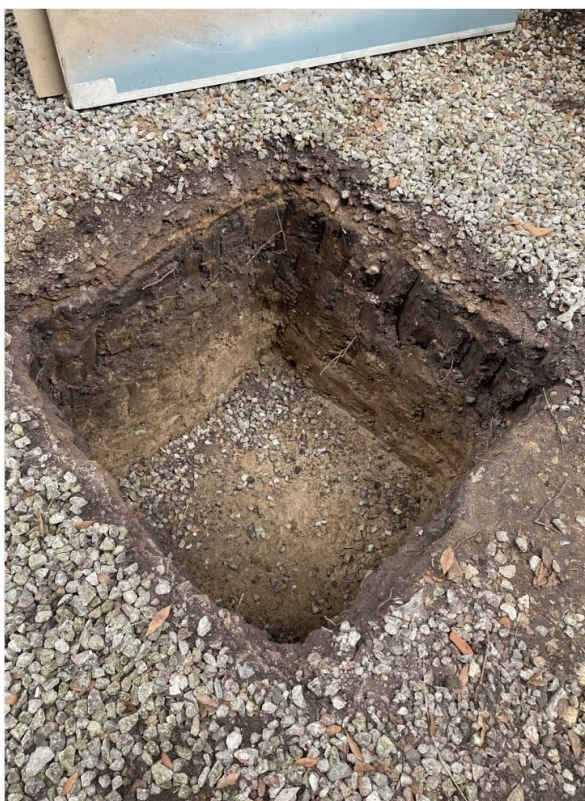
Photograph (ii): Trial pit

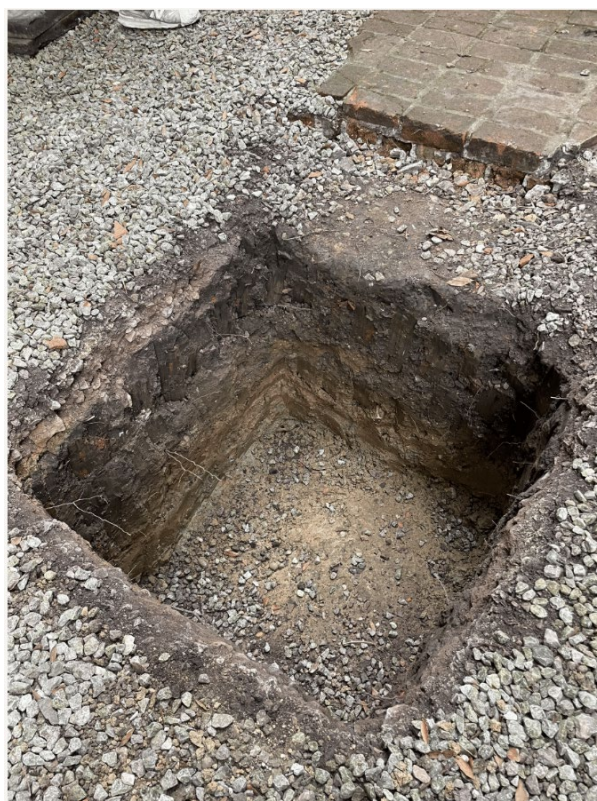
Photograph (iii) Trial pit
