2 HOLLY TERRACE: Applications covering changes on Highgate West Hill side - 2023/1725/L and 2023/1505/P

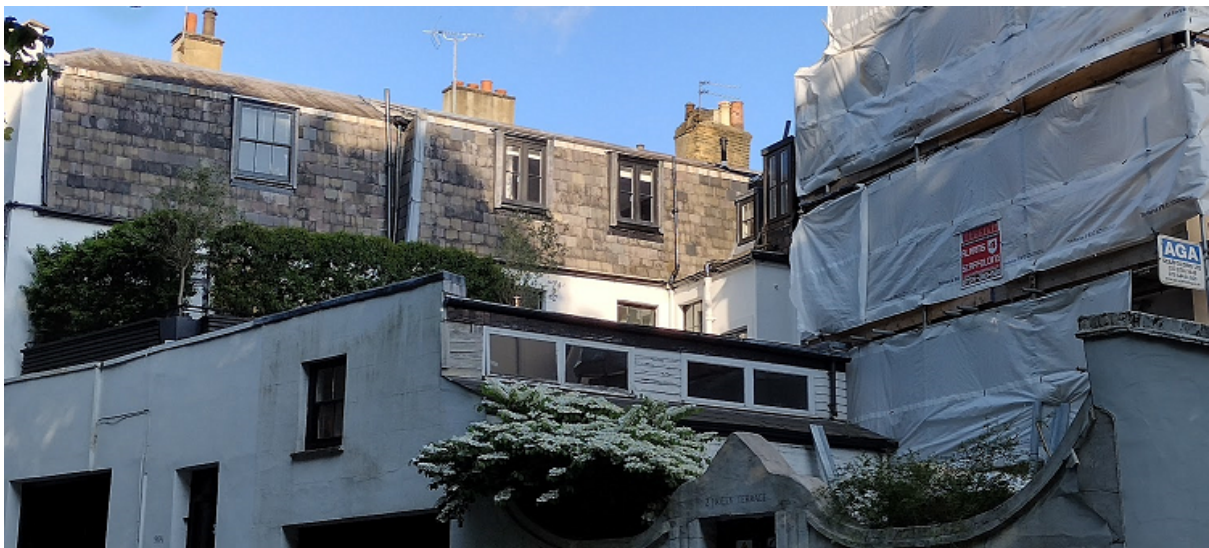
The flat roof membrane and external cladding on the side of the roof are to be replaced. New wood cladding may look quite different and more substantial than the existing given what a poor state it is in now:
