1. INTRODUCTION

INDEPENDENT REVIEW OF BASEMENT IMPACT ASSESSMENT

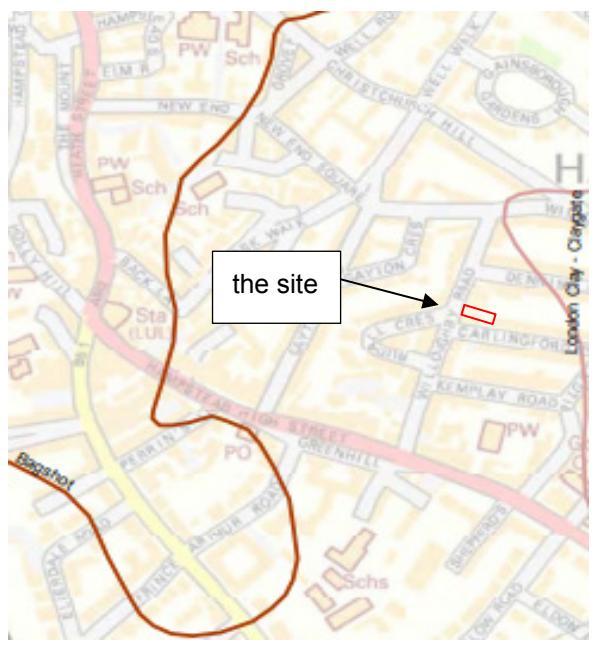
CORRECT POSITION OF THE SITE

A: Yes. The site is located directly above an aquifer.

The British Geological Survey clearly shows the site to be located on the Claygate and not on the London Clay. The red circle shown on Figure 2.2-1 of the BIA has been incorrectly centred some 40m to the south and east of the site, giving the incorrect impression that the site lies at the boundary of the Claygate Member and the London Clay. The Claygate is an acknowledged aquifer that has given rise to substantial hydrogeological issues in the area.

The blue red circle shown on Figure 2.3-1 of the BIA has been incorrectly centred over 100 m to the north and east of the site, giving the incorrect impression that the site lies over unproductive strata and not over an aquifer.

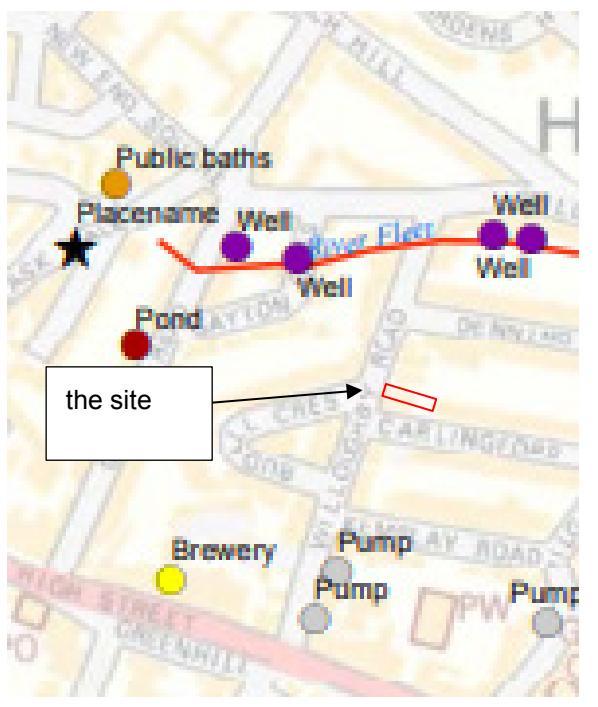
A: Yes. The site is <70m from a watercourse, well (used/disused) or potential spring line.

The BIA has misleadingly consulted only a small scale map of watercourses (Figure 2.4-1). Reference to the larger scale Fig 2 of the CGHHS shows the site to be less than 70m from a tributary of the River Fleet and a study old maps show that that there are historic wells and pumps nearby.

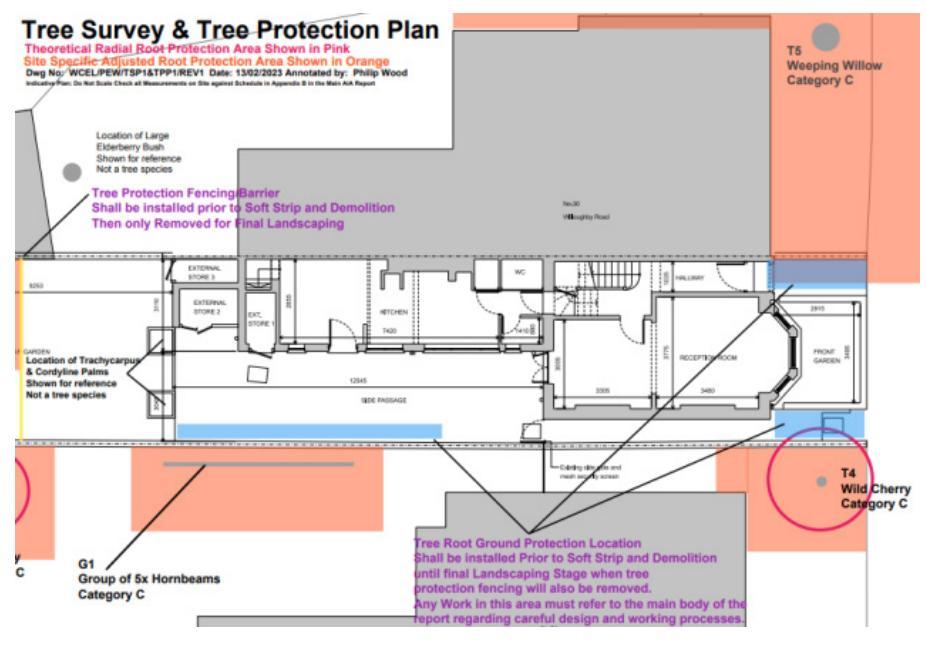
A: Yes. The arboricultural report acknowledges that excavations may affect the roots of three trees/tree groups T4, T5 and G1.

The guidance advises that the soil moisture deficit associated with felled tree will gradually recover. In high plasticity clay soils (such as London Clay) this will lead to gradual swelling of the ground until it reaches a new value. This may reduce the soil strength which could affect the slope stability. Additionally the binding effect of tree roots can have a beneficial effect on stability and the loss of a tree may cause loss of stability.
