# ARBORICULTURAL IMPACT ASSESSMENT REPORT FOR:

20 Crediton Hill London NW6 1HP

Ref: SCA/20CDH/AIA/01a

Date: 19th May 2023

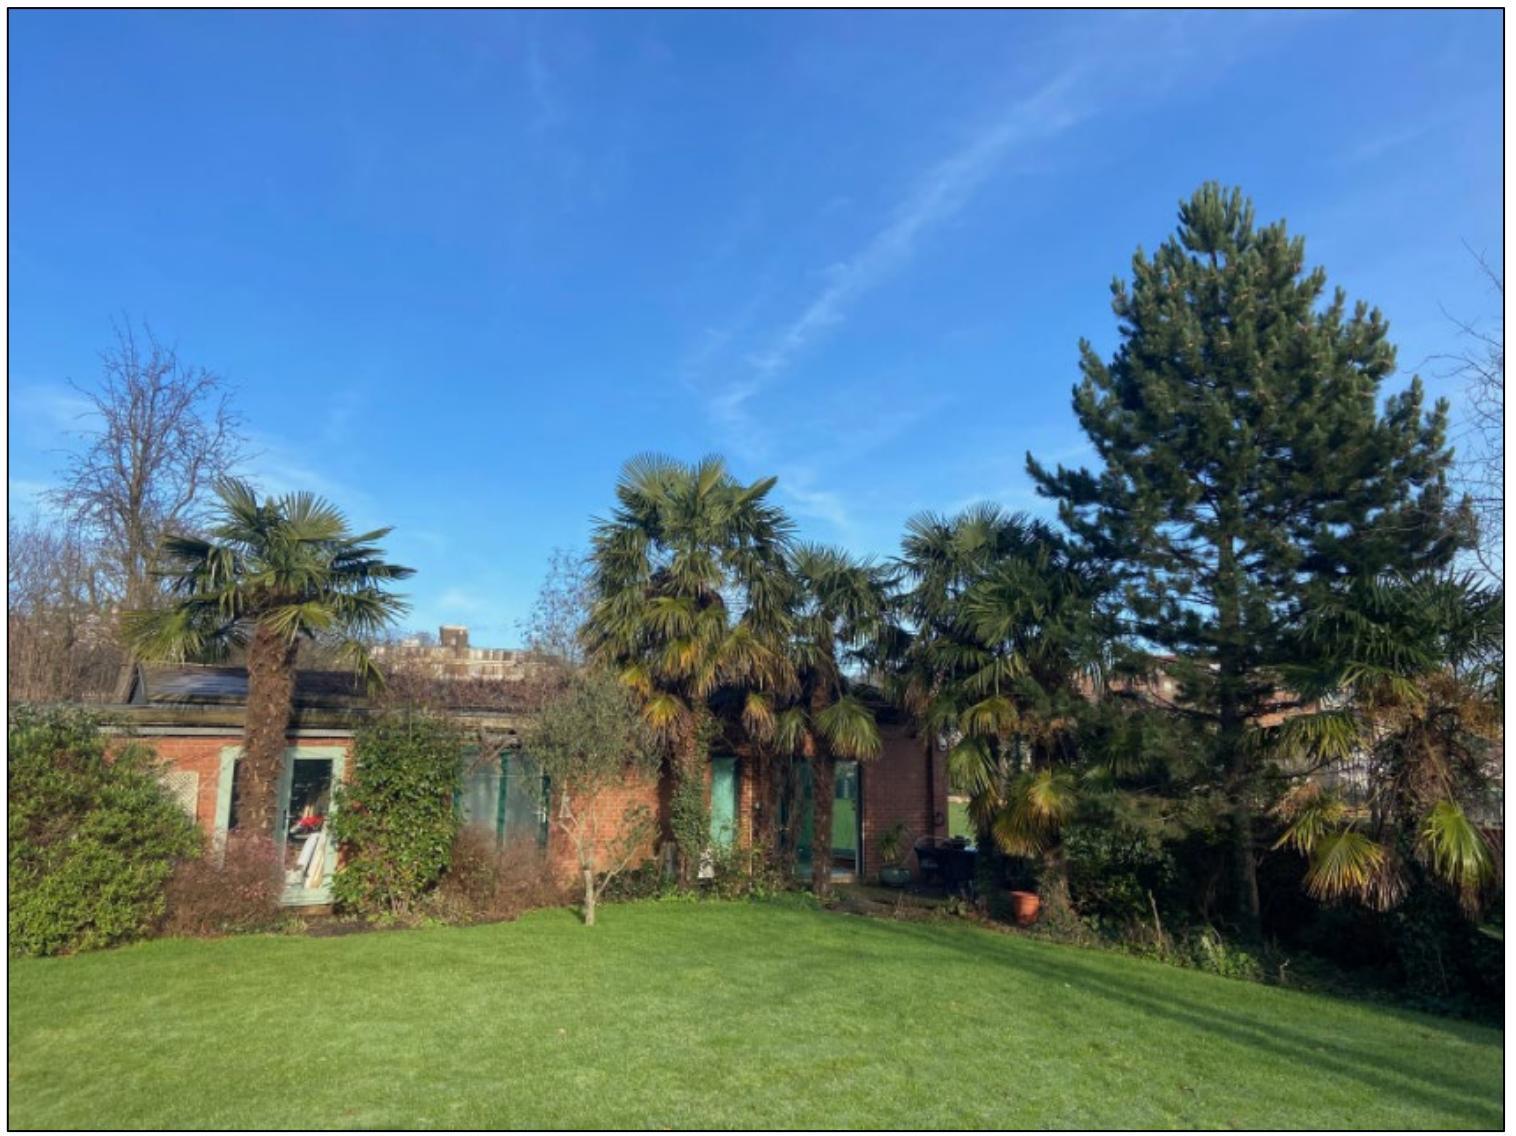
Photograph 2: G6 with T7 on right

- 6.1.3 It may be necessary to fell the closest members of G6 for construction access but, as noted at 3.3.2, these are not technically trees. The applicant will endeavour to preserve as much existing vegetation as possible and otherwise robustly replace with new plants). Very minor tip pruning of the off-site false acacia T2 may be required to provide overhead clearance to piling equipment so there will be at most a very low amount of canopy cover lost. The immediate reduction in canopy cover through felling and / or pruning is therefore rated as a very low impact unlikely to harm either the resource or the wider conservation area. It should be noted that these impacts would be the same as for the consented scheme.

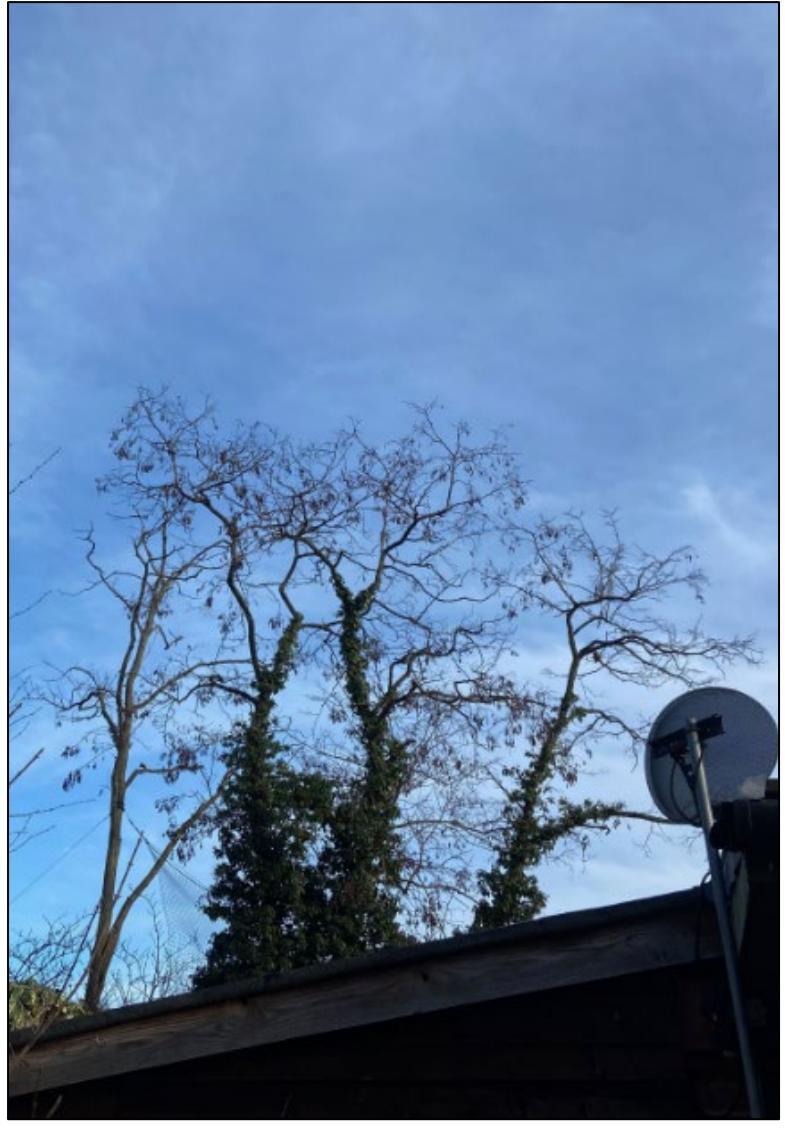
Photograph 3:Off-site false acacia T2

- 6.1.5 The principal impacts in the current proposals to the retained trees comprise the encroachments into the 'nominal circle RPA' of false acacia T2 and some of Chusan palm G6 by. However, these theoretical incursions would be beyond the 2.2m deep foundations of the existing buildings, so there is likely to be no impact in practice. It will also be noted that these impacts would be the same as for the partially implemented consented scheme.

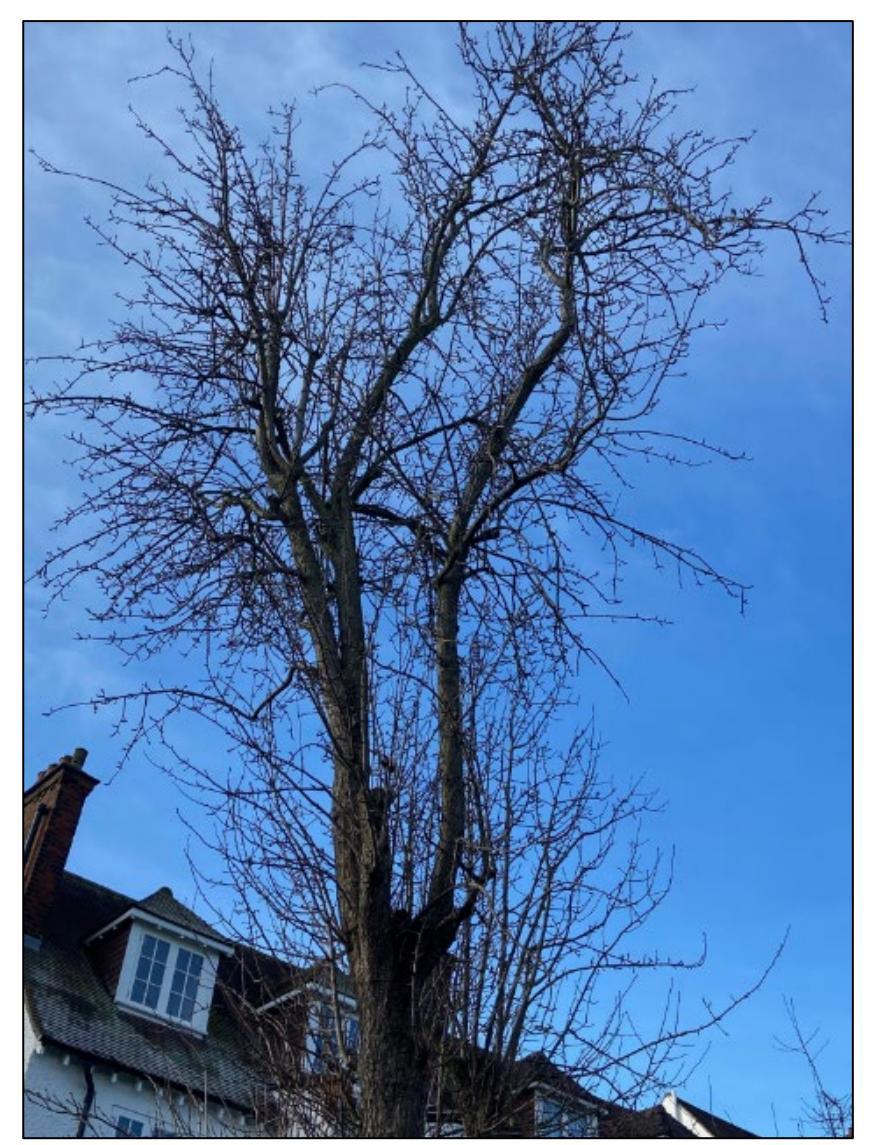
- 3.3.4 Full details of the surveyed trees can be found in Appendix 1 of this report.
- 3.3.5 There are recommended works for the pear T1 that are considered prudent regardless of development proceeding. These are listed in Appendix 2.

Photograph 4: Pear T1
