VAULT 02 EXISTING SITE PHOTOS

VAULT 03 EXISTING SITE PHOTOS

PROPOSED VAULTS PLAN

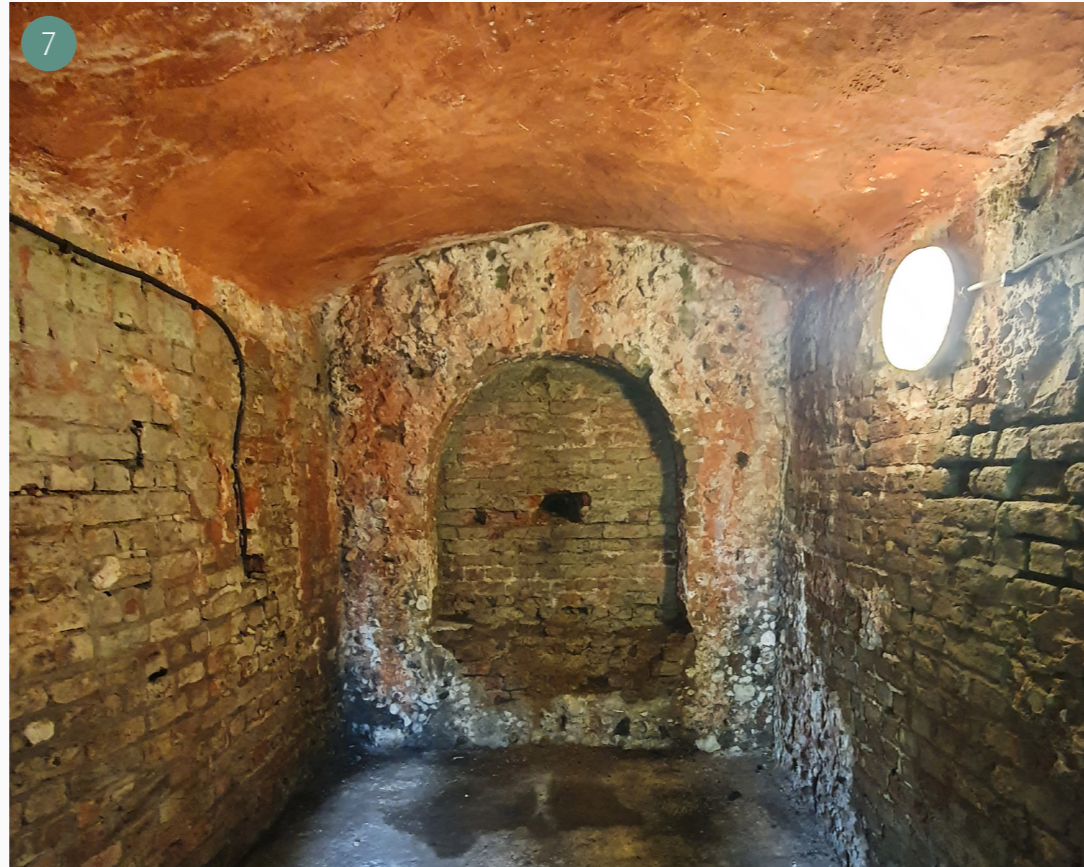
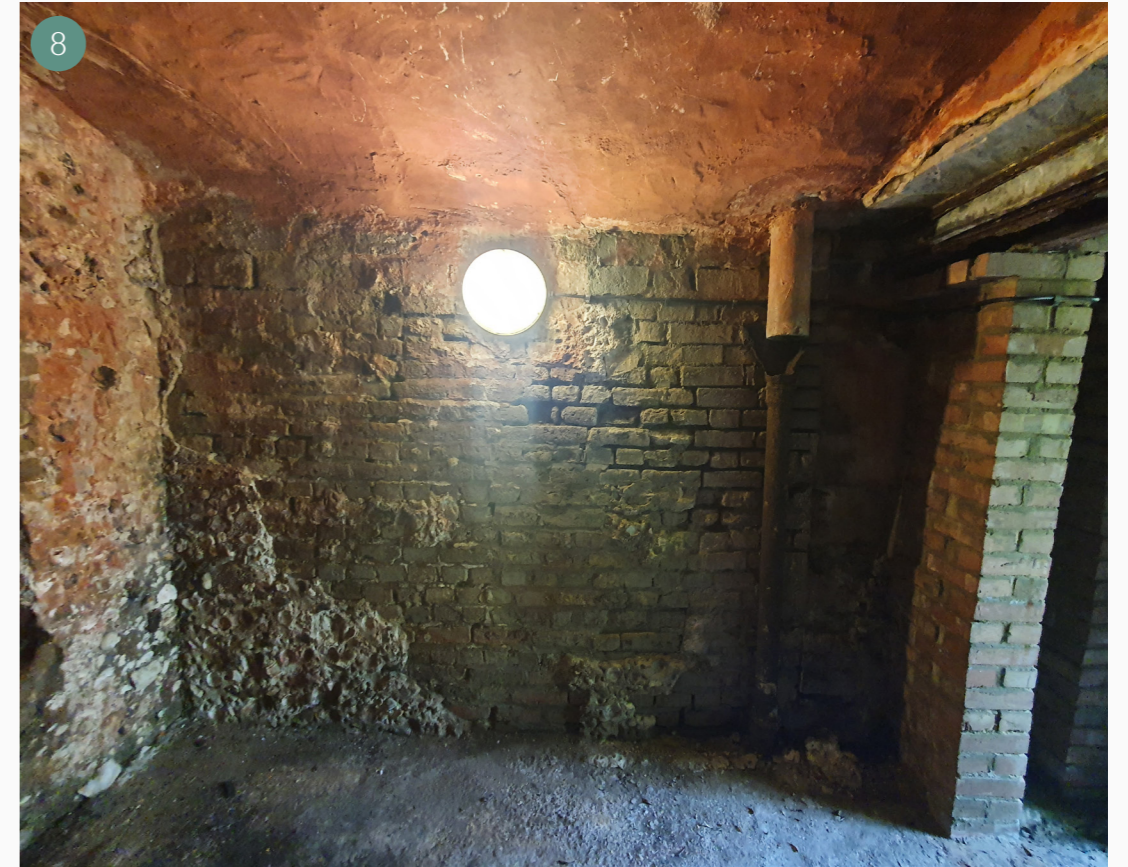
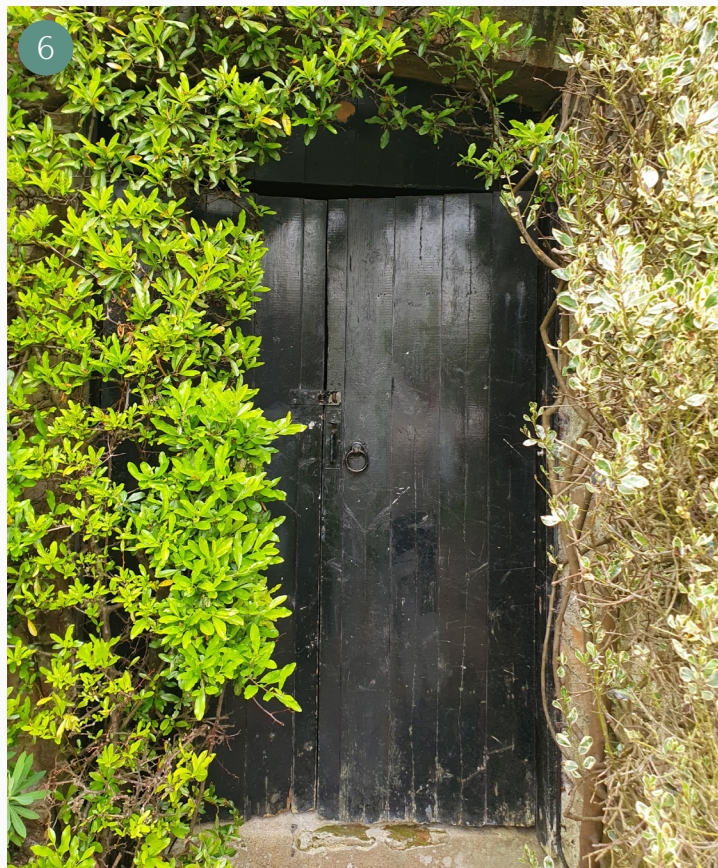
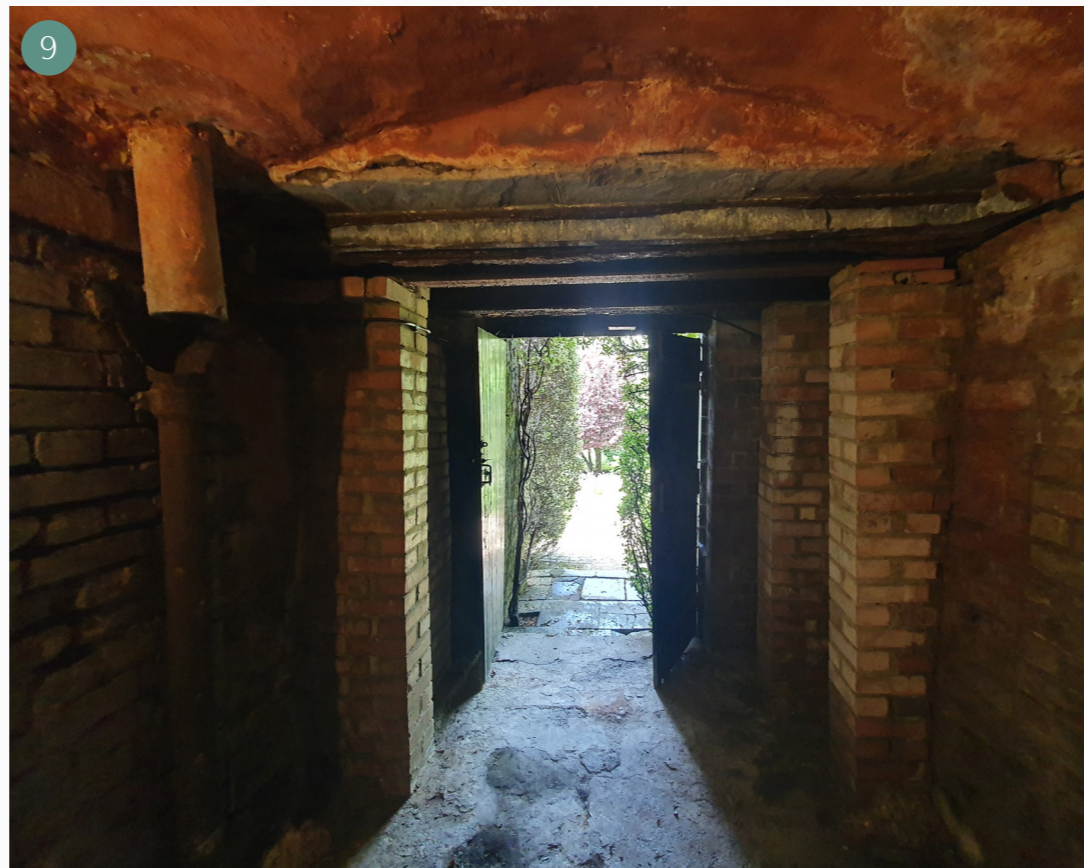
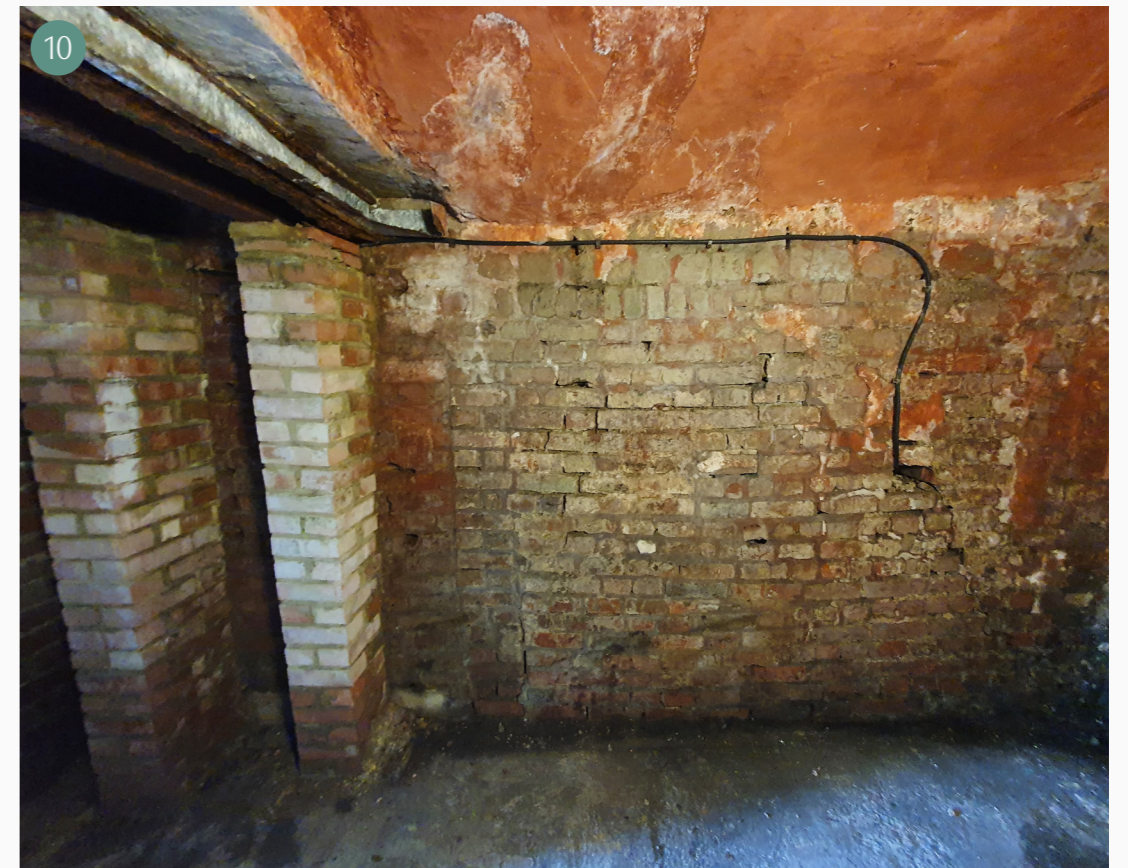
Vault 02 is modest in size and has existing power connections. Non-historic brick piers support a series of steel beams towards the entrance of the vault.

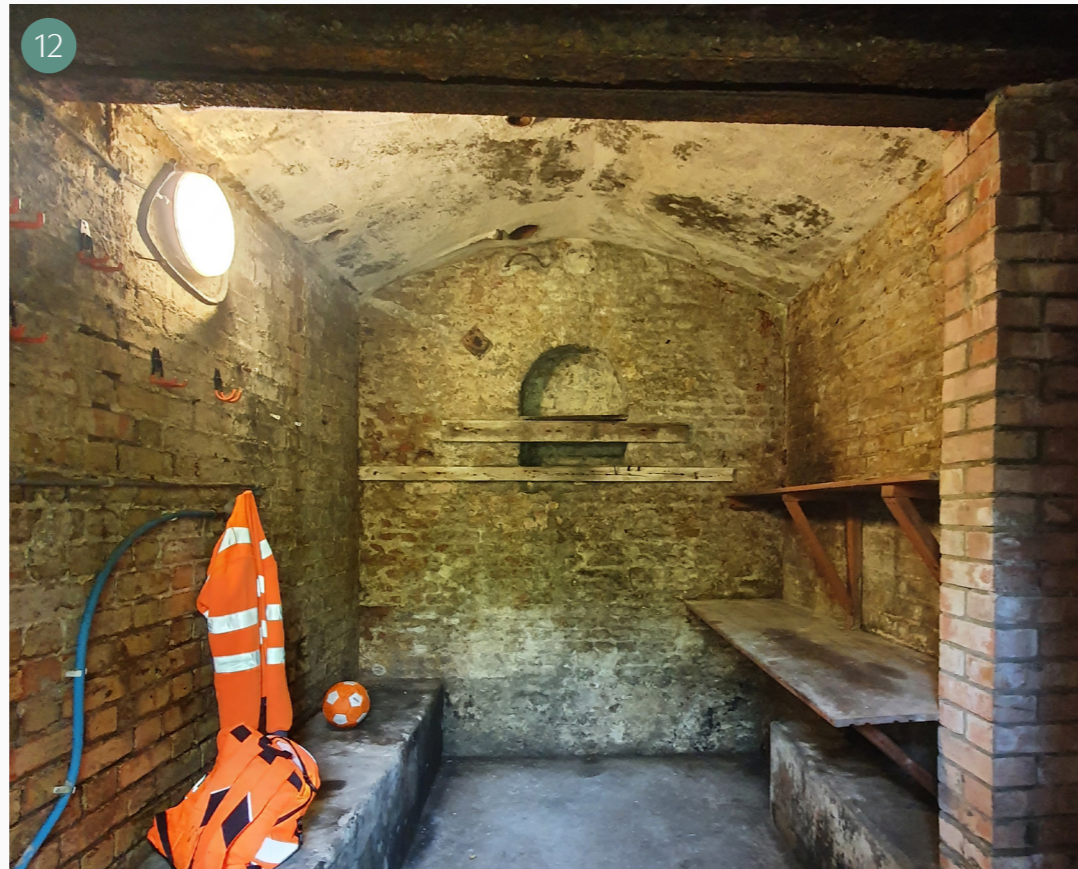
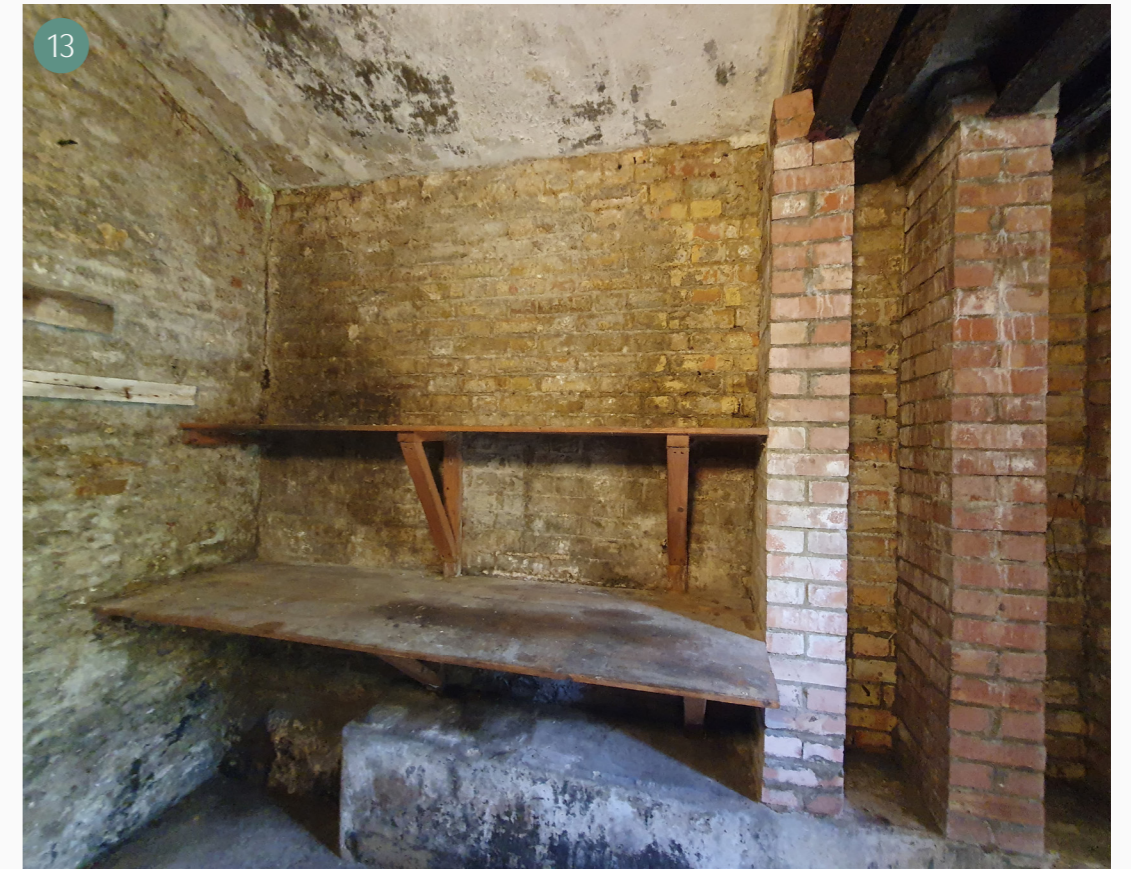
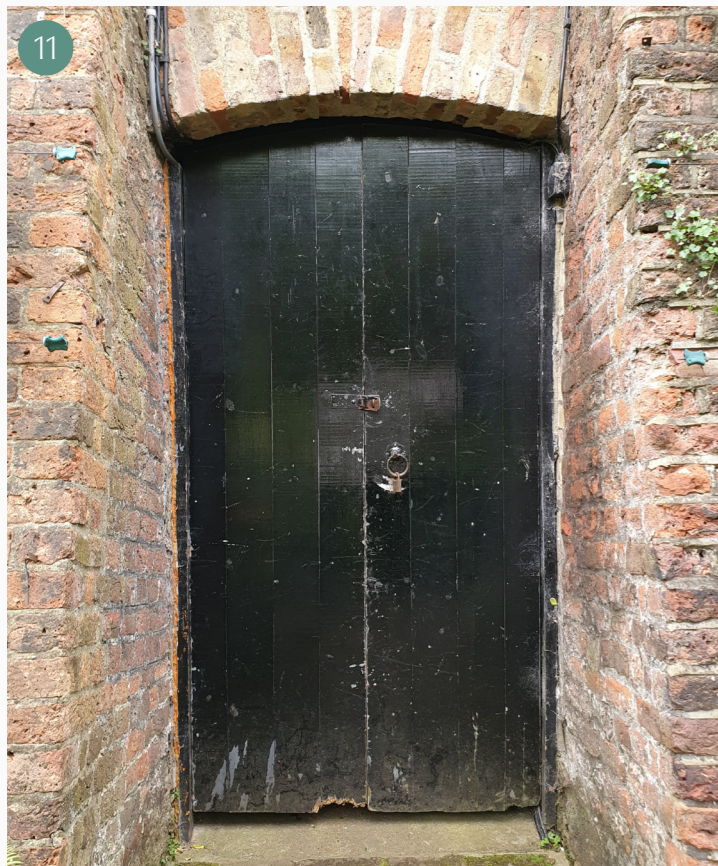
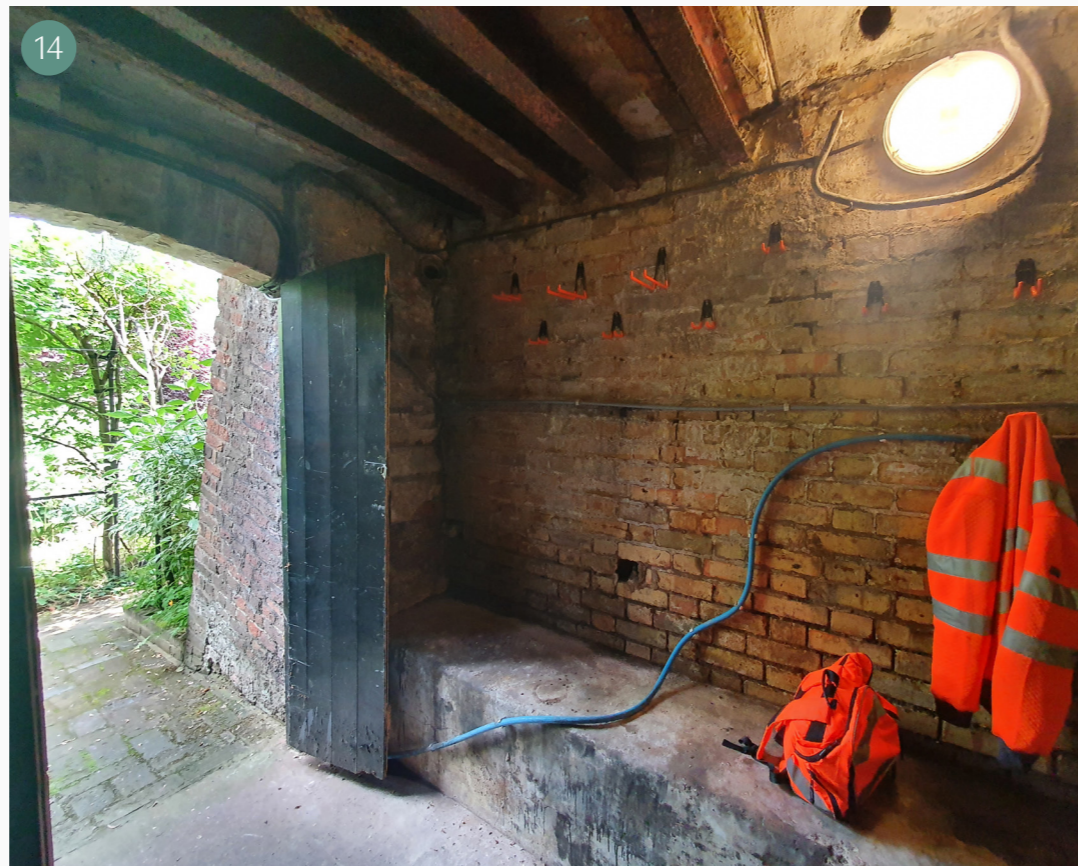
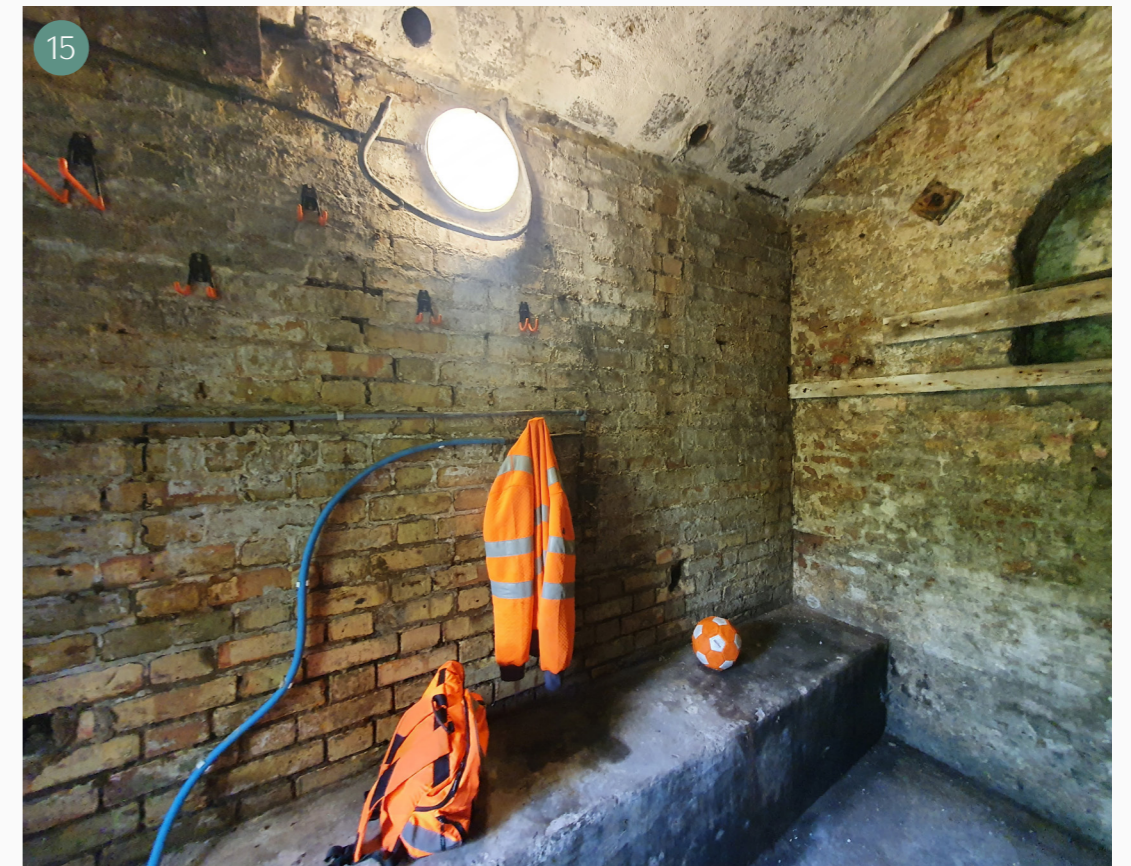
Similar to the previous vault, Vault 03 is modest in size and has existing power connections. Non-historic brick piers support a series of steel beams towards the entrance of the vault.

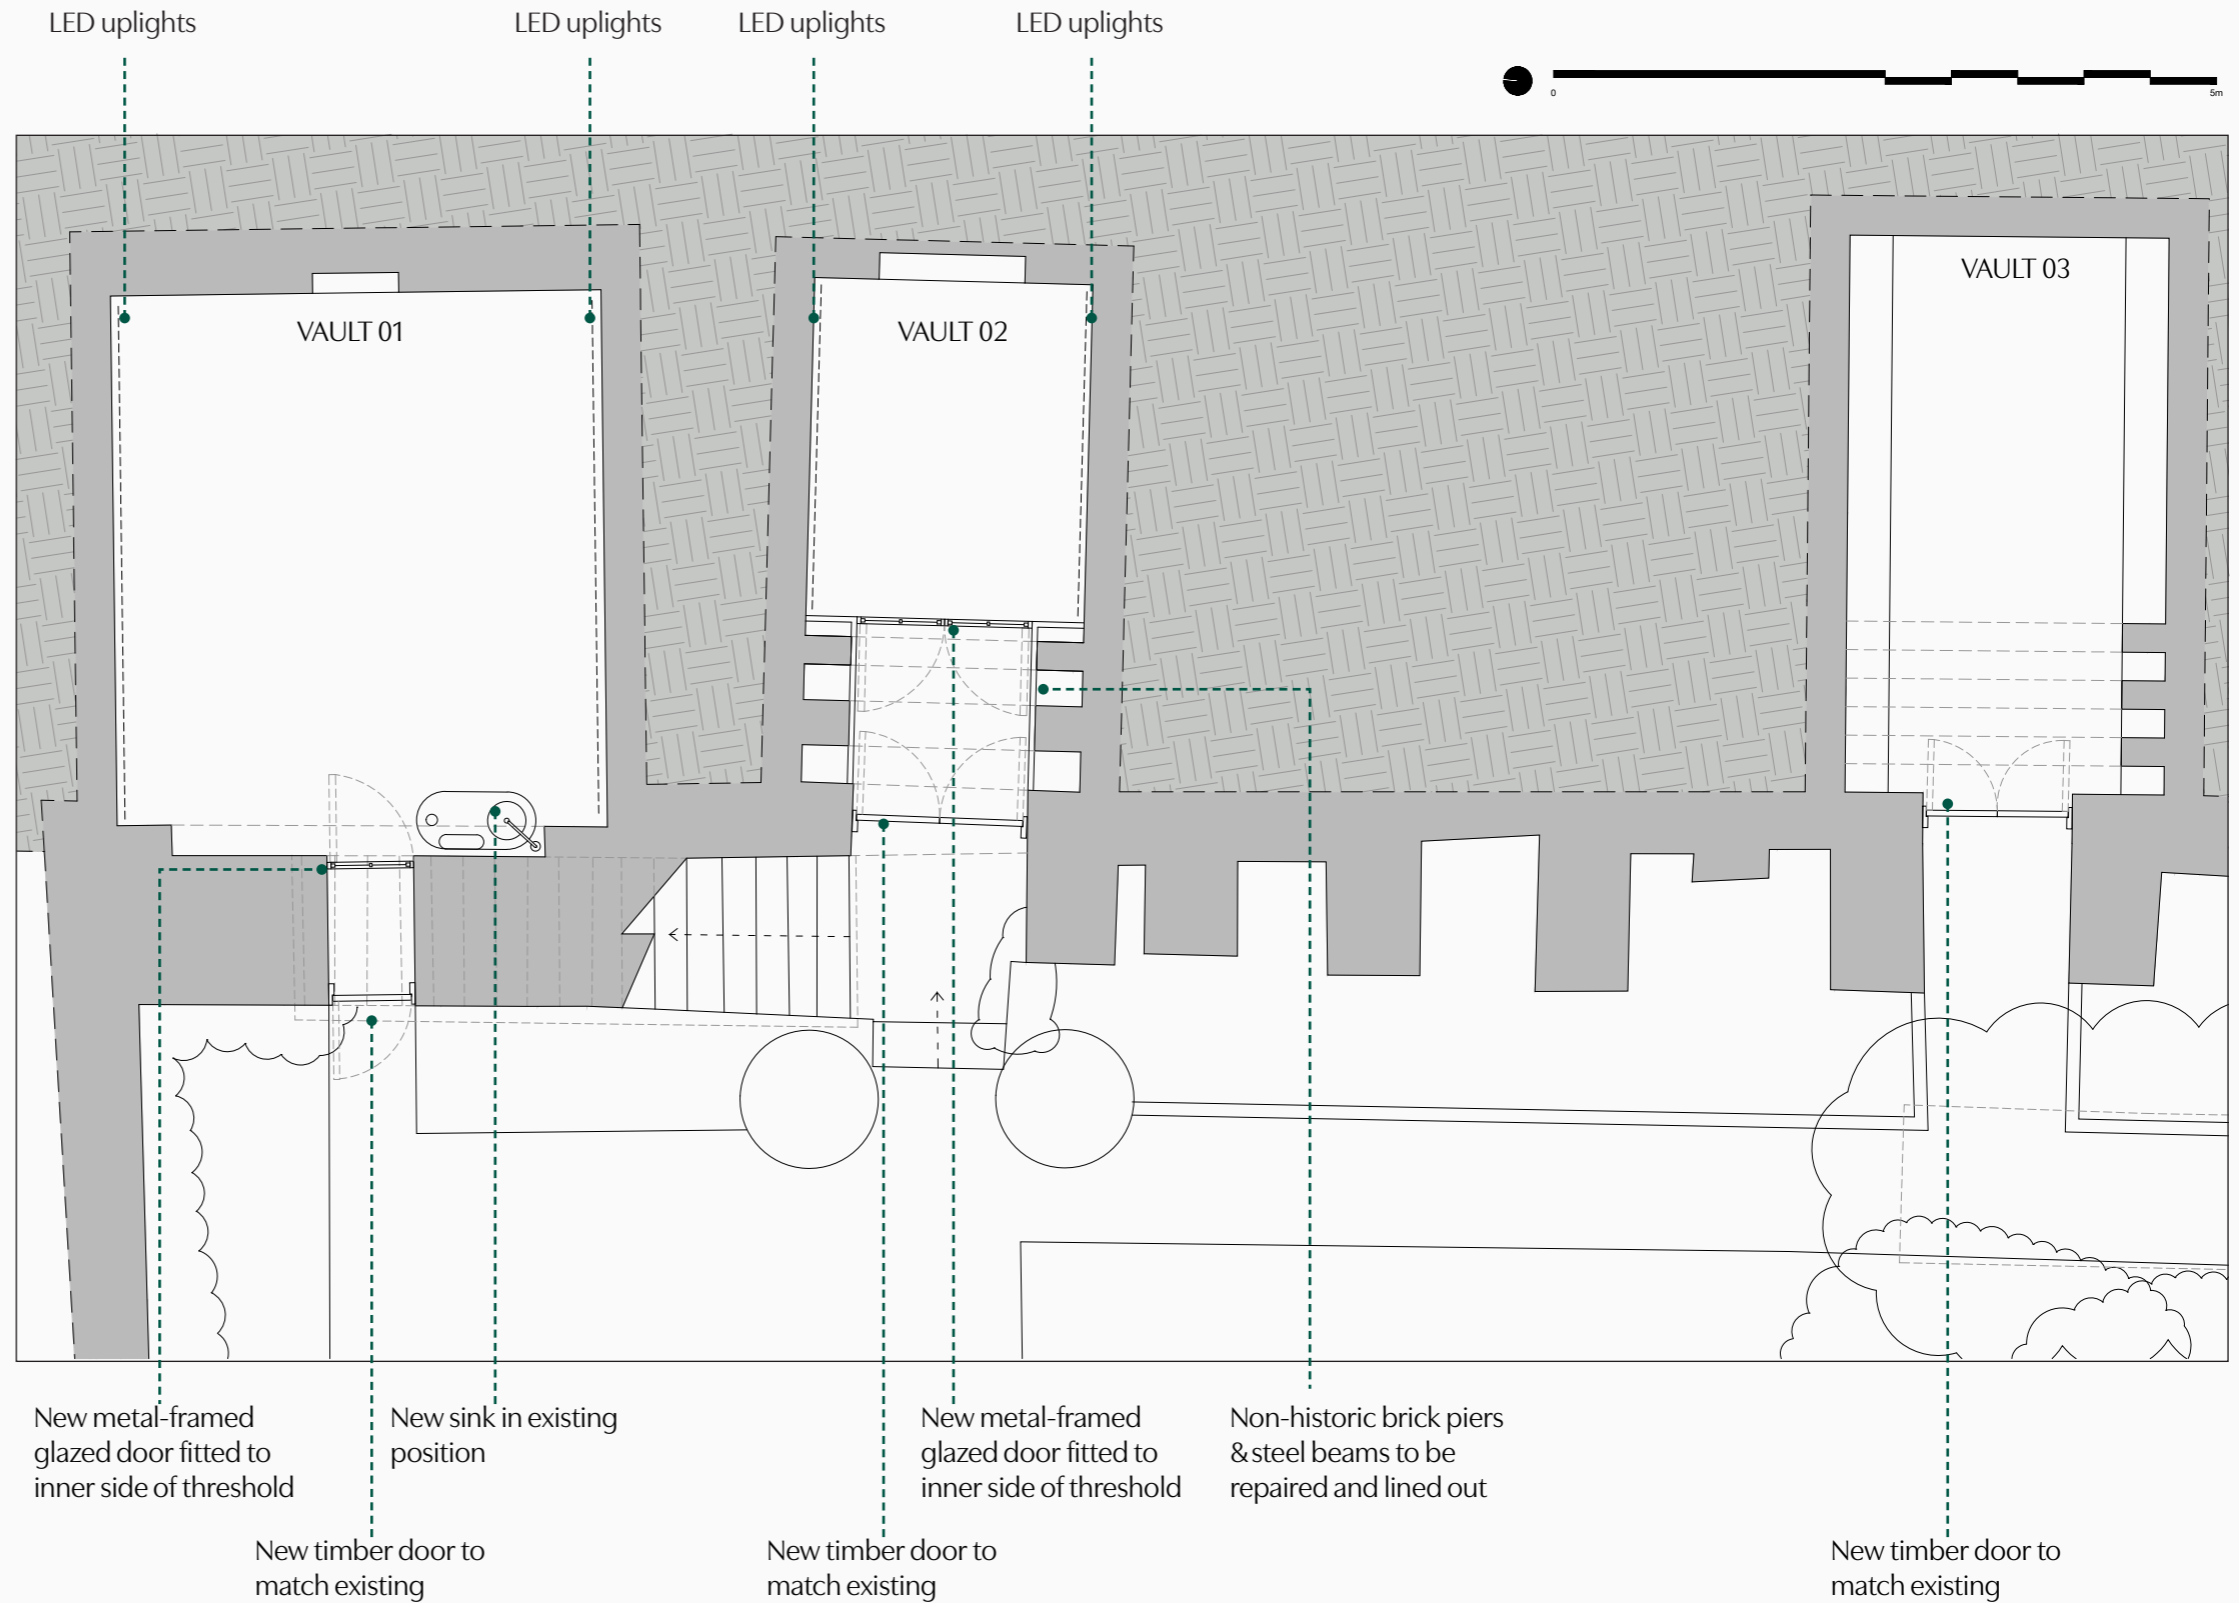
The existing painted timber doors are in a very poor condition and are proposed to be replaced on a like-for-like basis.

The proposal seeks to restore the three vaults into a useful and dryer state.

To preserve the visual character of the vaults a masonry injection system has been proposed to reduce water ingress in the vaults, please refer p.38 for further details. This approach to reducing water ingress will have no visual impact on the internal brickwork, which will then be repaired and repointed with lime mortar.

Repairs are proposed to the floor in each vault to level and reduce water ingress in the non-original screed floor.

To be sympathetic to the vaulted ceiling, cables and lighting are proposed to be moved into the floor leaving the walls and ceiling clear of as much wiring as possible.

In addition, internal opening metal-framed doors are proposed for Vaults 01 & 02 to allow natural light into the vaults when in use. The glazed doors are to be designed to match the detailing of the proposed summer house.
