35 Greville Road  
London NW6 5JB

Basement Impact Assessment  
Audit

For  
London Borough of Camden

Project Number: 12066-62  
Revision: F1

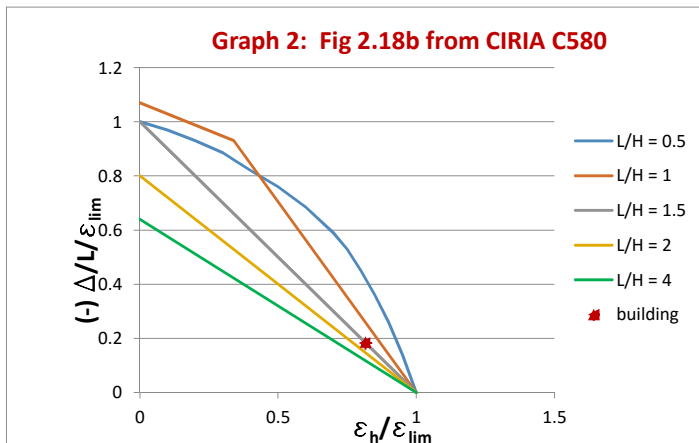
values above used for Graph 1, GMA - 2 (separate sheet)

For this building, L/H is 1.33. On Graph 2, the plot line for this will be between the plots for L/H = 1 and L/H = 1.5. The plot point for the building (in red), would fall below this, thus the max Damage Category is less than Category 2

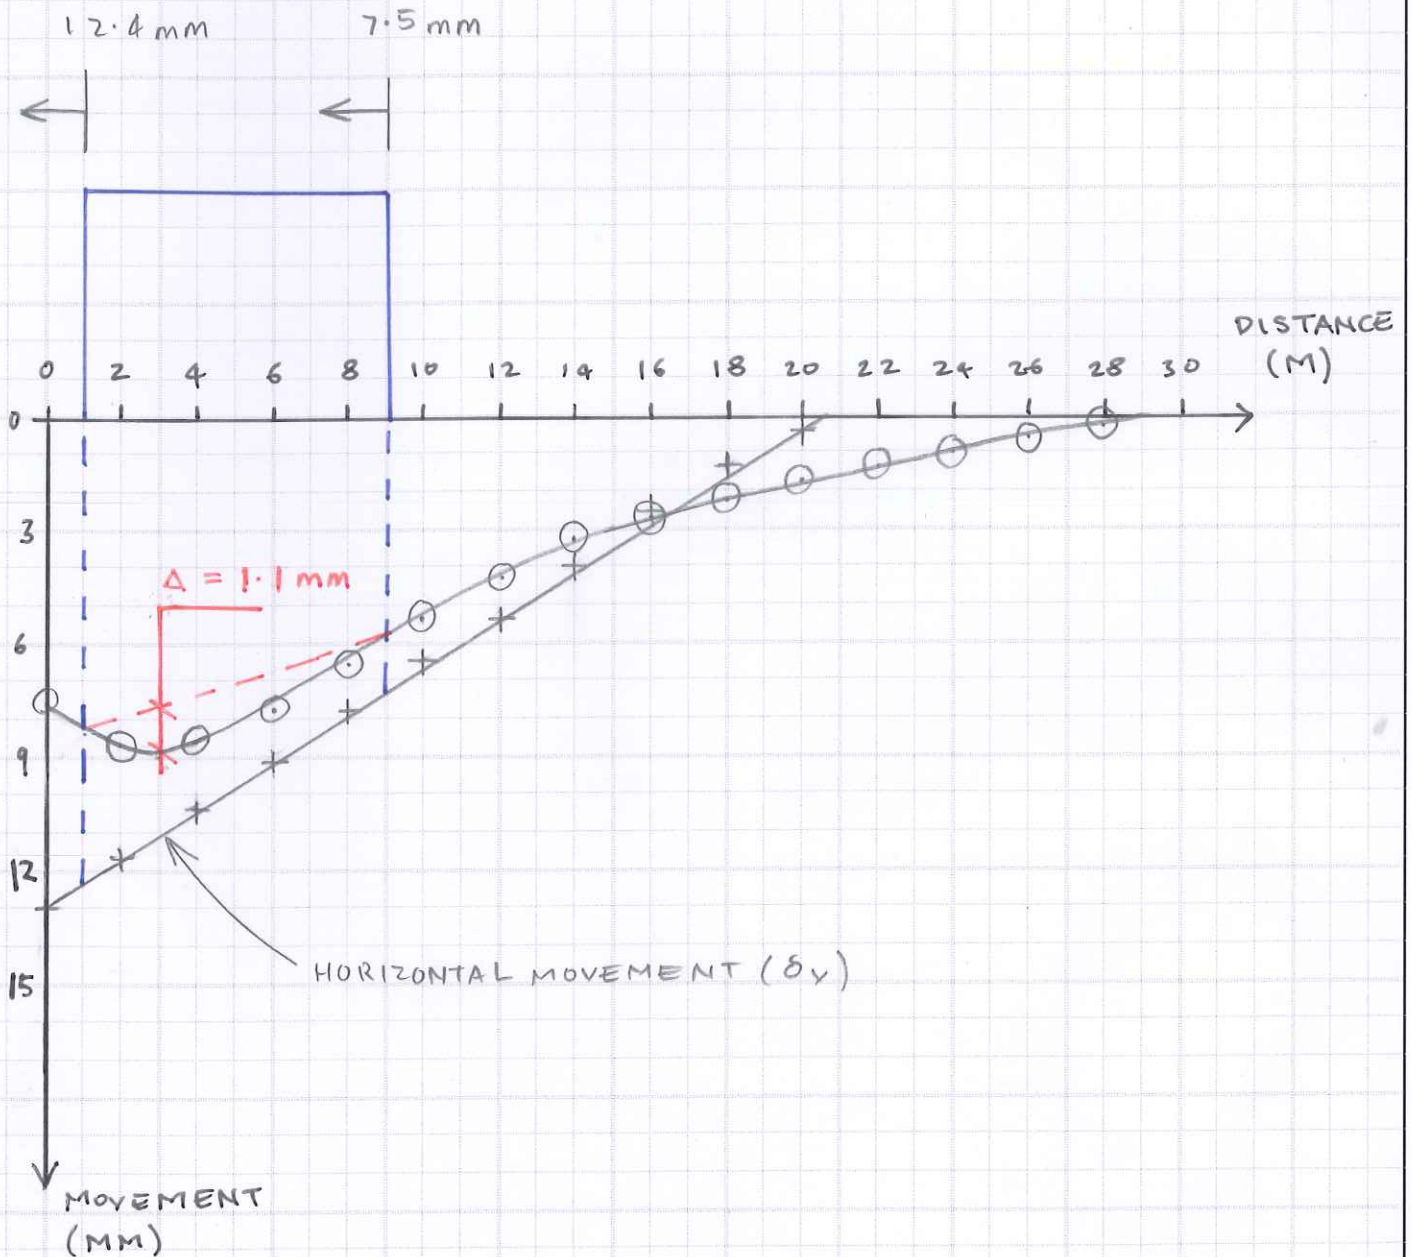
Section:  
Sheet: GMA-2  
Rev:

SECTION TAKEN THROUGH WALL CLOSEST TO N° 35
