ARBORICULTURAL IMPACT ASSESSMENT REPORT

Coal House, Branch Hill House, Branch Hill, London NW3 7LS

DATE: June 2023

OUR REF: SHA 681 AIA

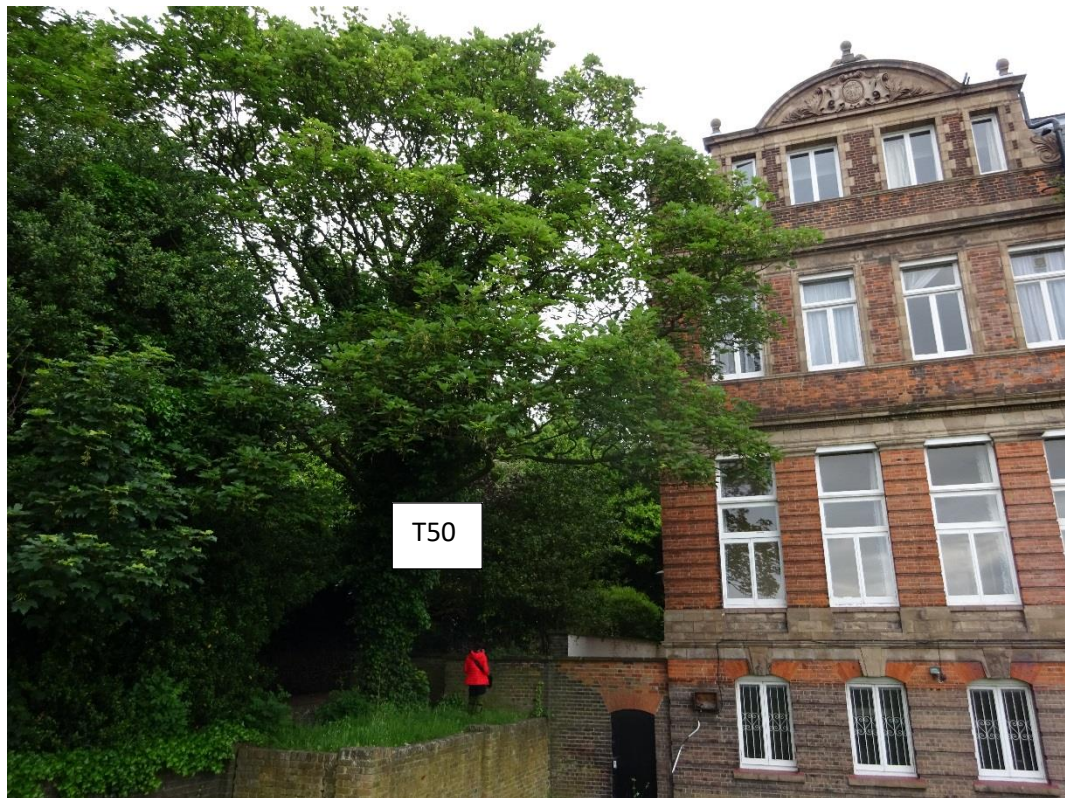
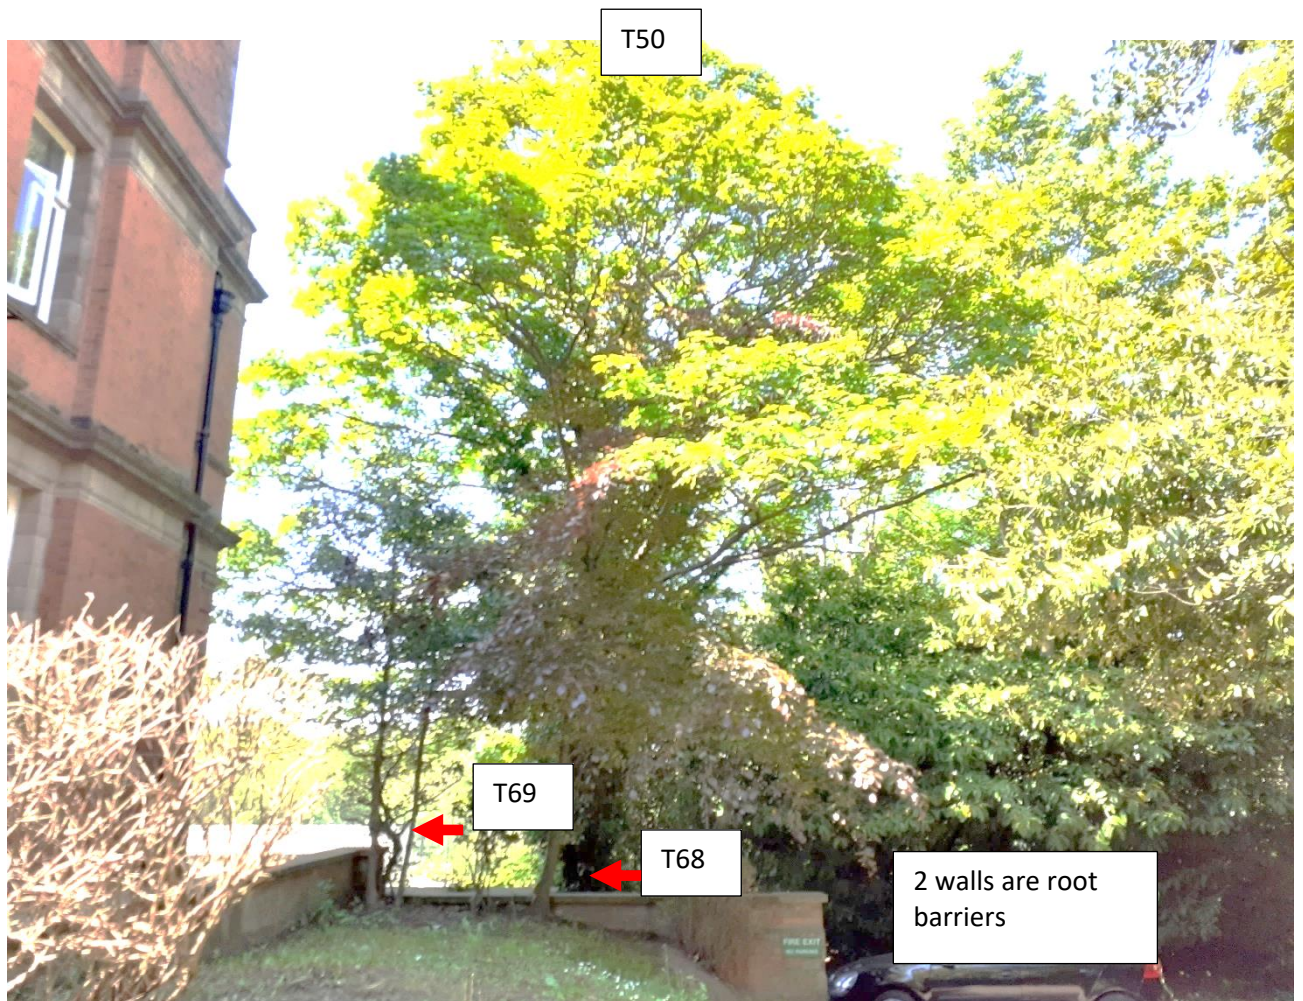
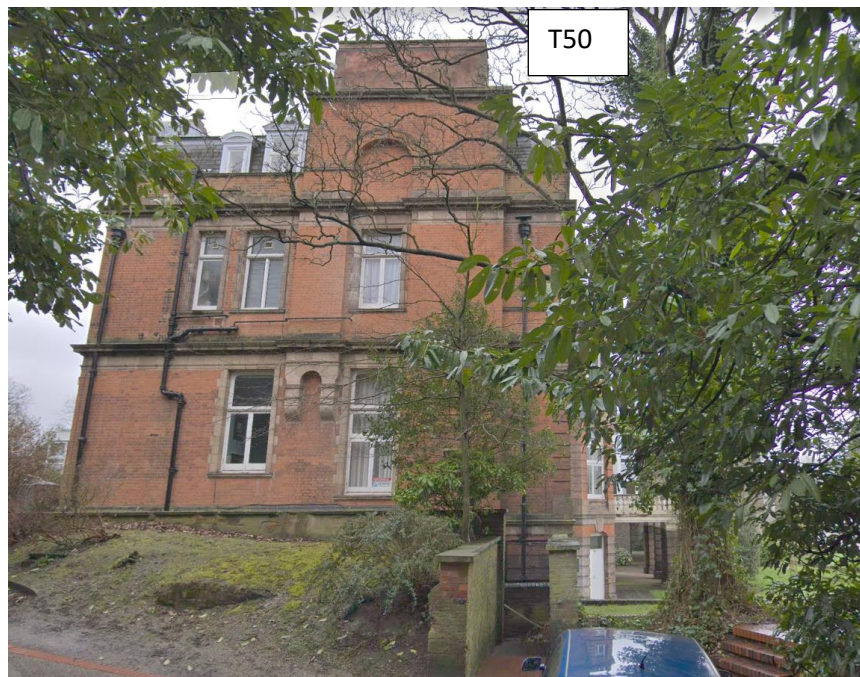
T50 is a mature sycamore with a stem diameter of 750mm, 18m tall and a crown spread of c.16m. It is growing in an elevated location in a raised bed which constrains its rooting area on the southern side, and a wall on the north east will be acting as a root barrier to the depth of its foundations.

Photo 1 of T50 looking north

Photo 2 of T50 looking south-west

*Photo 3 of T50 looking towards the property**Arboricultural impact assessment:*

Retain/remove and tree protection measures – T68 and T69 will be removed. This will have a negligible impact on visual amenity. T50 will be retained. The wall will be demolished in accordance with a method statement to be developed further post planning. The line of the new building is on the line of the wall and will be constructed using sheet piling. This negates the requirement for a piling mat, which is essential as no excavation can take place in the orange rectangle overleaf. The sheet piling will require pruning of the overhang of T50 along the building line to enable the sheet piling rig to operate. The details of this will be finalized post planning for a forthcoming method statement. Services and drainage can serve the proposal from Spedan Drive, and there can be no excavation for services or drainage in this area shown below. This area will be top dressed with additional ground protection and the soft vegetation protected with tree protection fencing in accordance with the location on the tree protection plan reference SHA 681 TPP at appendix 3 to a specification at appendix 5. Tree works are found at appendix 4. There will be a lightweight stair well in this area supported by localised pads constructed in accordance with the forthcoming method statement.

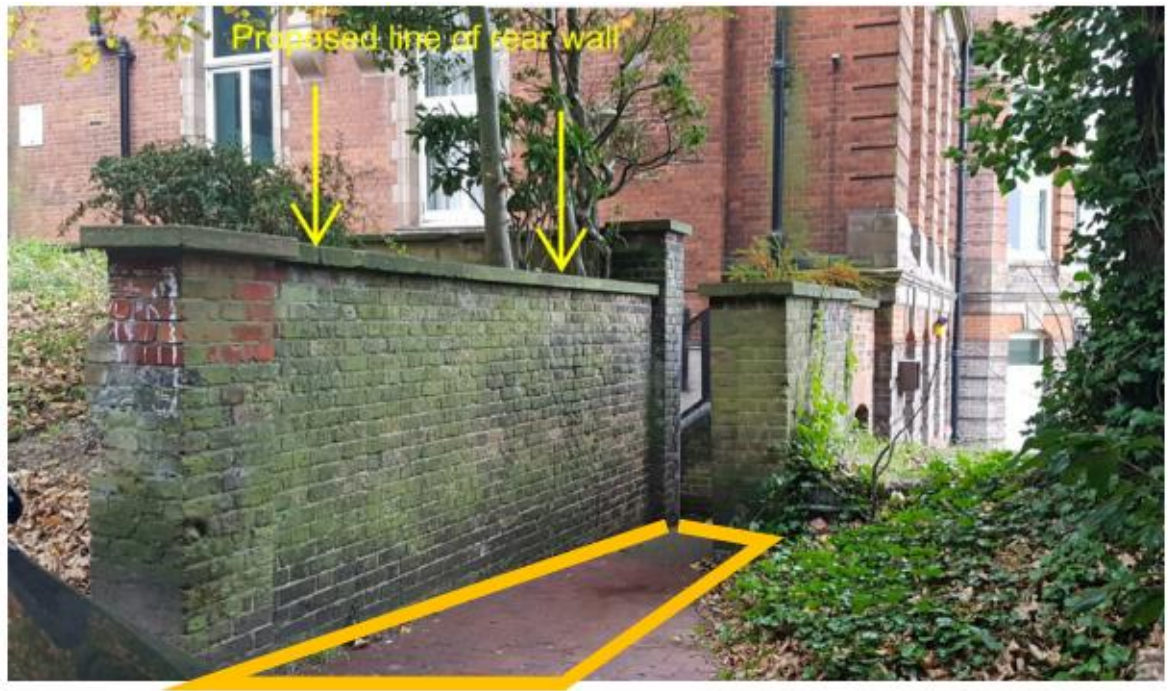
Photo 3 of the wall and sensitive area looking towards the existing house.

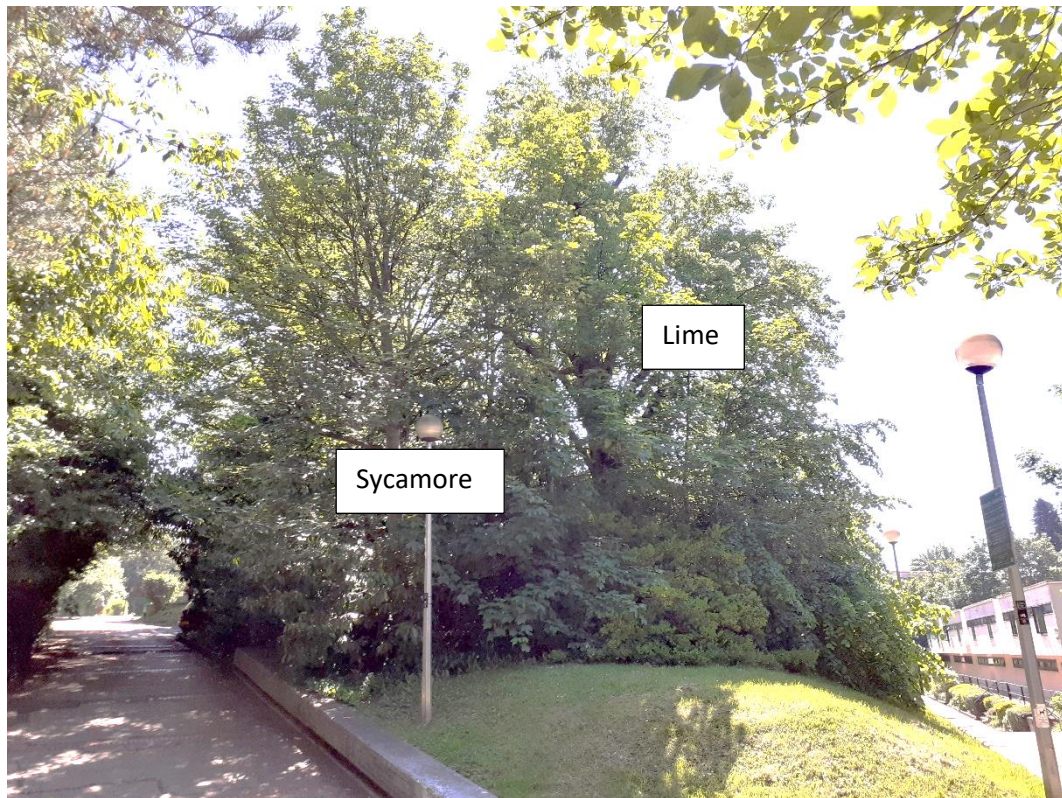
Photo 4 of G75 looking east along Spedan Close. Prominent trees to be retained

All will be retained and protected during construction in accordance with the specification at appendix 5 to a location on the tree protection plan at appendix 3. Minor crown lifting and dead wood removal is recommended over Spedan Drive for clearance and safety reasons. More generally, the area will be appropriately managed as part of the landscaped management plan.

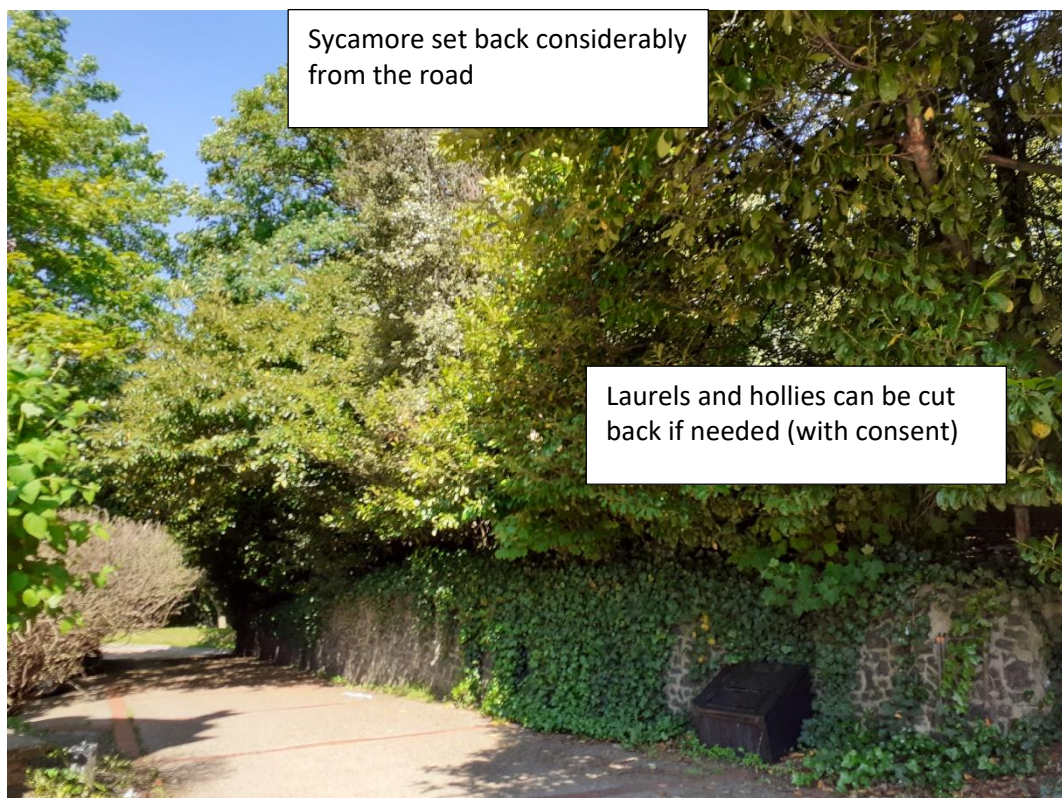
Photo 5 of G76 looking west along Spedan Close

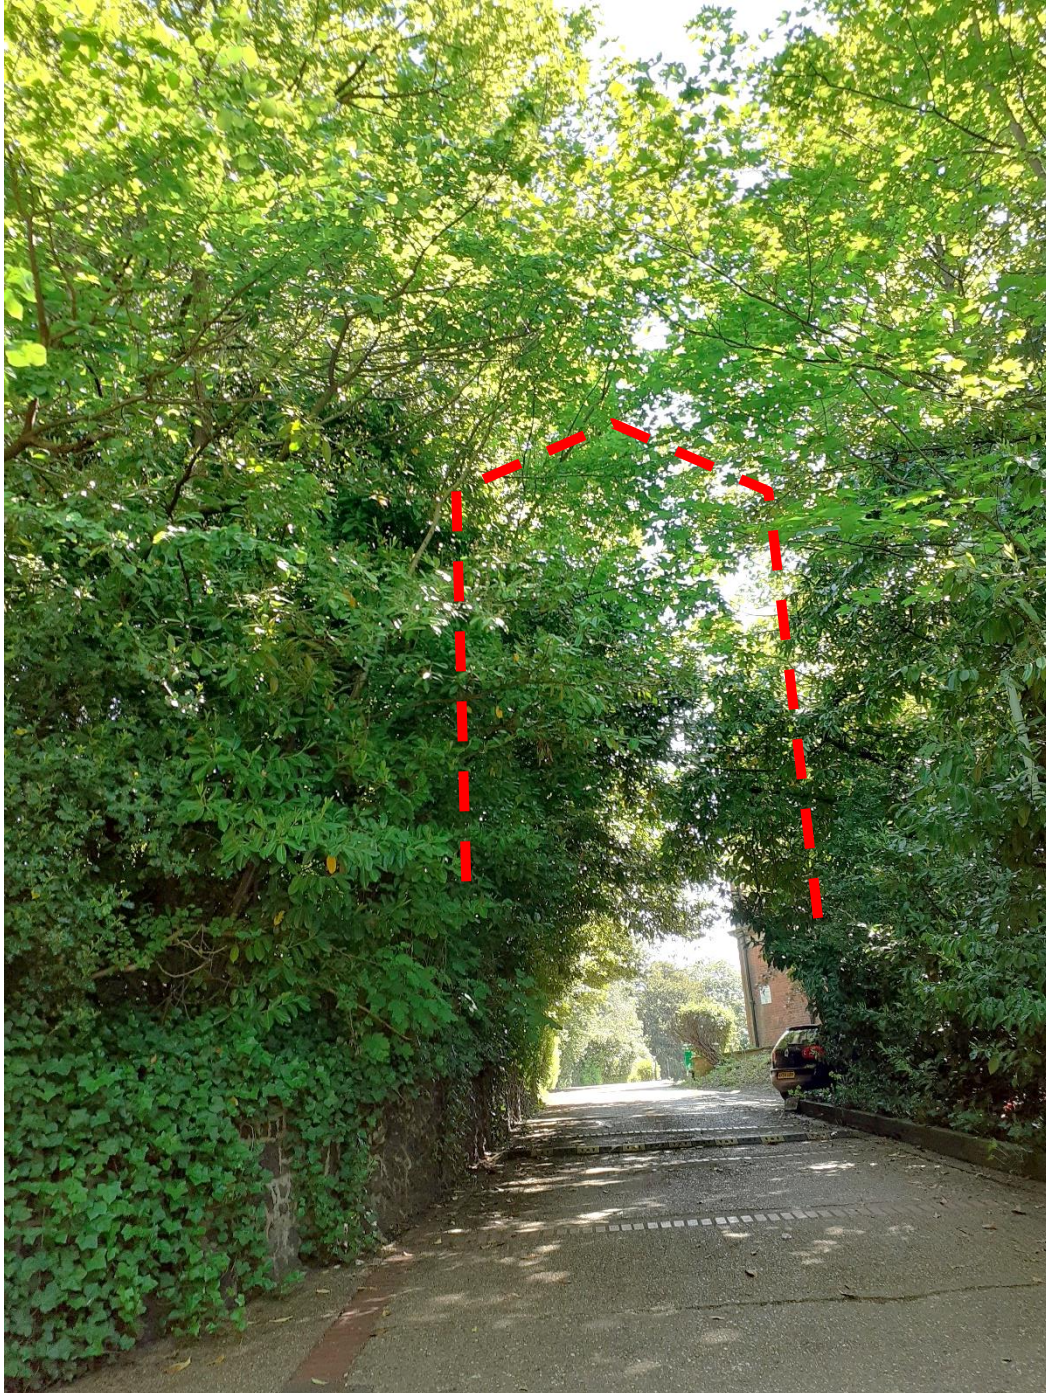
Photo 6 looking east along Spedan Close. Area of suitable pruning (subject to consent)
