49 Willow Road NW3 1TS

Door replacement

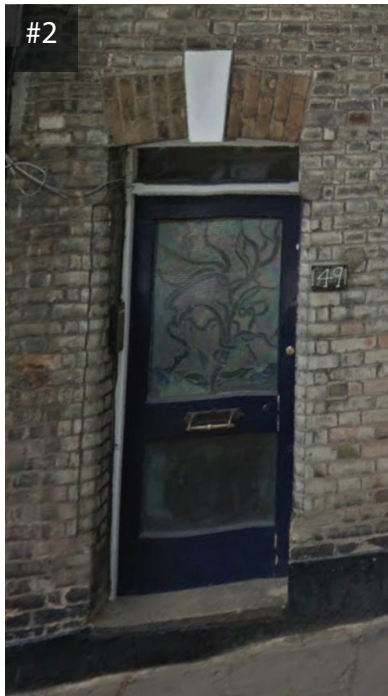
The existing door (#2) at 49 Willow Road (#1) is not the original door nor is in keeping with the Victorian style of the 1895 building. We believe that it was replaced circa 1962 when the building underwent a major and unsympathetic refurbishment. The door was at some point covered by a stained glass (#3) which was removed when the property was sold. The glass left underneath is wired glass (#4 & #5), which was invented in 1882.

Not only wired glass is not in keeping with the building's style, but it can shatter in a far more dangerous way than regular glass: the wire embedded in it can snare a hand or leg that passes through the broken glass, making injuries more severe. The US International Building Code effectively banned the material from use in 2006.

Existing door from the outside

We suggest replacing the existing door (#7) by the more sympathetic Victorian door model (#9) which can be seen on the twin building just opposite the road (#8).

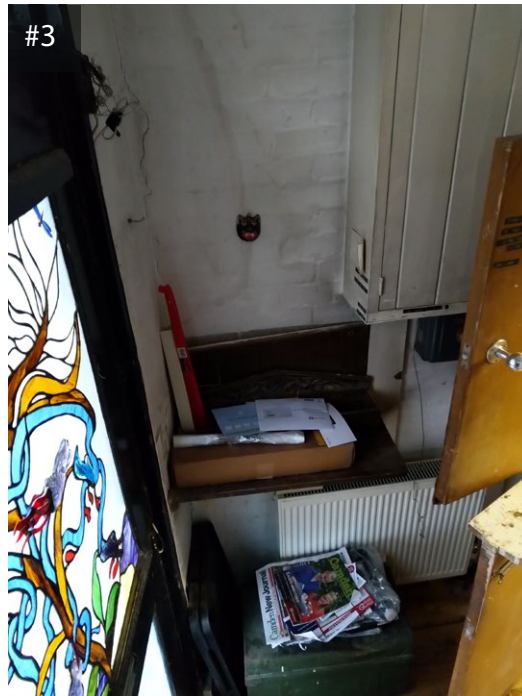
Existing door from the inside
