## 3.0 EXISTING BUILDING

101 Bayham Street is a handsome Art Moderne building. The facade has a strong horizontal emphasis and a highly symmetrical facade bookended by vertical bays at either end.

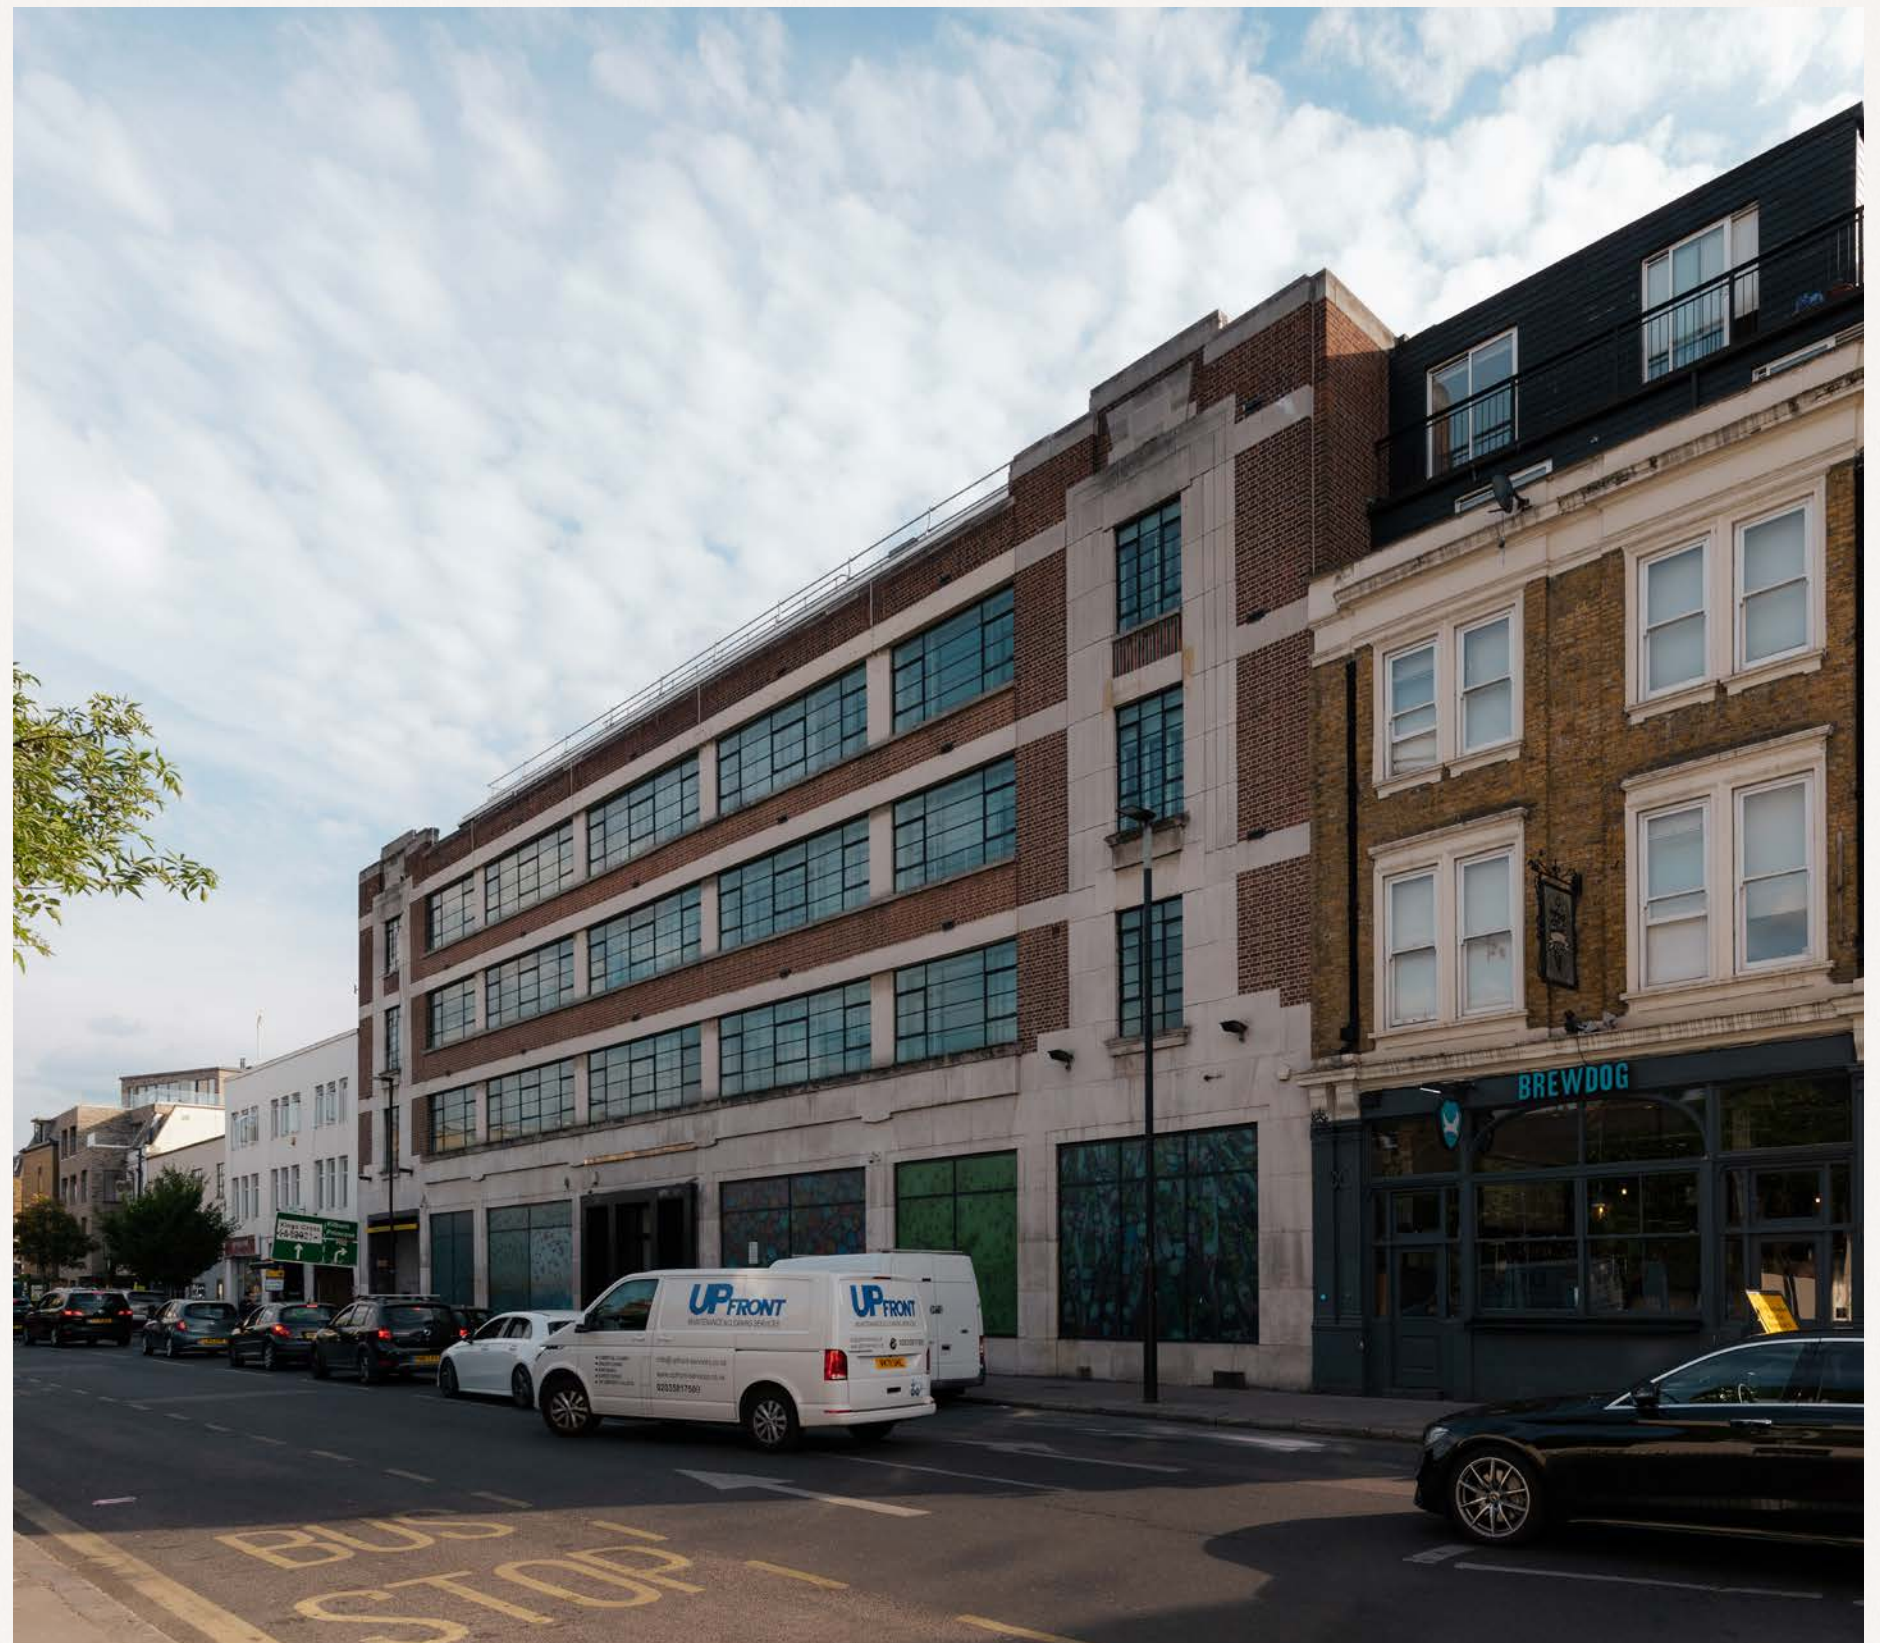
The facade at ground floor is opaque and contributes very little to activity of the street.

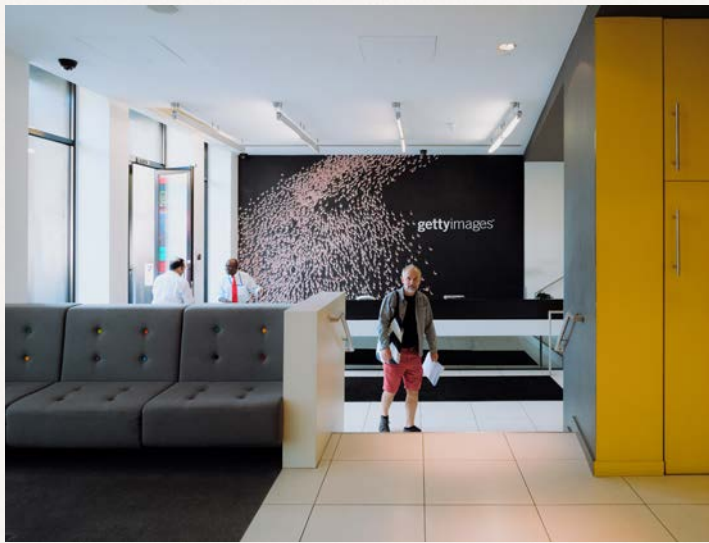
The reception is constrained and the building is inaccessible to wheelchair users

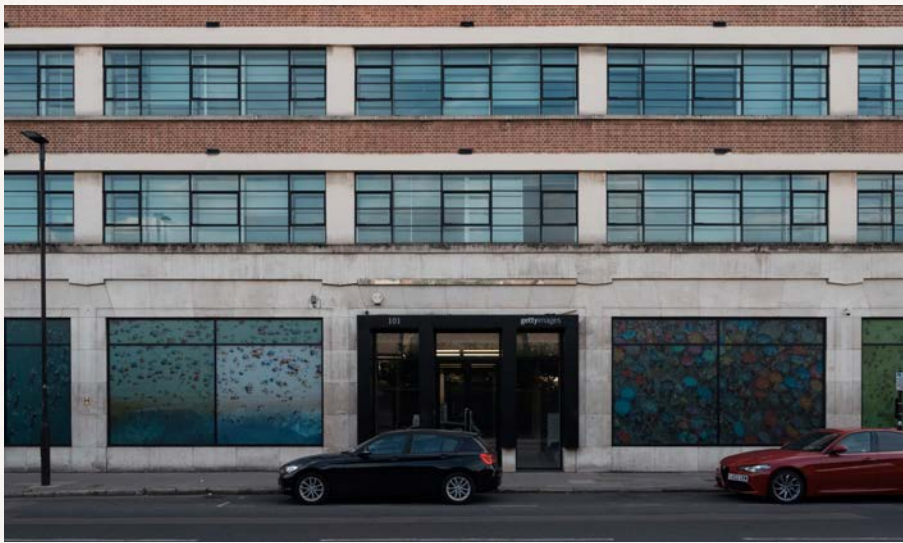
The Ground Floor is inactive and opaque, failing to bring positive value to the street

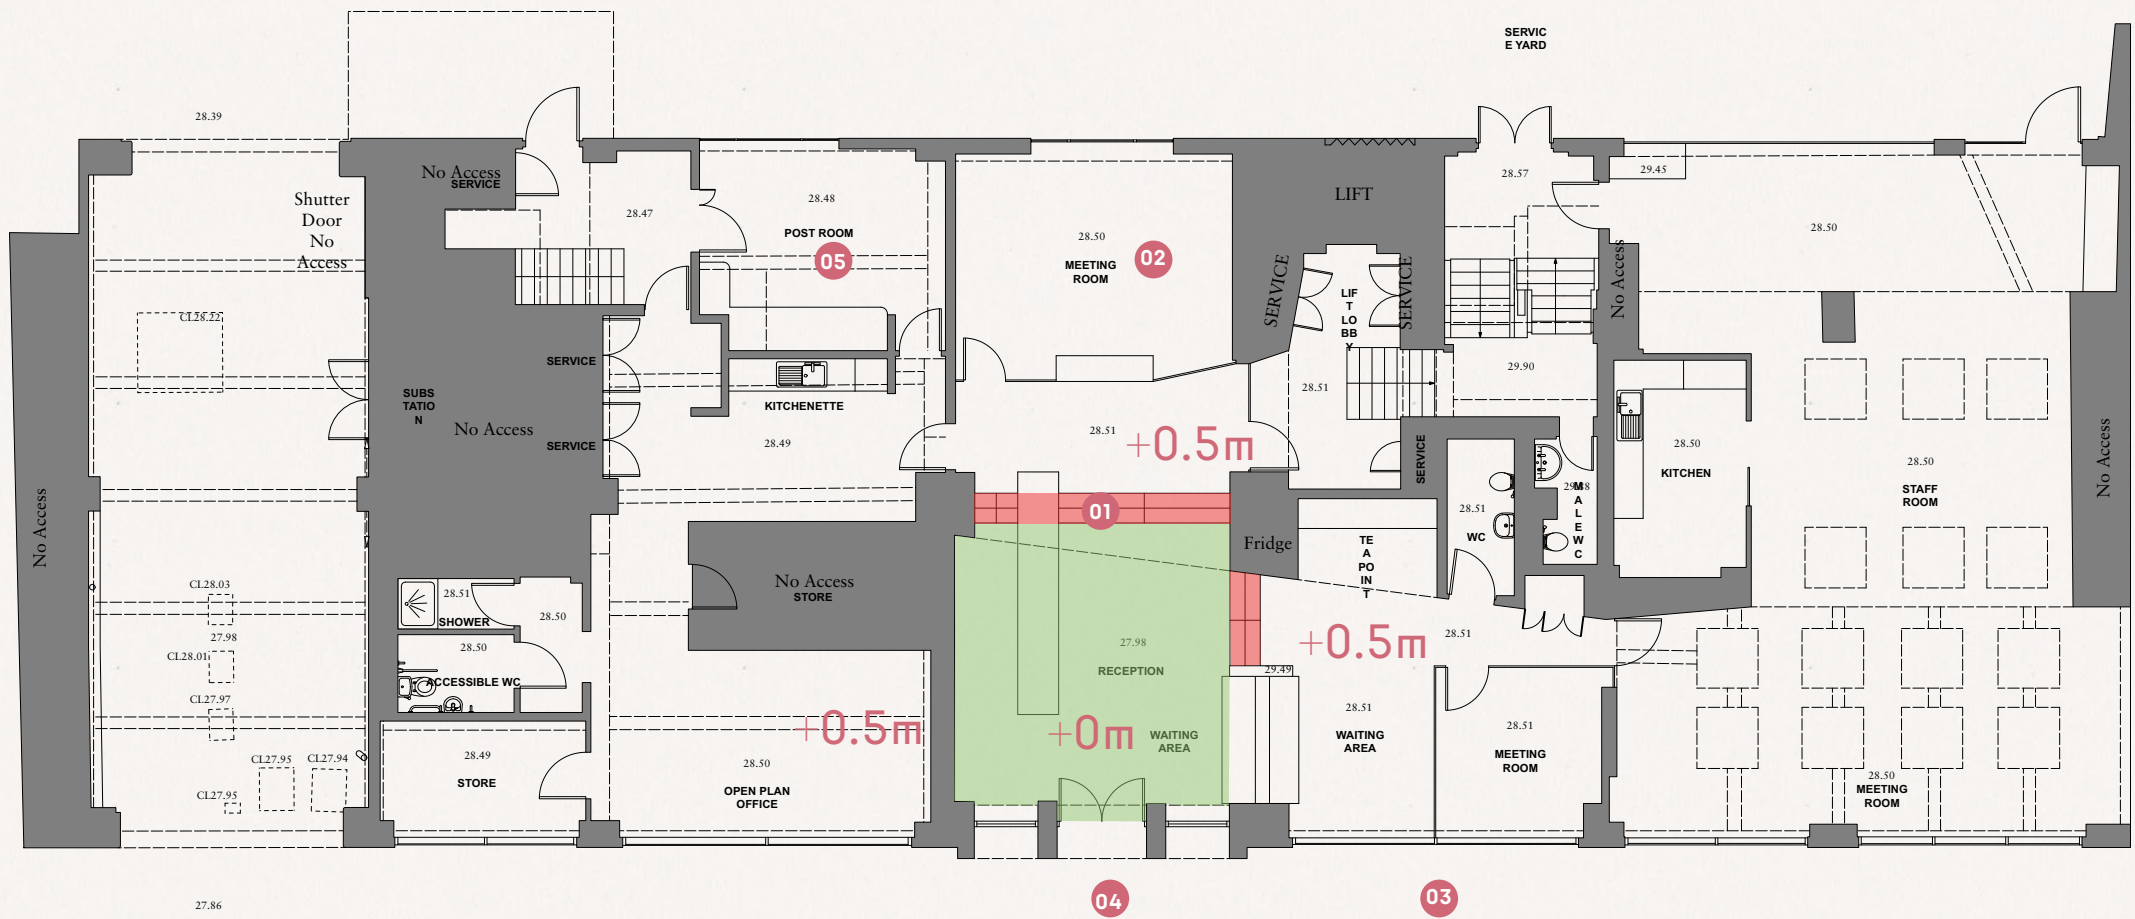
## Ground Floor Plan

- 01 Accessibility - Steps within entrance lobby render the building inaccessible to wheelchair users
- 02 Meeting room dominated entrance lobby limits sense of activity & inhabitation
- 03 Inactive street frontages
- 04 Noisy road adjacent
- 05 Inefficient / extensive back of house areas

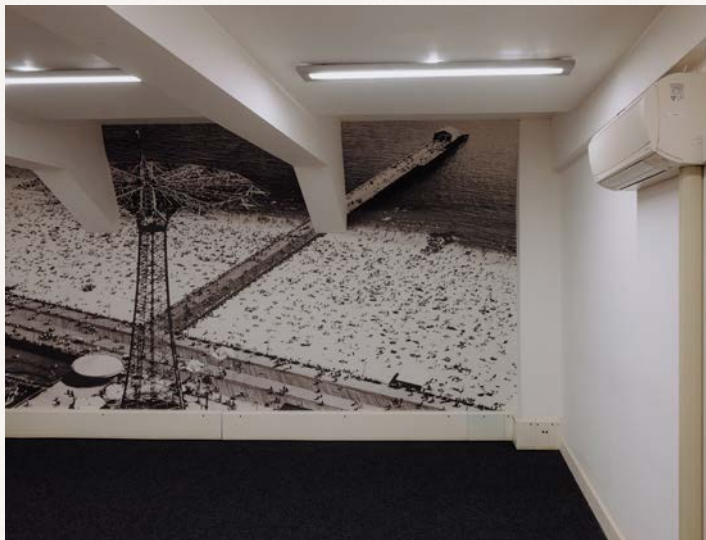
Low ceilinged meeting rooms with no natural daylight

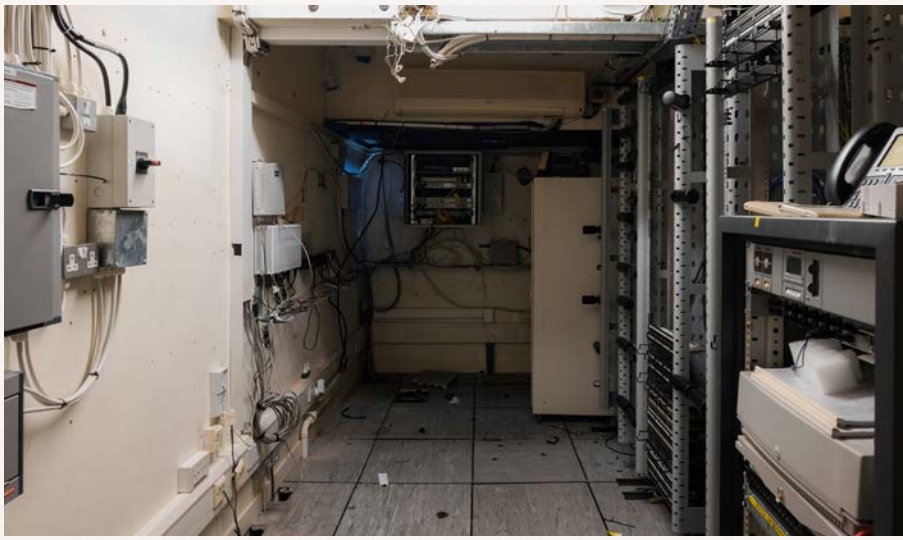
Underutilised server / storage room

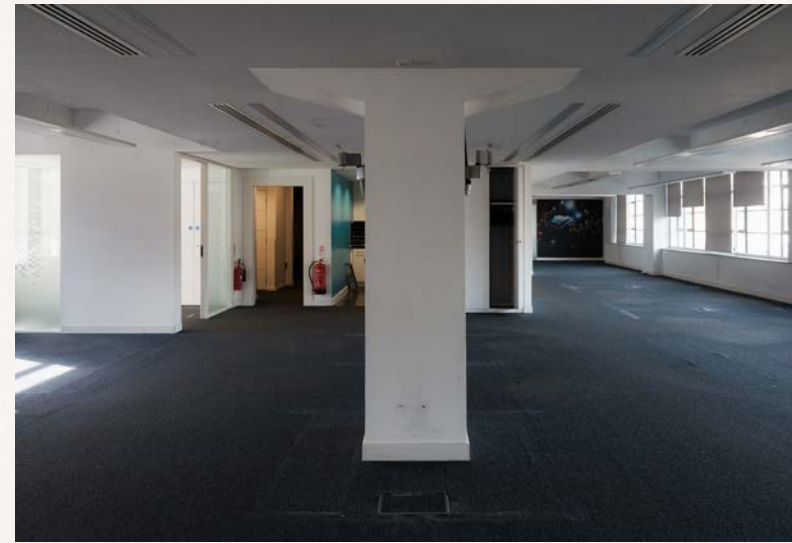
The existing structure and character of the interiors has been overclad in plasterboard.

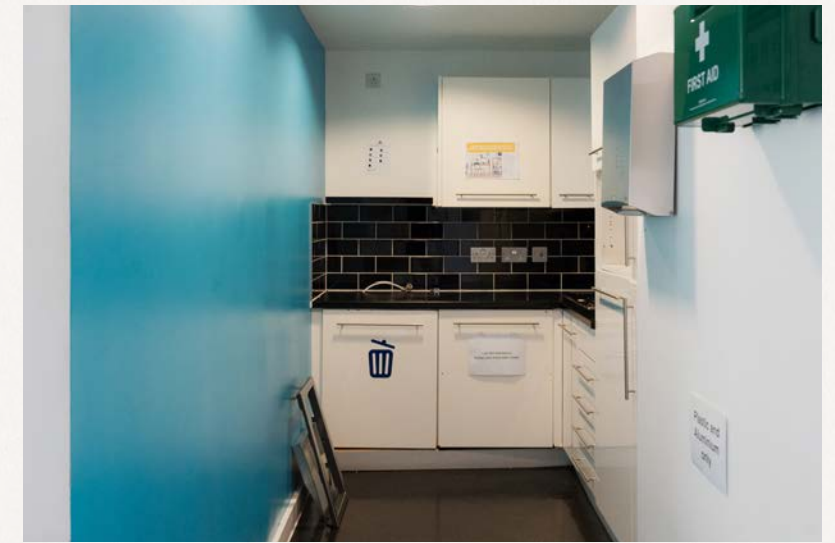
The kitchenette space is gloomy, generic and reduces the overall flexibility of the typical floors.

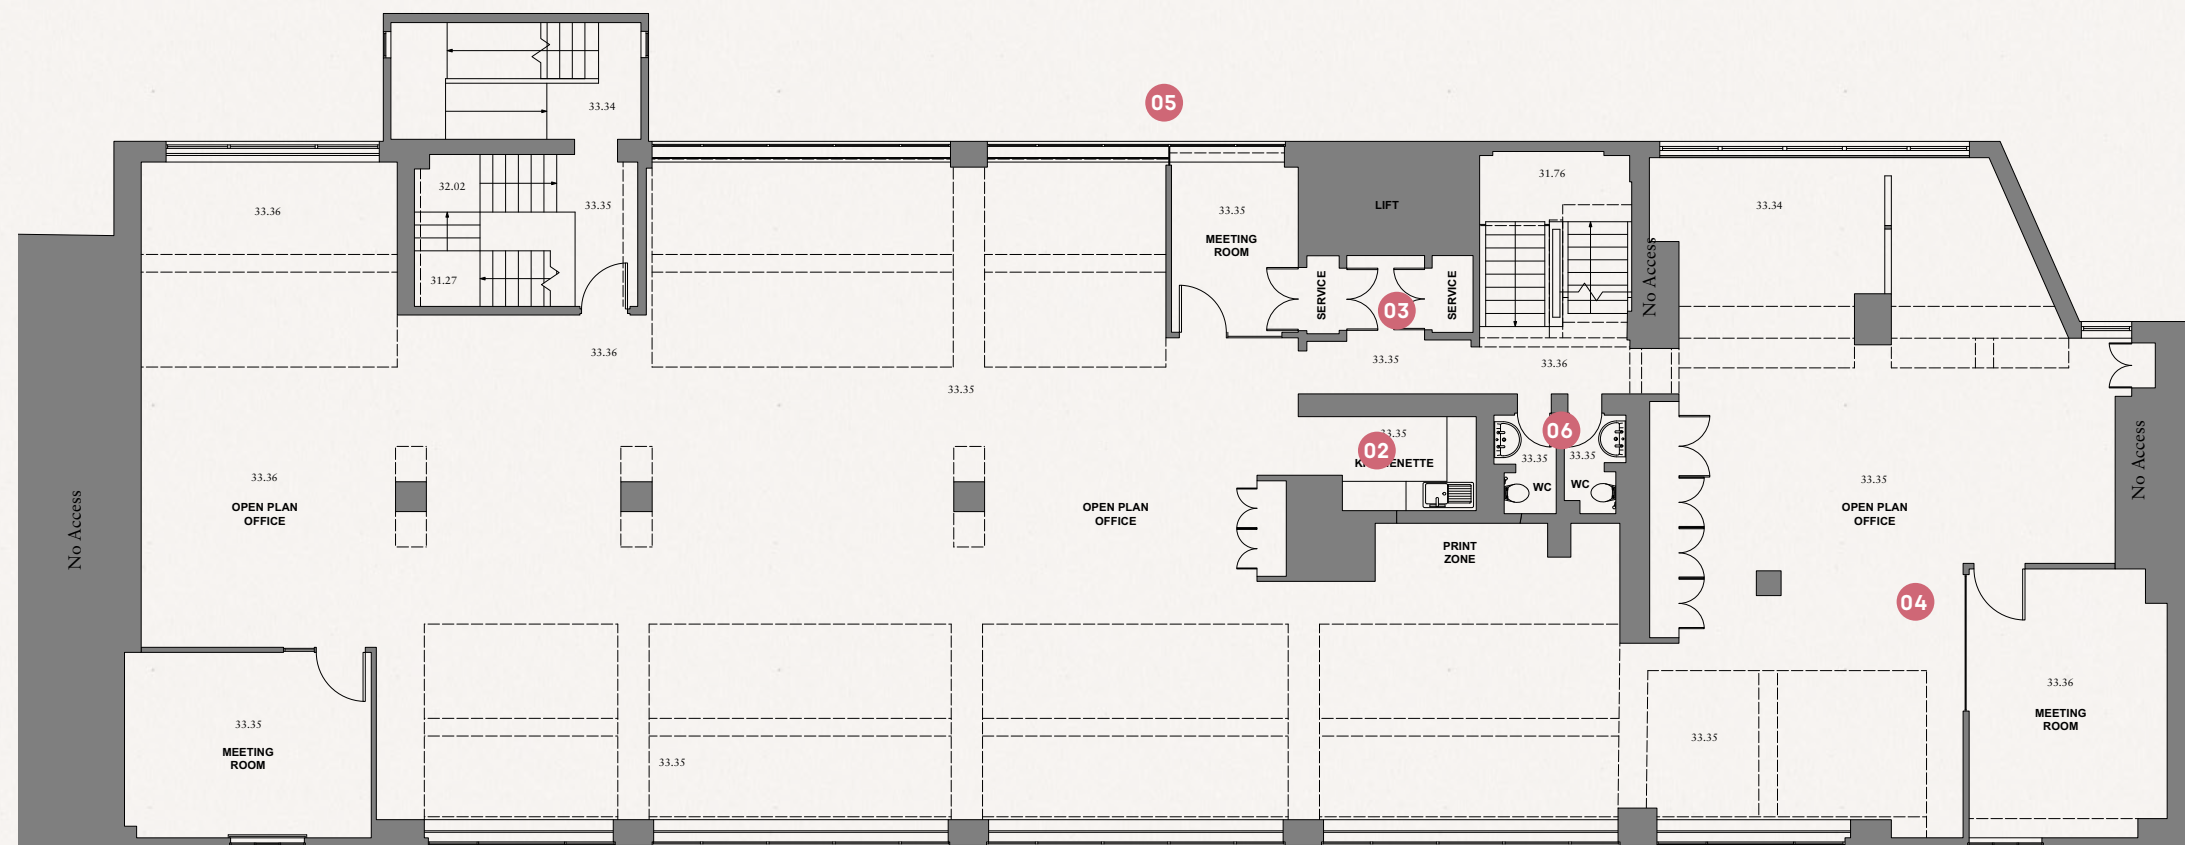
**01** Arrival experience on each floor is currently under whelming, spatially tight & blighted by WC's

**02** Location of WCs and kitchenette creates division within the floor plate, limiting flexibility & diluting the sense of space

**03** Location of risers clutter and dominate lift arrival

**04** Existing building structure and fabric has been overclad / 'whitewashed'

**05** South West facing windows create overheating & high energy/cooling

**06** No accessible WC's are provided

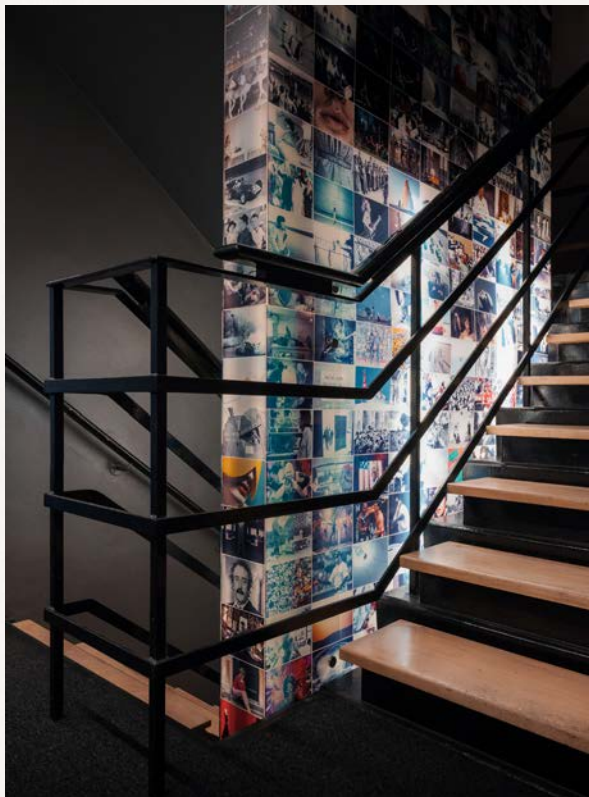
- Existing stairwell has character but no natural light

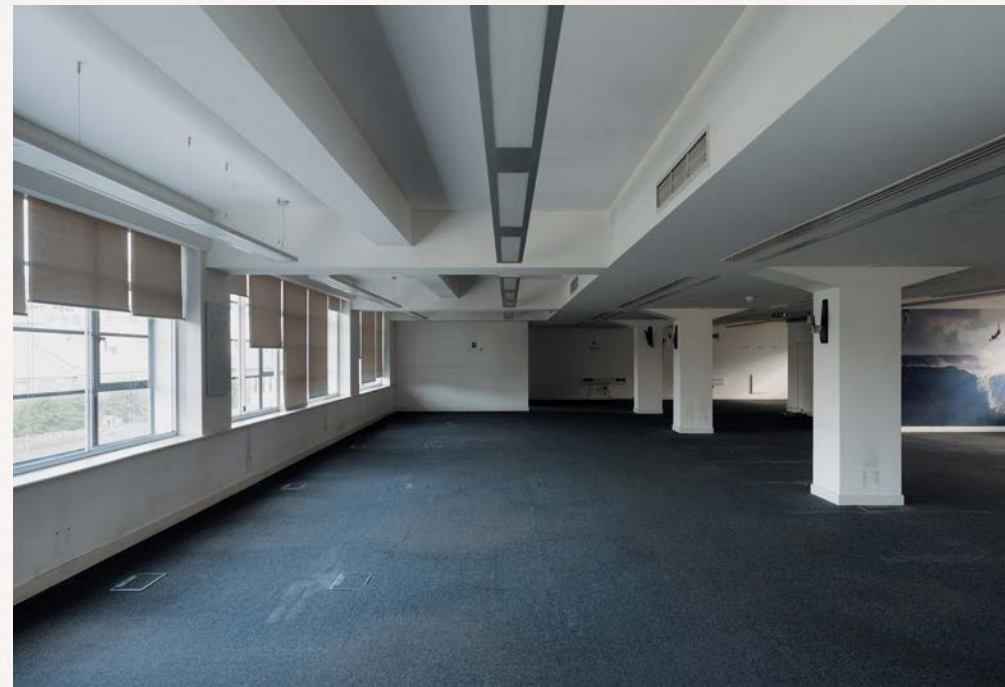
- Plasterboard finishes make the space feel lower in scale and generic in character, the finishes minimise thermal mass benefits.

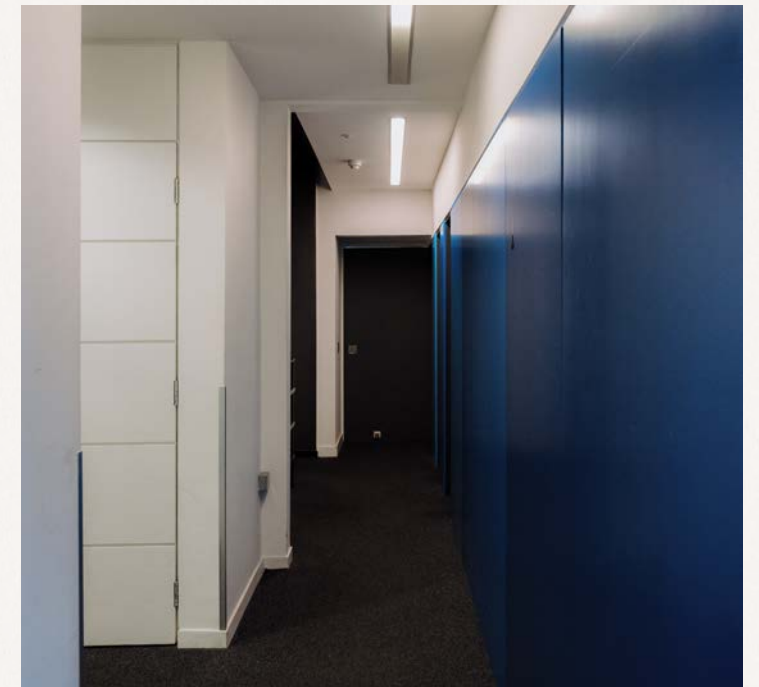
- Internal corridors lack daylight and WC's open up directly to shared circulation.

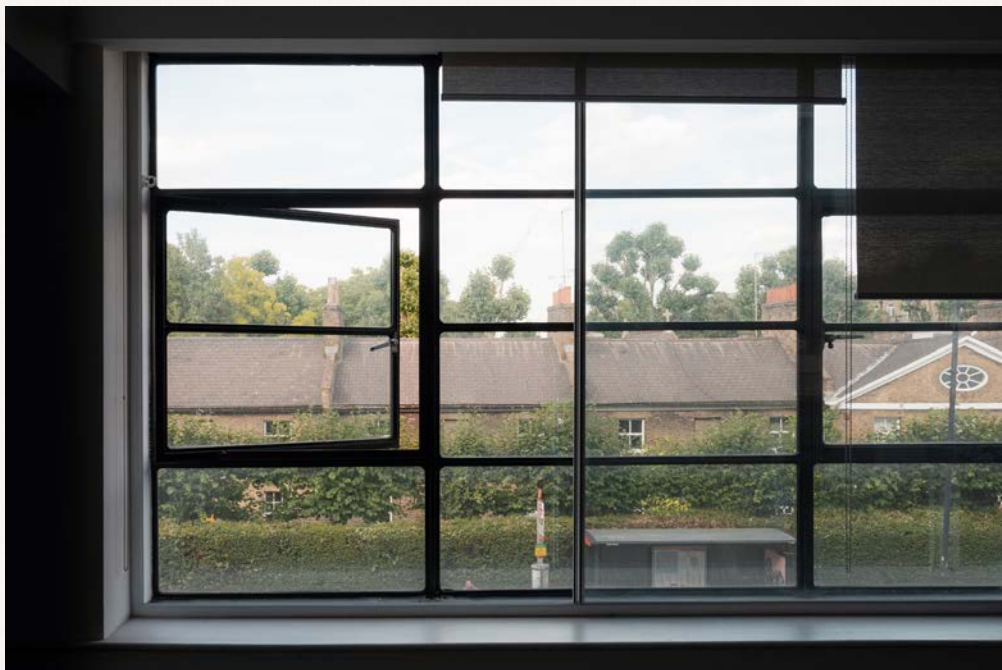
- The existing windows perform poorly from an environmental perspective, with high thermal loss and solar gain.

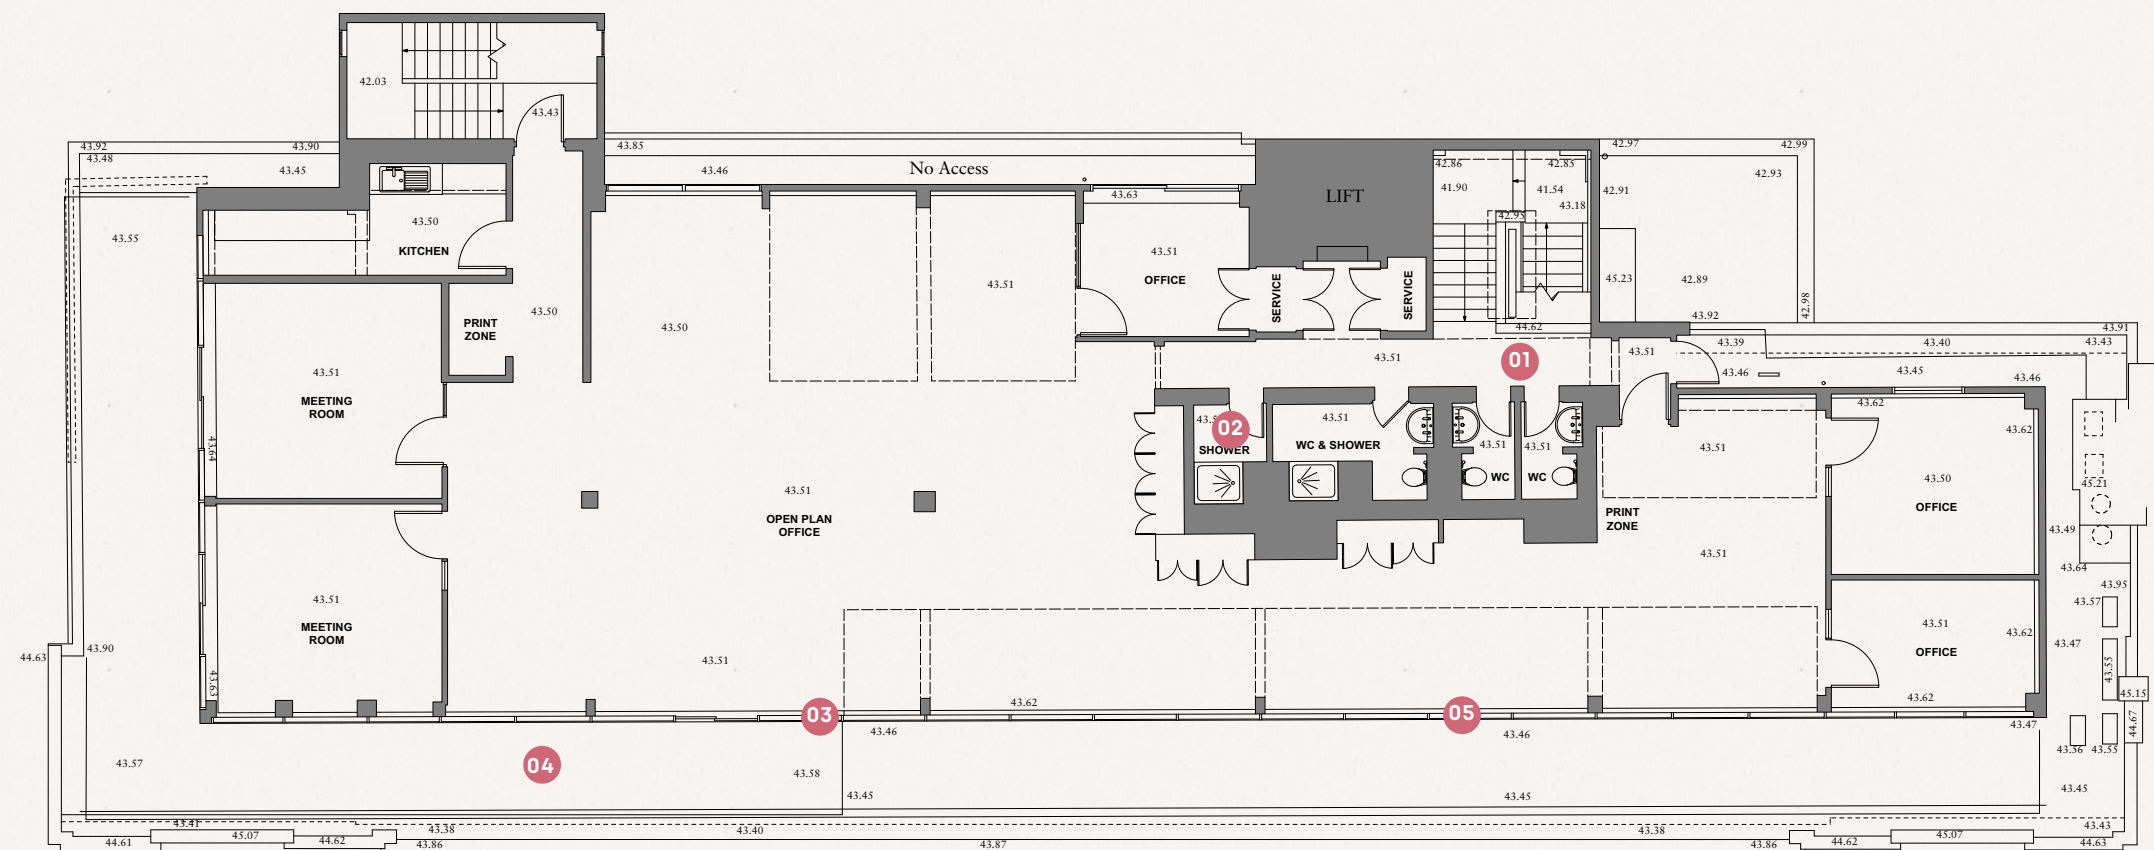
### Fourth Floor Plan

**01** Arrival experience on each floor is currently underwhelming, spatially tight & blighted by WC's

**02** Location of WCs and shower room creates division within the floor plate, limiting flexibility & diluting the sense of space

**03** Full height exposed fenestration leads to overheating and high energy demand

**04** Roof terrace currently very exposed and bleak but with great views over St Martin's Gardens

**05** There is currently no level access between the internal and external floor levels and existing doors are sliding so are non-DDA compliant.

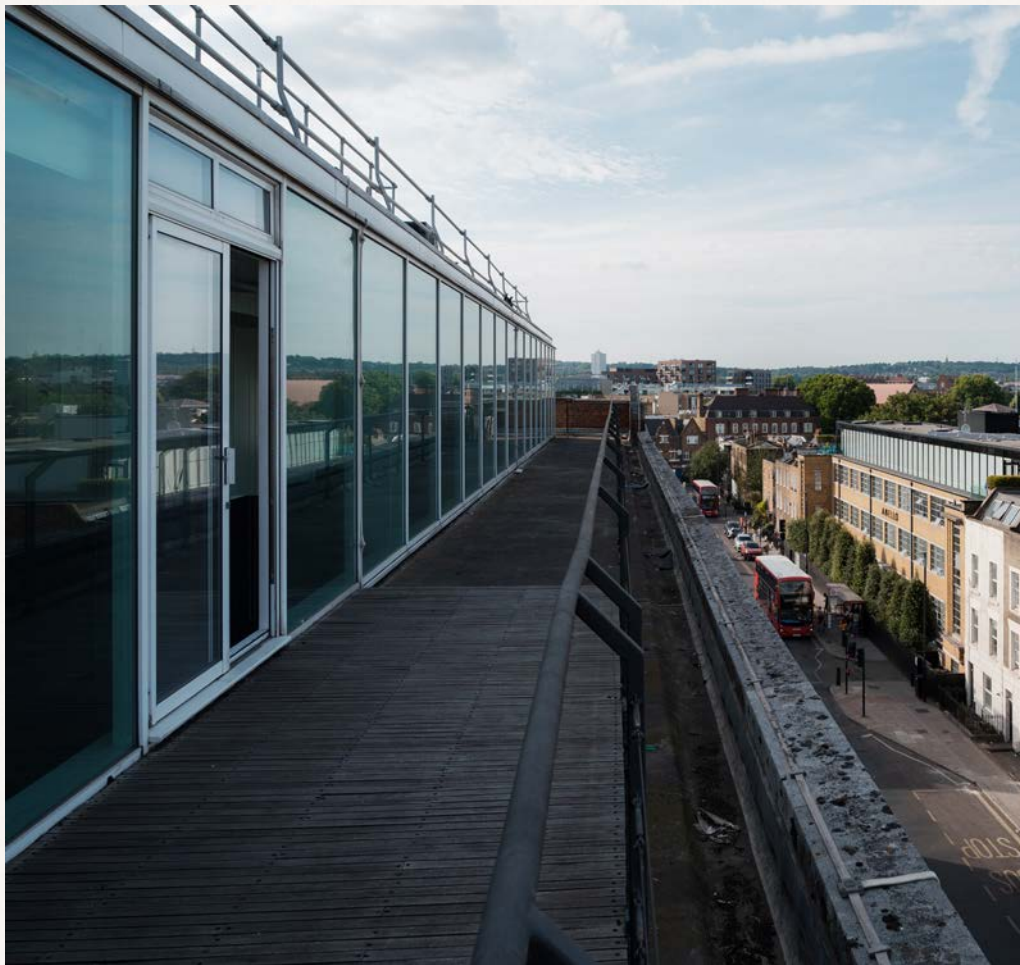
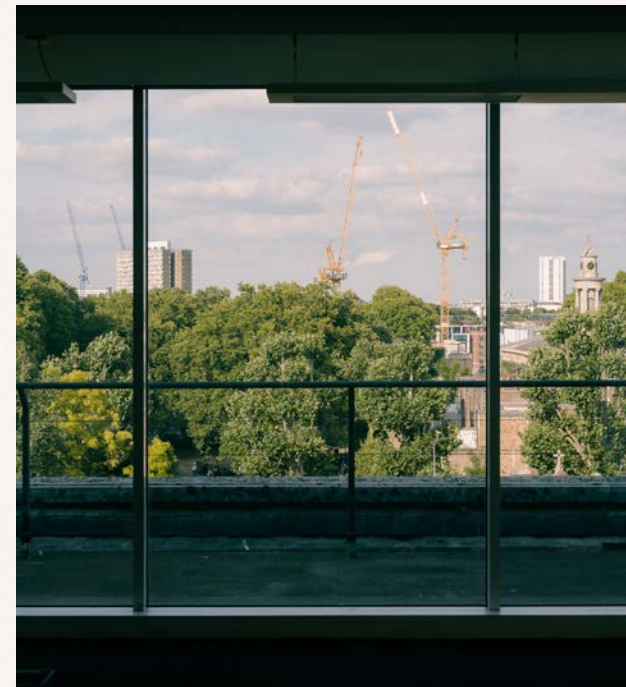
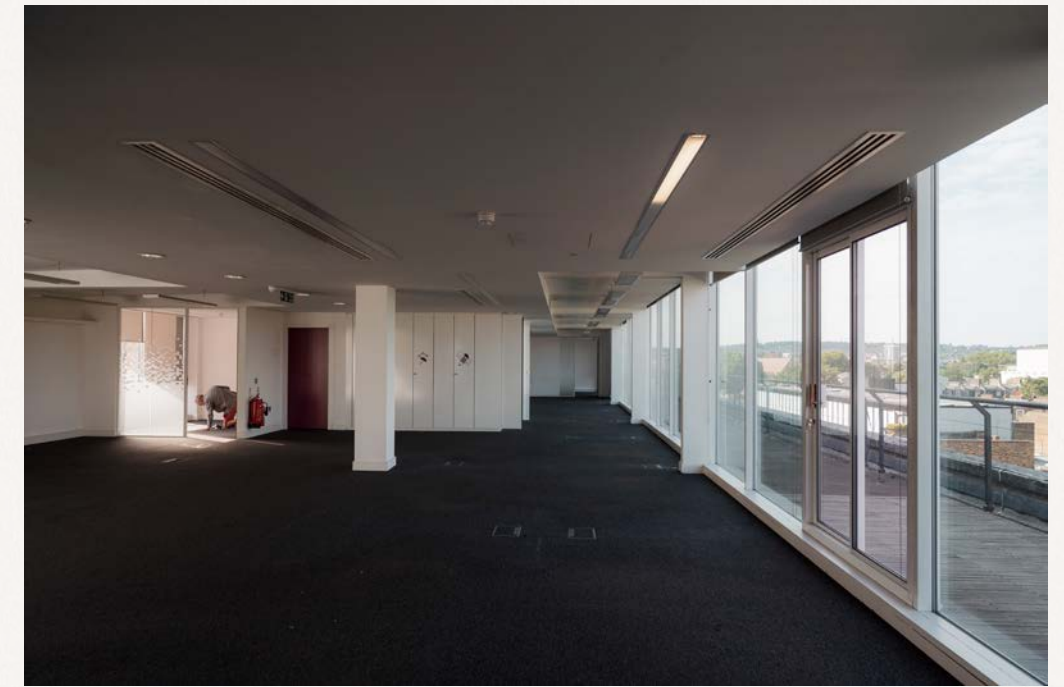
- The East and South facing terraces are tired and underutilised, the thermal insulation beneath deck requires upgrading. The glazed facade bears little relation to the building below.

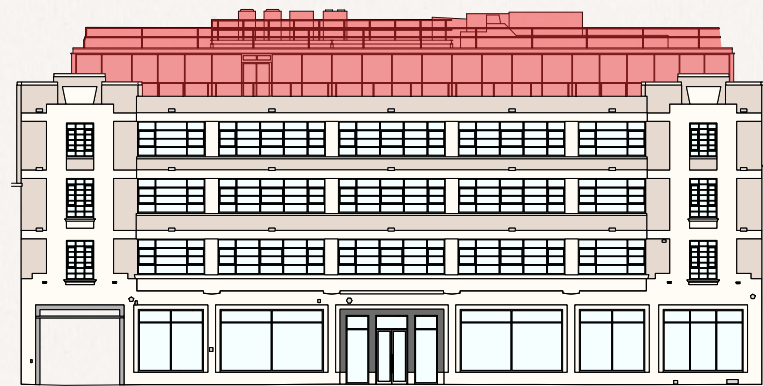
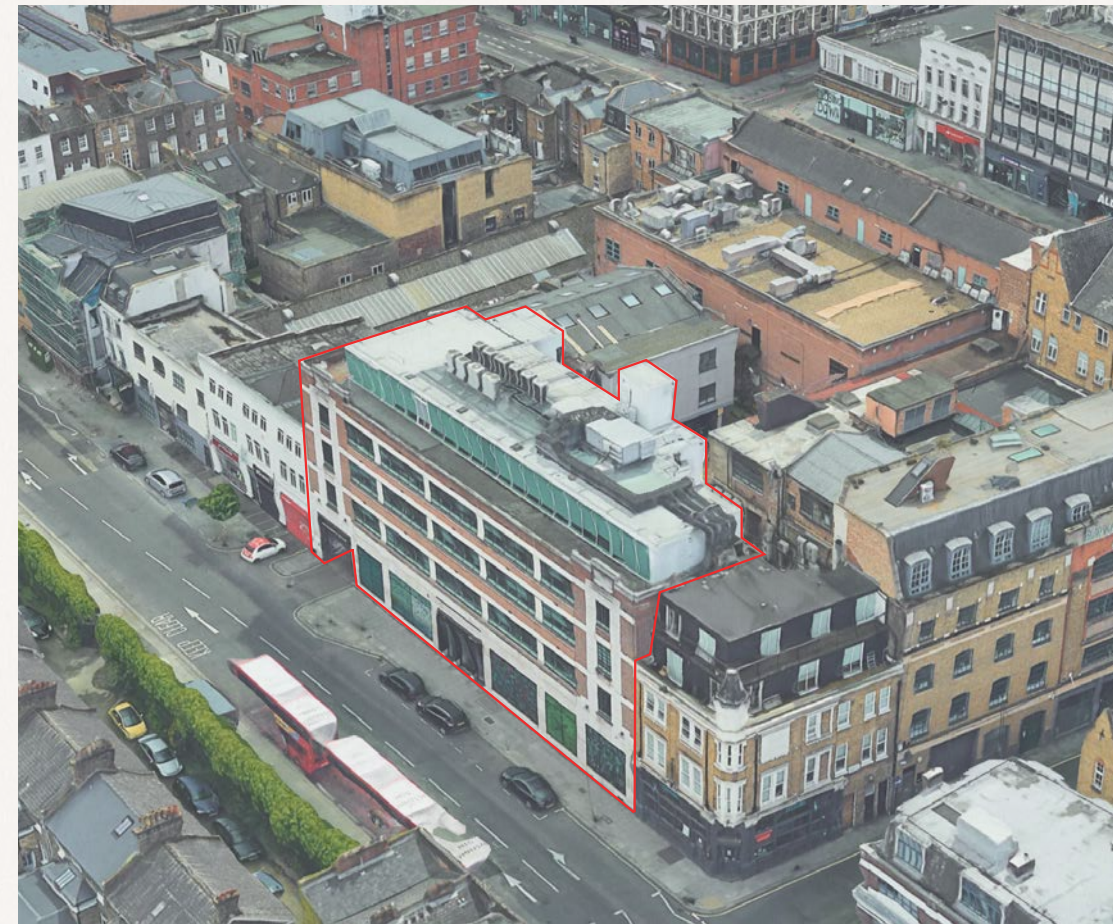
- The space has low ceilings and a generic character, large east and west facing windows present severe solar gain issues and the fabric of the extension has high levels of thermal loss.

- Existing plant is not curated or screened.

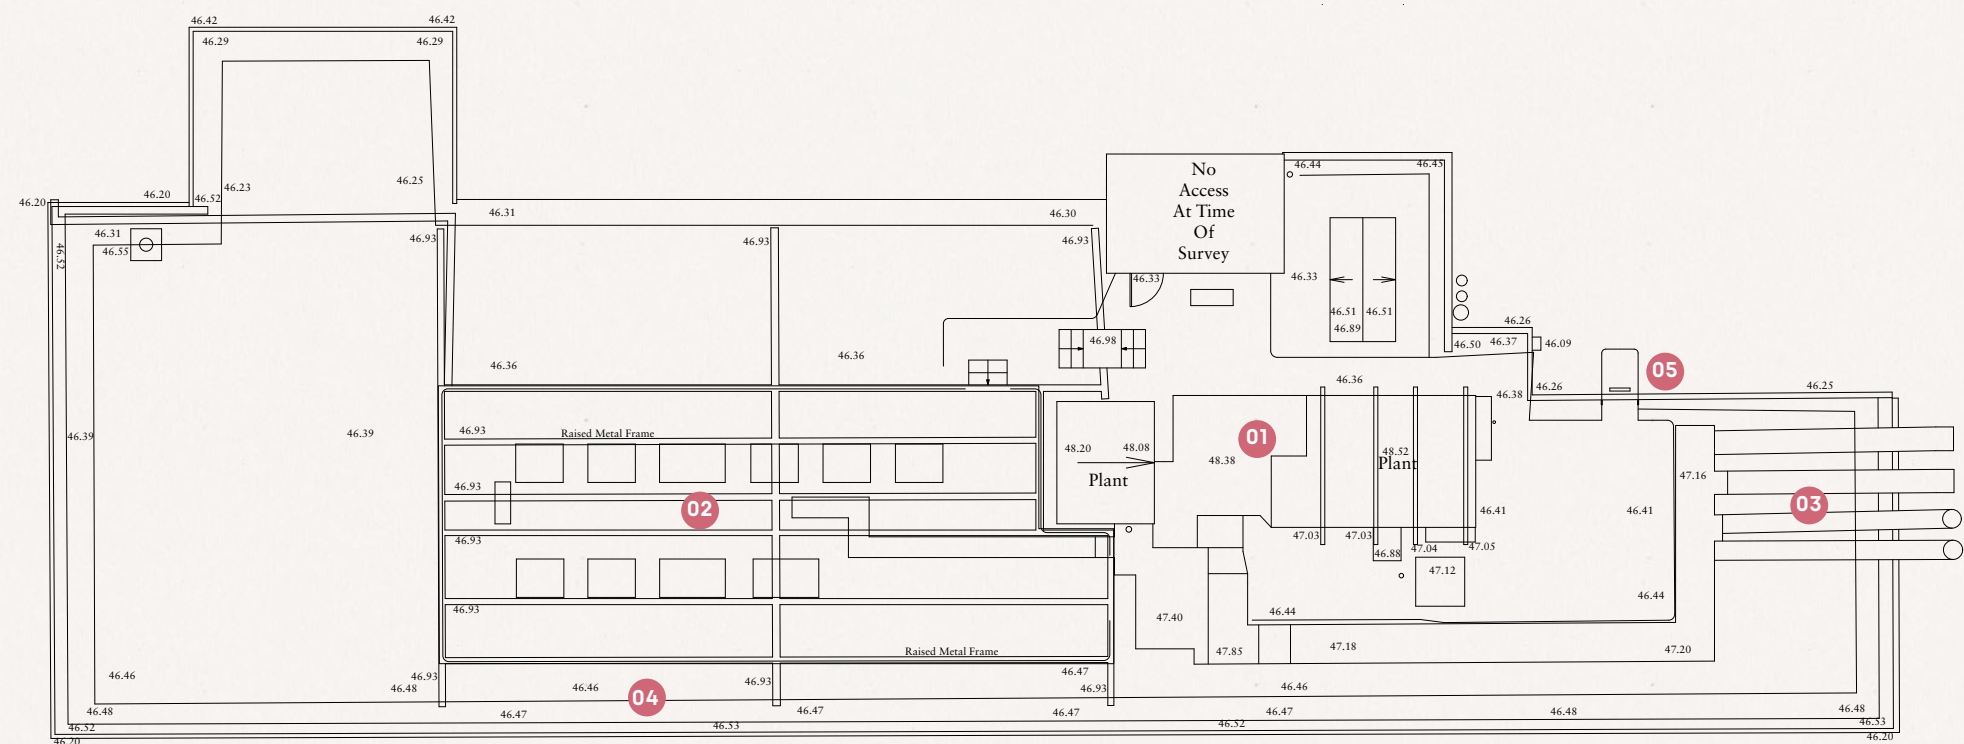
Roof Level

- 01** Large Air Handling Unit is inefficient in terms of operational energy, is very prominent in townscape views and must be replaced.
- 02** Air conditioning units must be replaced with modern Air Source Heat Pumps

- 03** Ductwork pipes are visible from surrounding townscape views
- 04** Existing protection from falling is unsightly and prominent in townscape views

- 05** Maintenance access to roof is via a hoop ladder in close proximity to a large drop from the fourth floor terrace. Access feels precarious.

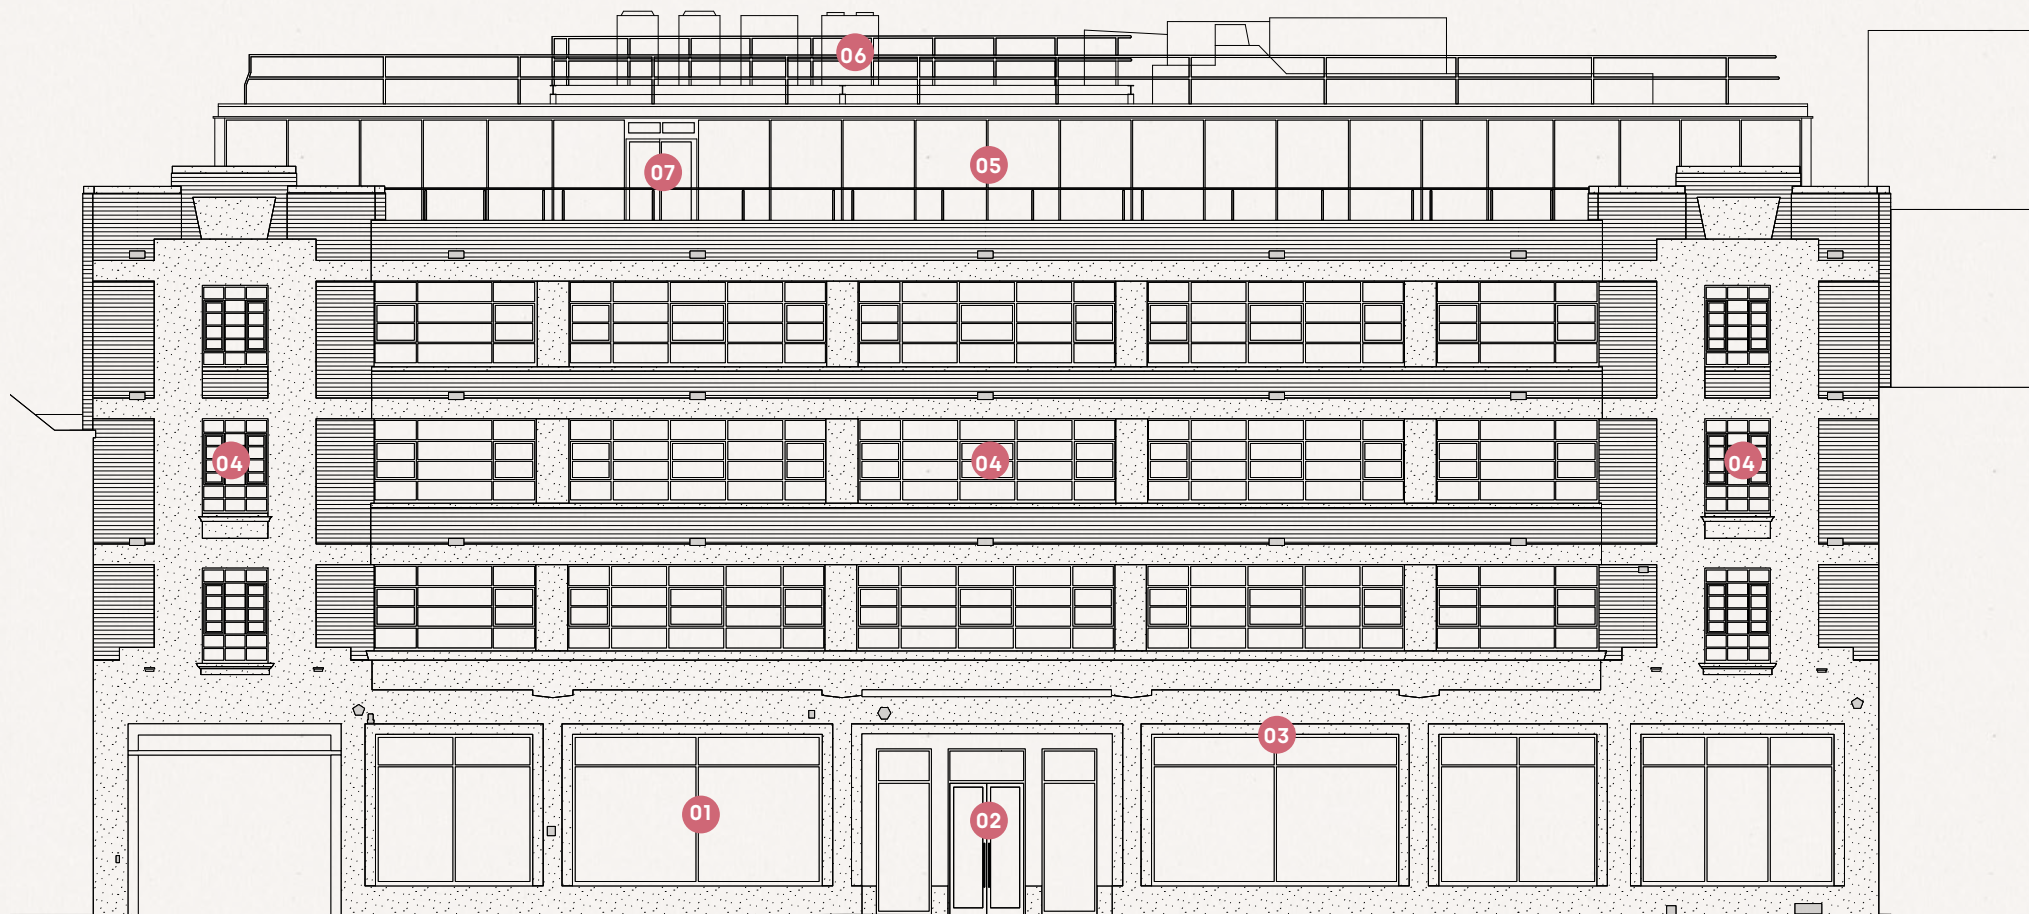
### Bayham Street Elevation

- 01** Film on Ground Floor Windows makes street frontage inactive.
- 02** Existing entrance feels incongruous to the building and doesn't offer generosity to the street.
- 03** High percentage of unshaded glazing generates high energy demand
- 04** Windows perform poorly from an environmental perspective with high solar gain and thermal loss.
- 05** Glazing on fourth floor has higher thermal performance but suffers from thermal gain.
- 06** Existing roof top plant and key clamp guarding is unsightly / visible from surrounding streetscape.
- 07** Terrace doors are slide opening and inaccessible to wheelchair users.
