## 3.0 EXISTING BUILDING

101 Bayham Street is a handsome Art Moderne building. The facade has a strong horizontal emphasis and a highly symmetrical facade bookended by vertical bays at either end.

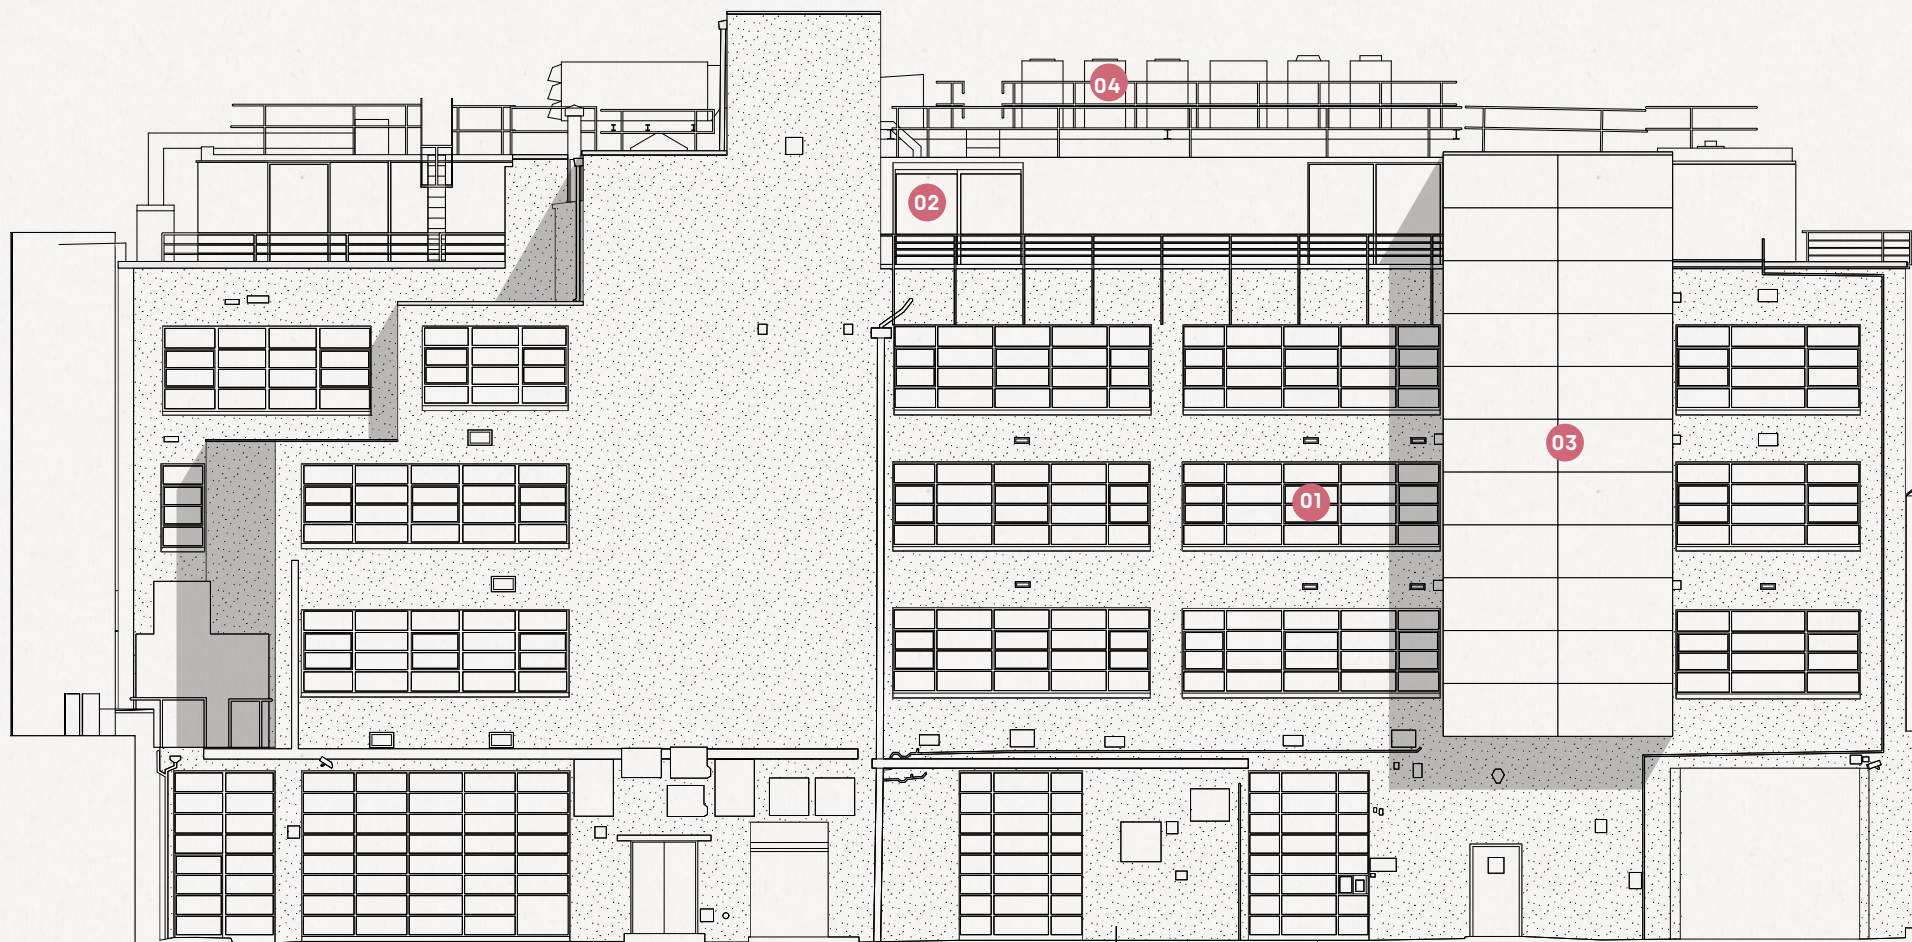
- 01 Windows perform poorly from an environmental perspective.
- 02 Significant West facing solar gain at 4th floor level.
- 03 Existing fire escape.
- 04 Prominent plant.

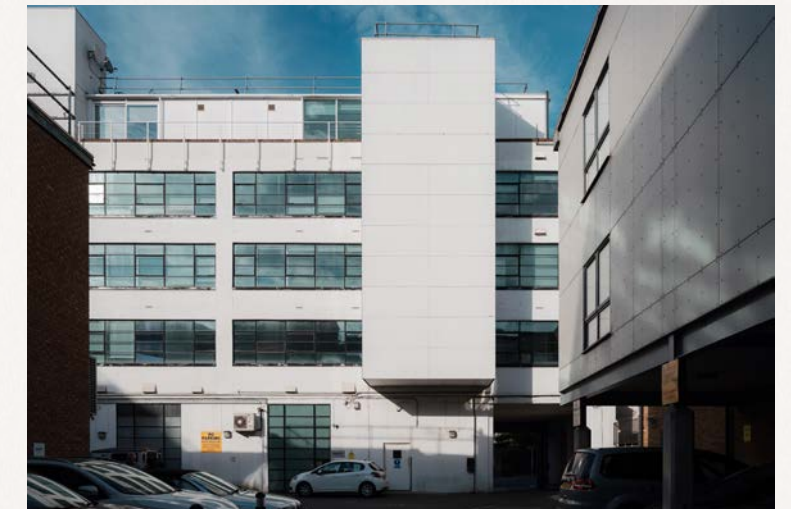
Rear elevation with overclad fire escape
