## Structural Report

## **Collapsed Balcony at**

**69 Albert Street**

Prepared by Dr. G. S Allen CEng MICE For Client Susan Plowden Dated September 2023

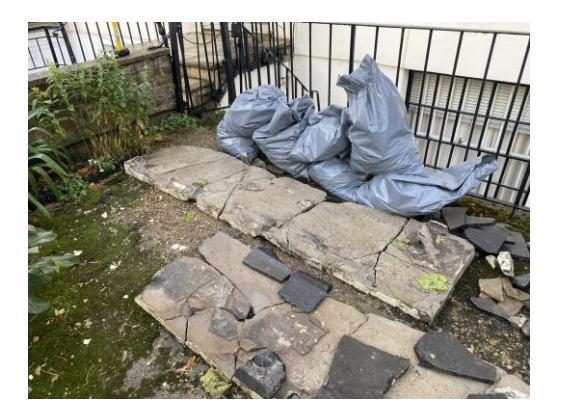
Figure 3.1 Balcony Sections

The laid out sections of the stone balcony are shown in Figure 3.1 and Figure 3.2.

Regarding the condition of the stone, it was noted to be quite soft, fragments were quite easily broken with a hammer. The stone also appeared saturated, upper sections appeared de-laminated and these could be easily removed in places.

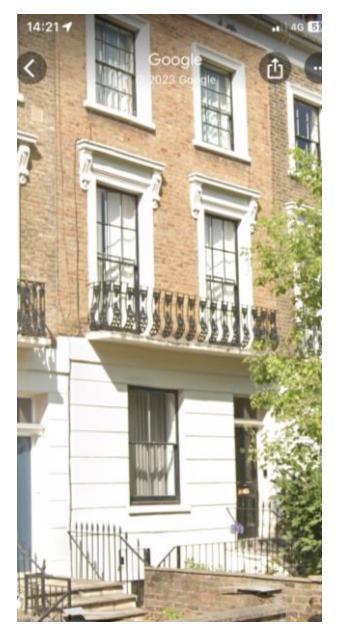
Figure 3.3 Google image prior to collapse

We referred to google images (see Figure 3.3, below) which does not indicate any significant defects that would have alerted a layperson owner to likely collapse.

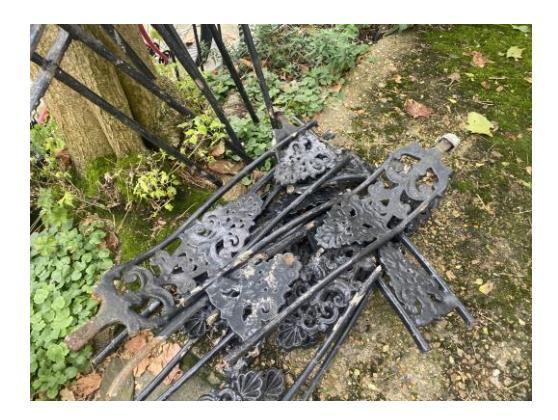
Figure 3.4 Balcony railing sections Figure 3

As a result of the collapse the cast iron balcony railings were damaged as they were connected to the stone balcony, although the railings did not form an integral part of its structural purpose.

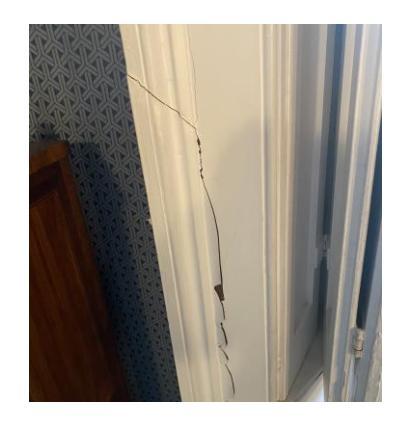
Figure 3.5 Internal damage

At ground floor there is damage to the timber window frame and surround, internally (see Figure 3.5) and the shutters now do not close properly.

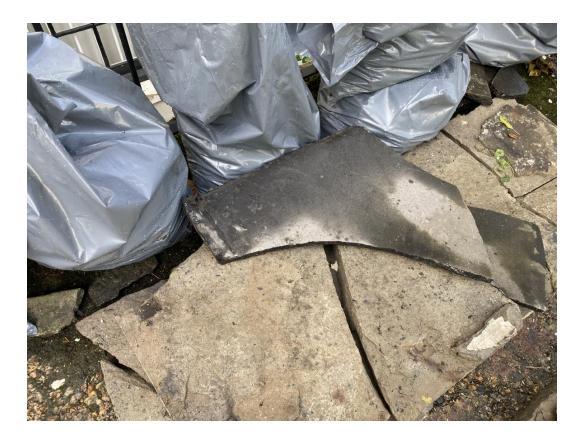
## Figure 4.1 Larger section of intact bitumen finish

See Figure 4.1 showing the large section of bitumen that covered the left side stone surface within the window reveal. Crucially the bitumen section is intact and

this would have fully obscured cracking to the stone work below, at the junction, which would have ordinarily alerted a homeowner to a potential problem.

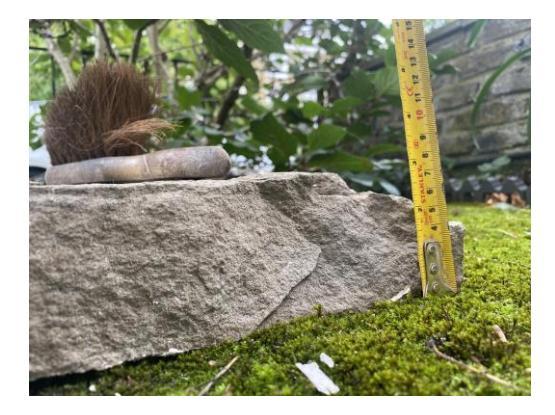
Upon close inspection of the laid out sections we noted that the stone was only 40mm thick on the left-hand side, adjacent to a railing embedment.

Given the 40mm thickness it is possible that failure initiated on the left hand side and progressed to the reminder of the balcony.

Note calculations indicate that balcony stone of 40mm thickness would be liable to collapse in bending at the junction.

Figure 4.2 Left corner of balcony thinning edge

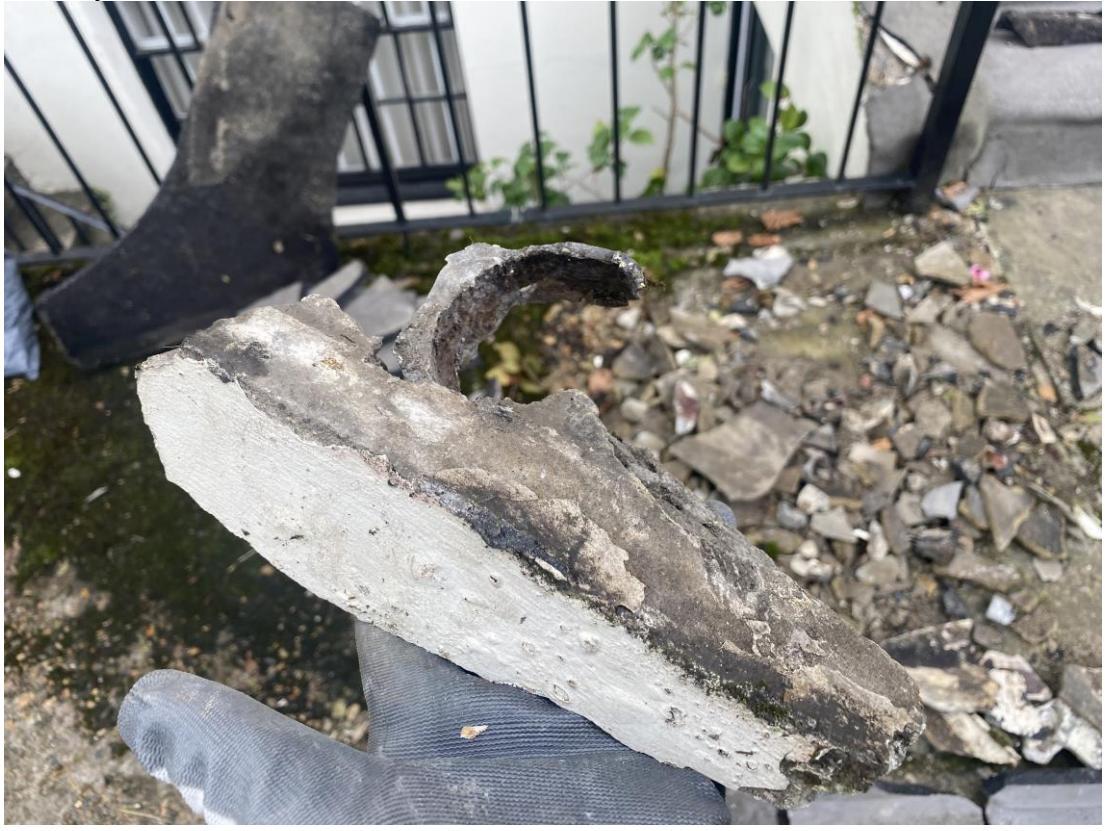
Stone section note embedded railing shoe

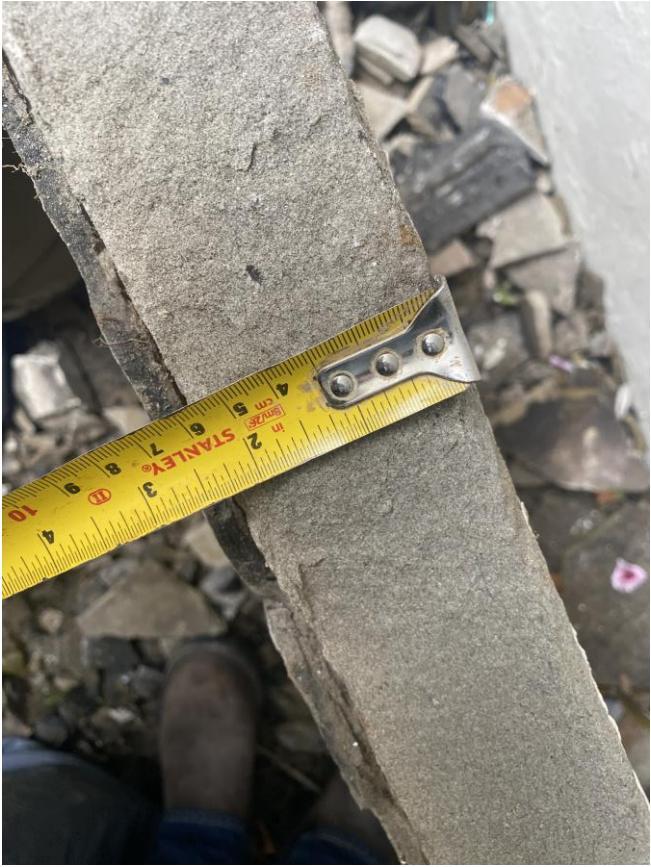
Stone balcony section 60mm thickness

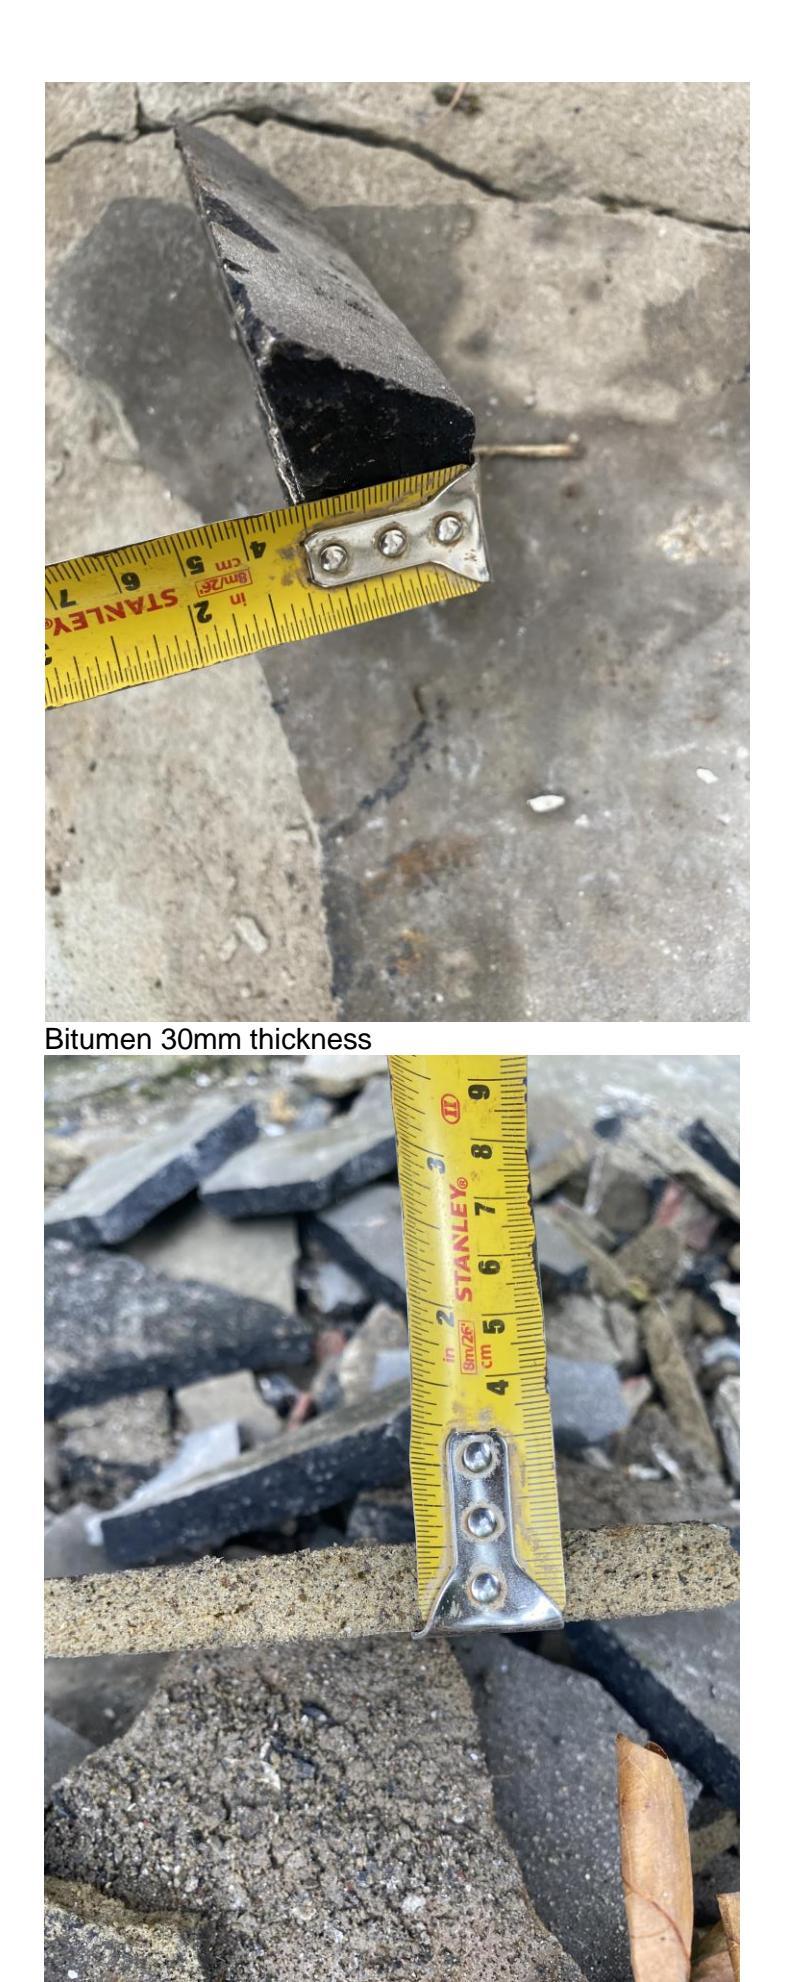
Cement mortar bed 10mm thickness

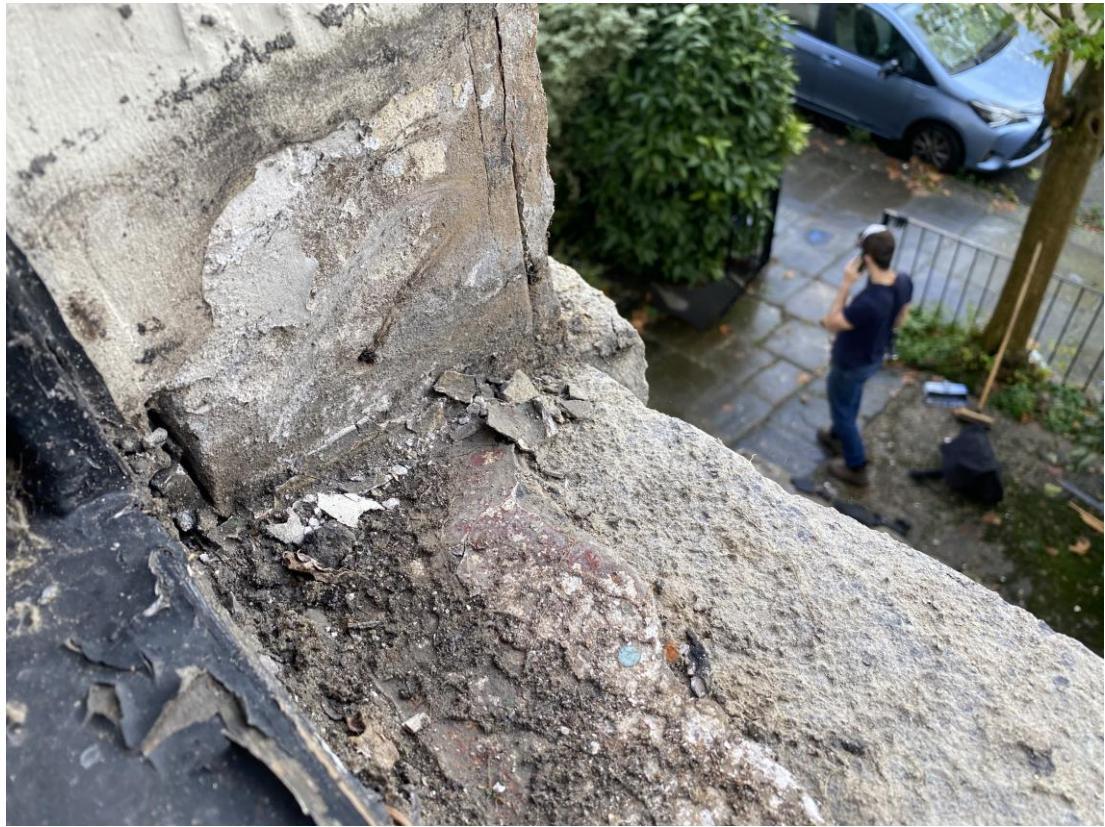
Left side window reveal, showing fracture at junction

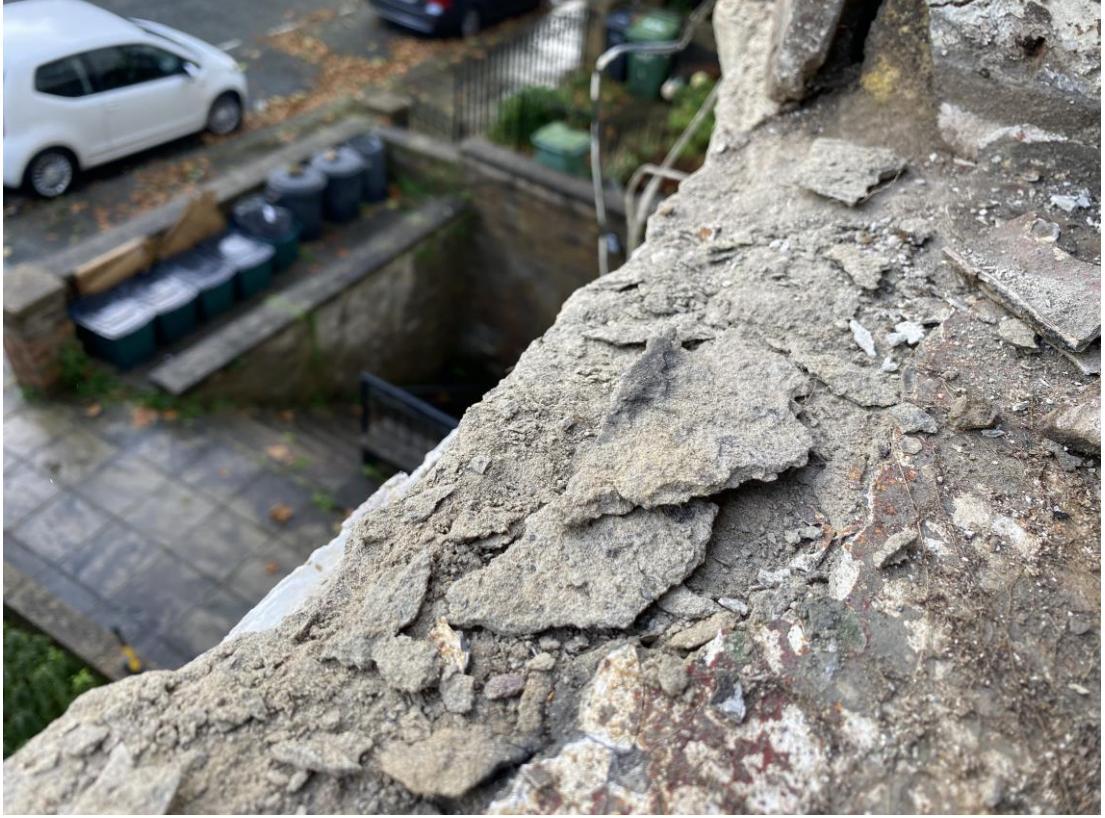
Left side window reveal, showing fracture at junction and delamination of upper surface

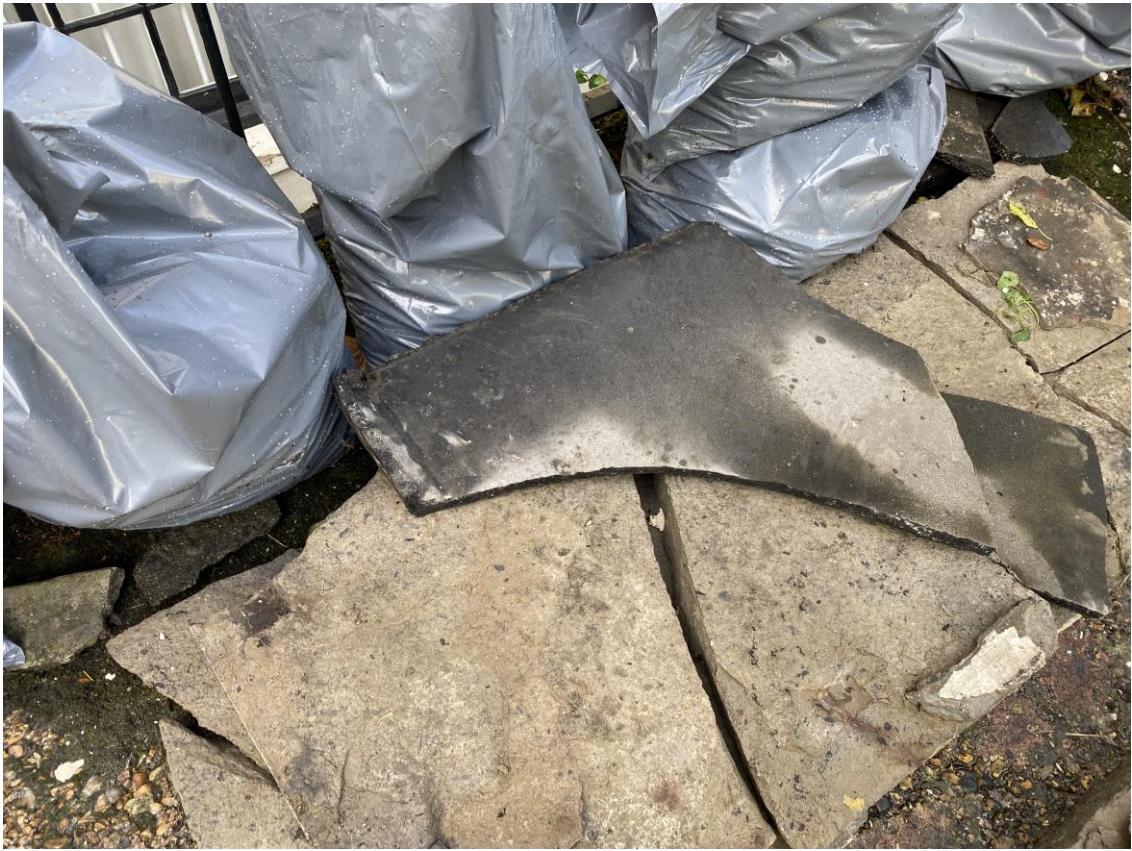
Large bitumen section obscuring cracks and condition of underlying stone balcony
